## STILLWATER SOUTH OVERLOOK

SHPO INV. # WA-OHC-005

**MNDOT HISTORIC ROADSIDE DEVELOPMENT  
STRUCTURES INVENTORY**

## Stabilization/Preservation/Restoration

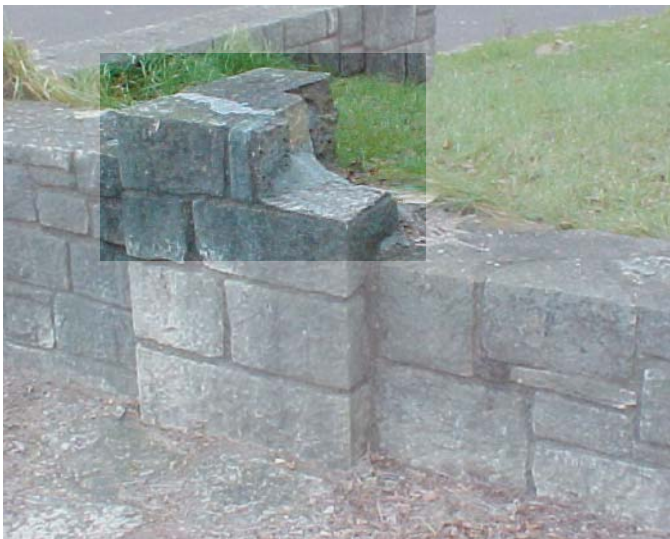
Missing stone(s) at wall pier

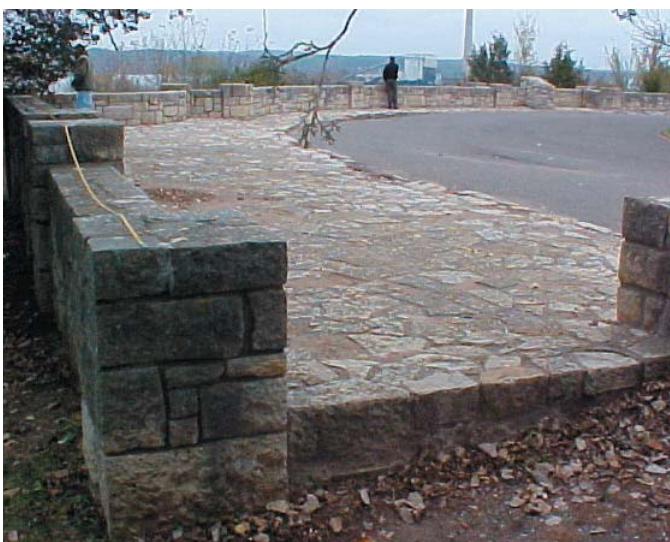
Pedestrian entrance at northwest corner

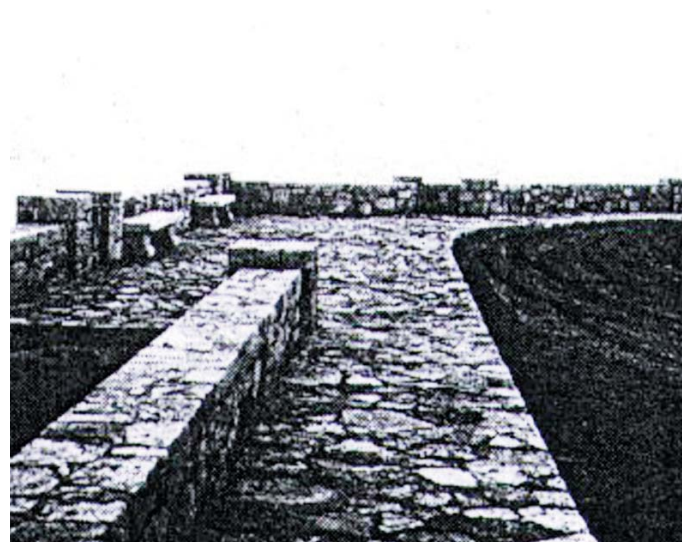
Original bench locations - taken from Olson photo album (1942)

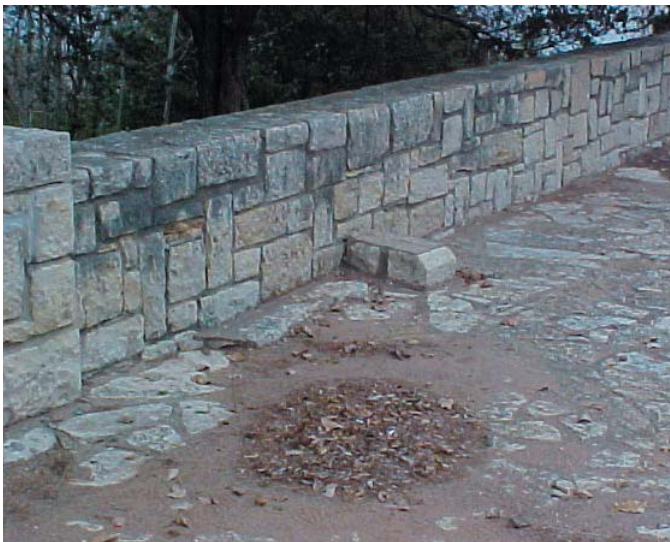
Original bench pedestal

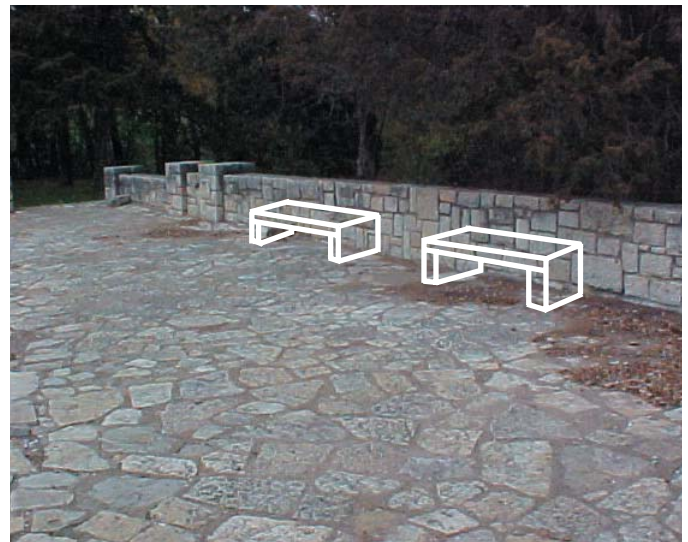
Original stone bench location

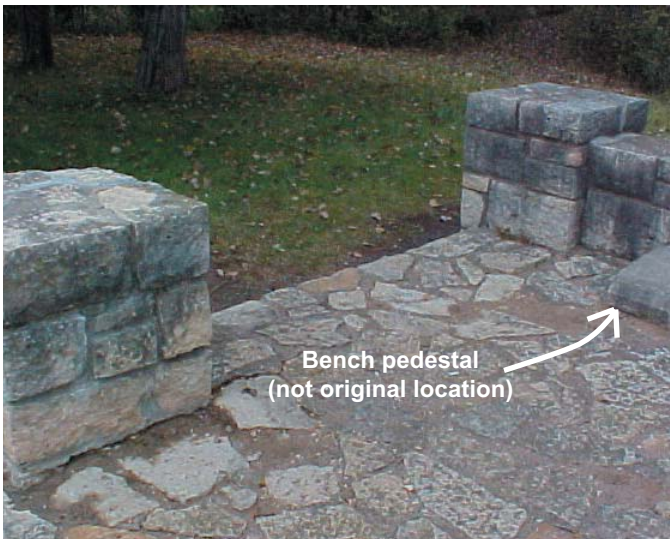
Bench pedestal  
(not original location)

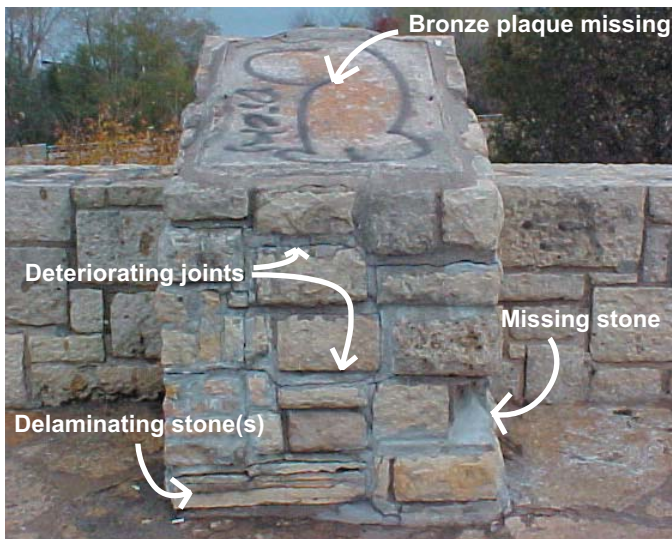
**Lectern-style Stone Marker:** A lectern-style historic stone marker was added to the wall in 1954 by the Minnesota Historical Society and the Minnesota Department of Highways. It replaced the timber-framed steel marker (see 6c above) in the rectangular lookout bay. A bronze plaque (see below) is mounted atop the stone lectern. The text of this marker is identical to that of the site's original steel sign. The limestone is in fair to poor condition; some stones are missing; graffiti is present. Most joints are failing.

Stone marker - added 1954

**Preservation/Restoration:** Catalog locations of each stone piece and dismantle the northeast overlook and adjacent sections of wall that have settled and are overturning. Reinstall as part of **Stabilization**. Repoint all other stone joints on remaining wall sections. Match original color, texture and style to existing joints. MnDOT shall periodically inspect to ascertain condition and take action if deterioration has advanced. Clean stone surfaces of all graffiti and dirt. Replace missing units with stored units or matching pieces cut to the same shape of the original pieces. Repoint entire marker area. Do not remove patina from plaque.

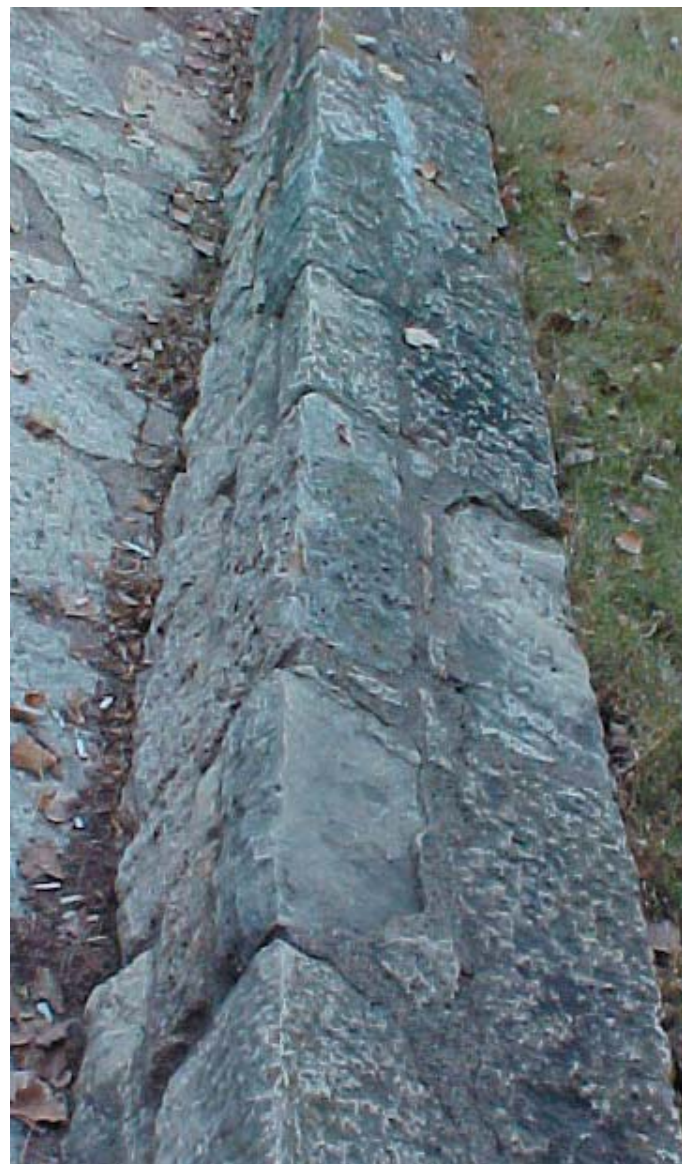
West wall condition

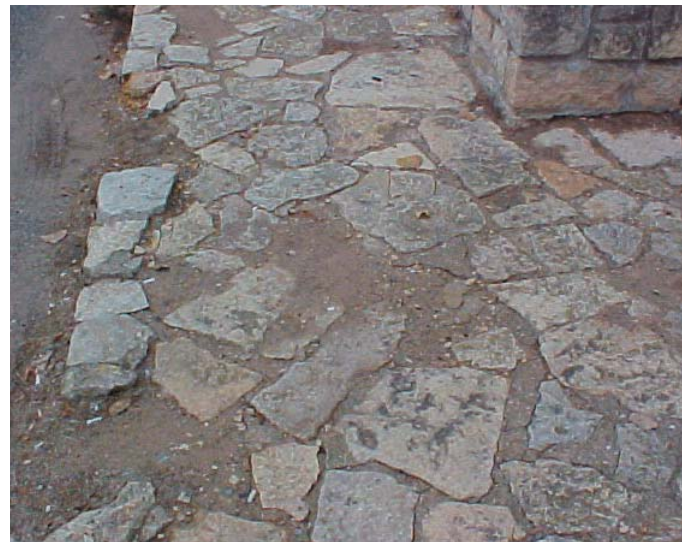
- **Assessment:** A 5'-0" wide flagstone walk parallels and abuts the overlook wall and extends into the lookouts. The walk is very uneven and has settled in numerous areas. 35% to 50% of the flagstones are either loose or missing. Asphalt overlays cover up to the first 18" of both the curb and flagstone along the north wall. The joints have deteriorated and need repair.

**Flagstone condition at northwest  
(near pedestrian entrance)**

**Preservation/Restoration:** Remove all asphalt from surfaces and then remove all flagstone. Catalog locations of each piece. Install compacted sand base as required and reset stones to provide positive drainage and provide a safe walking surface. Add grout joints to match the color, texture and size of the original joints. MnDOT to periodically inspect the stonework joints and to properly make repairs before problems become severe. **Work Period:** 1 - 5 years (This work must occur simultaneously with the Overlook construction.)

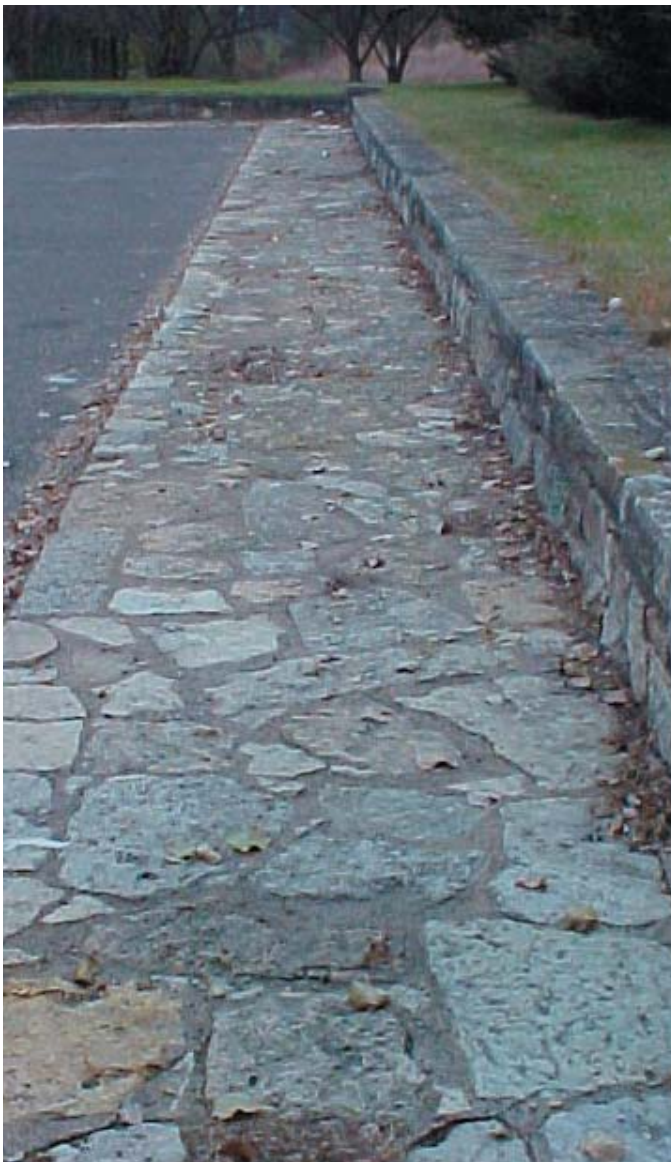
**Flagstone walk condition at west end - looking north**

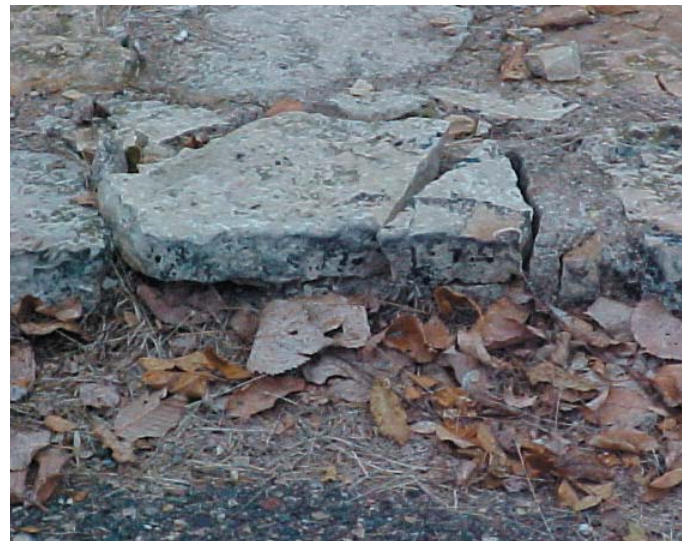
**Loose flagstones**

**Stabilization:** MnDOT shall monitor the state of all loose stones to insure that they remain in place until construction begins. **Work Period:** Immediately

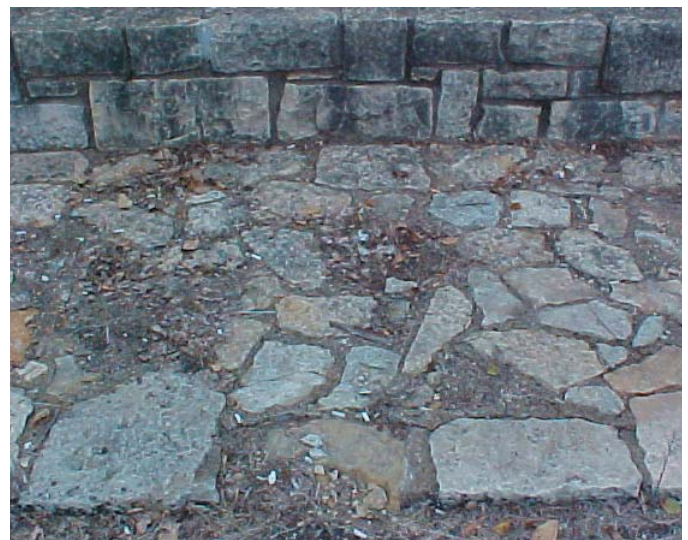
**Typical flagstone condition**

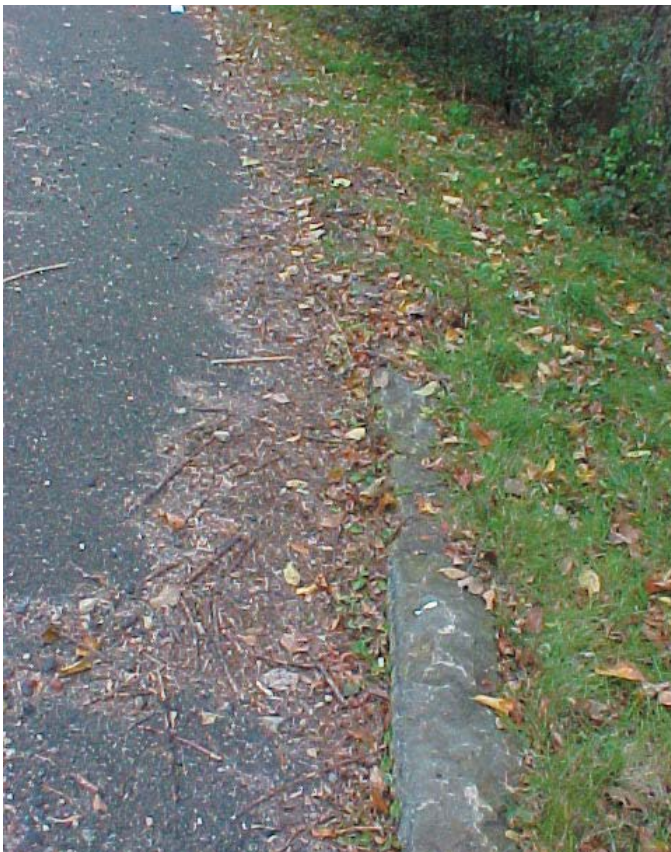
- **Assessment:** The site is approached from the south by a curbed lined drive. The limestone curbing also lines the circular island and flagstone walk bordering the wall. The curbing along the island and flagstone walk appears square-cut, while along the entrance drive the curbing is larger and more irregularly shaped. Repaving efforts have obscured the view of about 20% of the curb. The curbing which aligns the entrance drive is severely overgrown with vegetation.

Overgrown limestone

- **Recommendations:**  
Stabilization: Remove excess turf and regularly maintain. **Work Period:** Immediately  
Preservation/Restoration: Remove excess turf. Remove existing asphalt and re-grade. Replace/reset any loose and/or missing limestone curb sections, carefully matching new stones to originals. Provide a stone accessible curb cut at the north-west edge of the drive near the pedestrian opening--remove curb and lay flagstone to meet the required accessible slope. All new mortar joints shall match original depth, style, color and texture. MnDOT shall periodically inspect the stonework joints and properly repair any problem areas as they appear. **Work Period:** 3 - 5 years

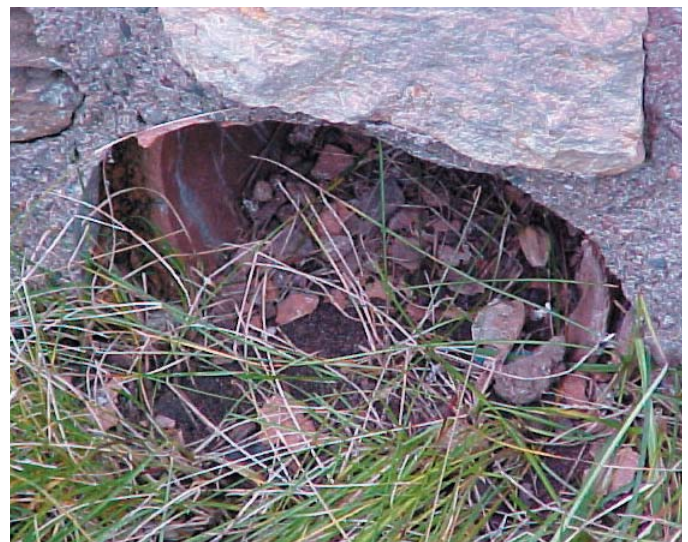
Original clay tile weep at base of wall

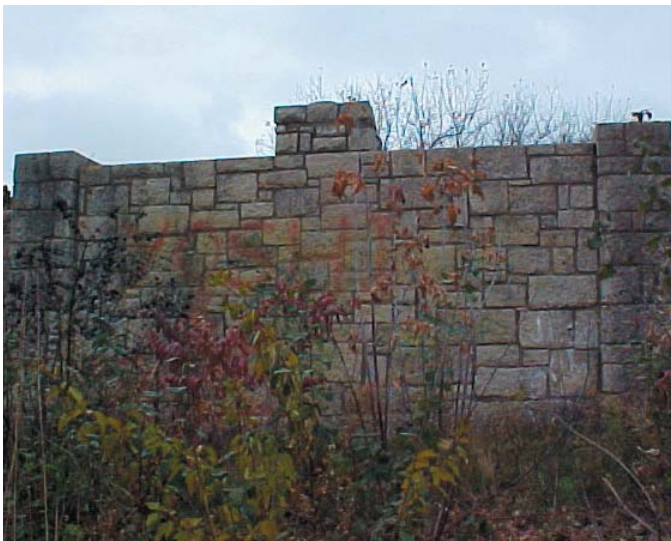
the grade on the west and southwestern sides to approximately 9'-0" on the east side. A 6'-10" pedestrian opening exists at the northwest corner and is one step above the adjacent turf. No evidence exists that this connected to a trail. The limestone is in fair condition but areas have graffiti on them and are soiled from environmental conditions. Stones are missing in various locations as indicated on the Field Note drawings. Mortar joints are in poor condition and several areas show recent repairs, which do not match the original size, texture and color of the original grout. The northeast section of the wall appears to be leaning toward the road below.

Rectangular overlook - east elevation

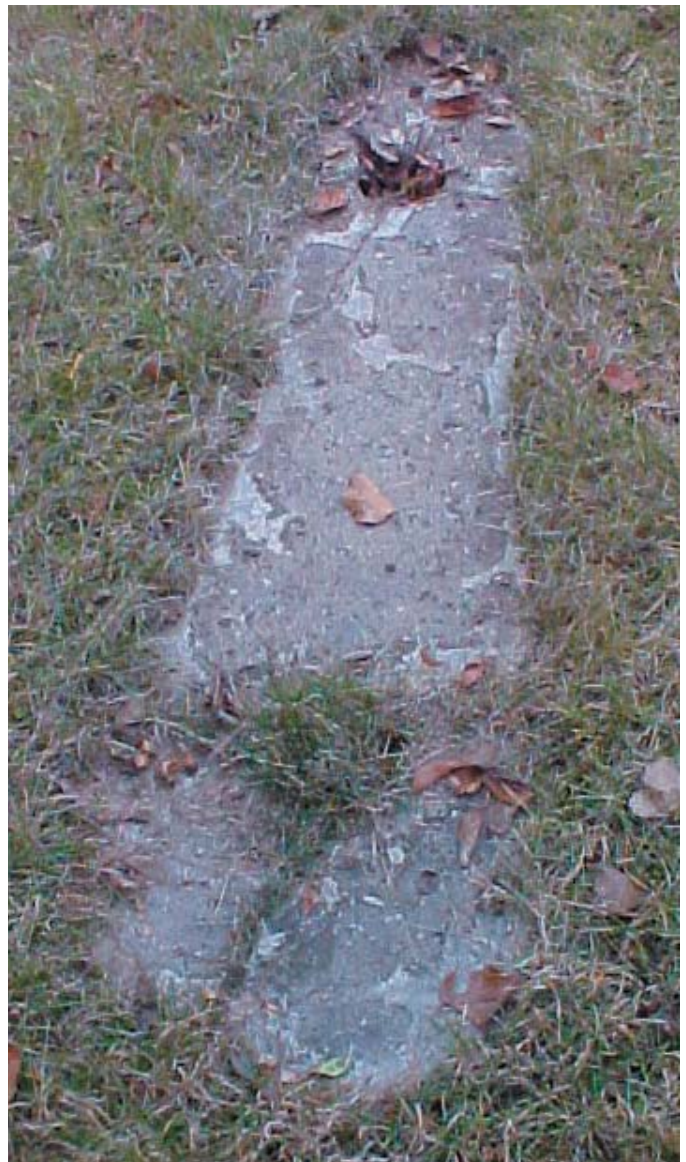
- **Assessment:** In circa 1970 a concrete base measuring 5'-0" long by 1'-6" wide and flagpole was added to the site. The base contains a hole measuring 6" in diameter. It is located a few feet from the west wall and is in poor condition. No flagpole exists.
- **Recommendations:**  
Stabilization: None.  
Preservation/Restoration: Remove concrete base and fill with topsoil and plant with grass seed to match existing turf. **Work Period:** 1 - 5 years

Concrete flagpole base
