# Pavement Condition Report

## Marshall - Southwest Minnesota Regional Airport (MML)

**December 2016**

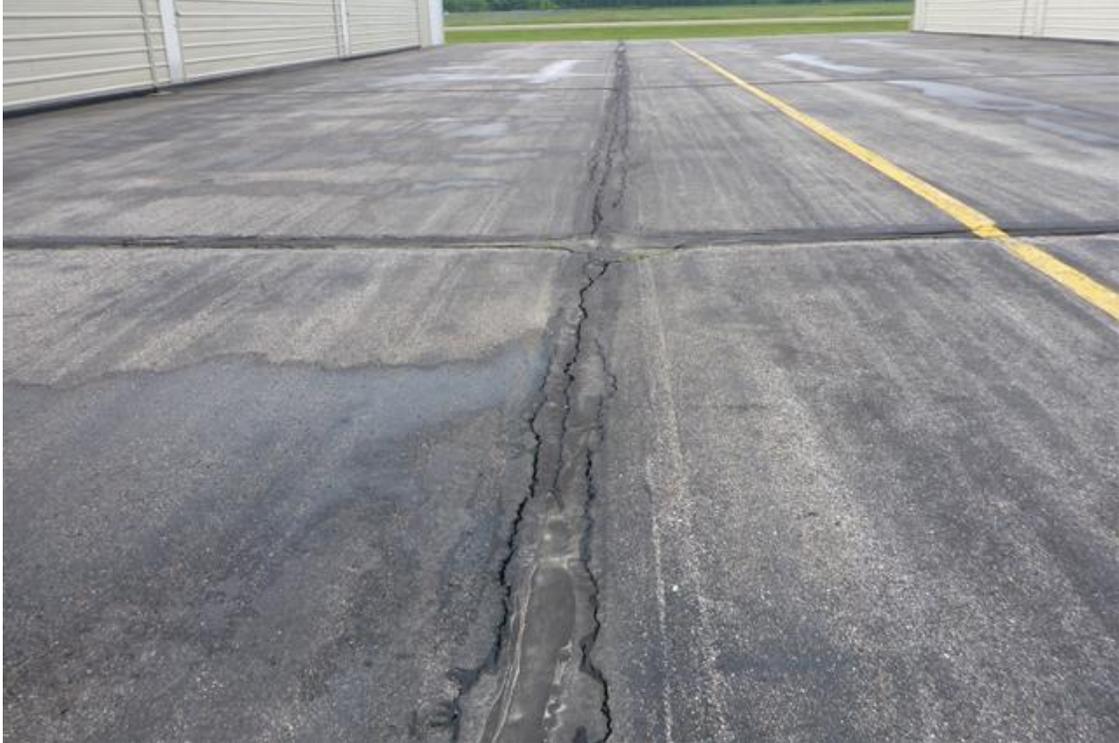
MML TLF 003 (PCI = 74)

Branch ID	Section ID	Surface type <sup>1</sup>	Section area (SF)	LCD <sup>2</sup>	2013 PCI	2016 PCI	Drop in PCI/Yr <sup>3</sup>	% Deduct due to		Distress types
								Load <sup>4</sup>	Climate <sup>5</sup>	
RY1230	002	AC	63,000	2006	89	85	2	-	100	L&T cracking
RY1230	003	AC	211,400	2006	87	83	2	-	100	L&T cracking
RY1230	004	AC	4,000	2006	84	80	2	-	100	L&T cracking
RY1230	005	AAC	221,000	2006	92	86	1	-	100	L&T cracking, Weathering
RY220	001	AC	30,375	1996	72	67	2	-	100	L&T cracking
RY220	002	AC	37,350	2006	85	81	2	-	100	L&T cracking
RY220	003	AC	160,875	1996	62	60	2	18	81	Alligator cracking, Depression, L&T cracking, Patching, Raveling, Swelling, Weathering
RY220	004	AAC	62,625	2005	78	75	2	-	100	L&T cracking
TLE	001	AC	10,930	2001	71	76	2	43	57	L&T cracking, Patching, Rutting
TLF	001	AC	24,255	2001	80	76	2	-	100	L&T cracking, Weathering
TLF	002	AC	15,000	2001	85	75	2	-	100	L&T cracking
TLF	003	AC	15,200	2001	80	74	2	40	60	Alligator, L&T cracking

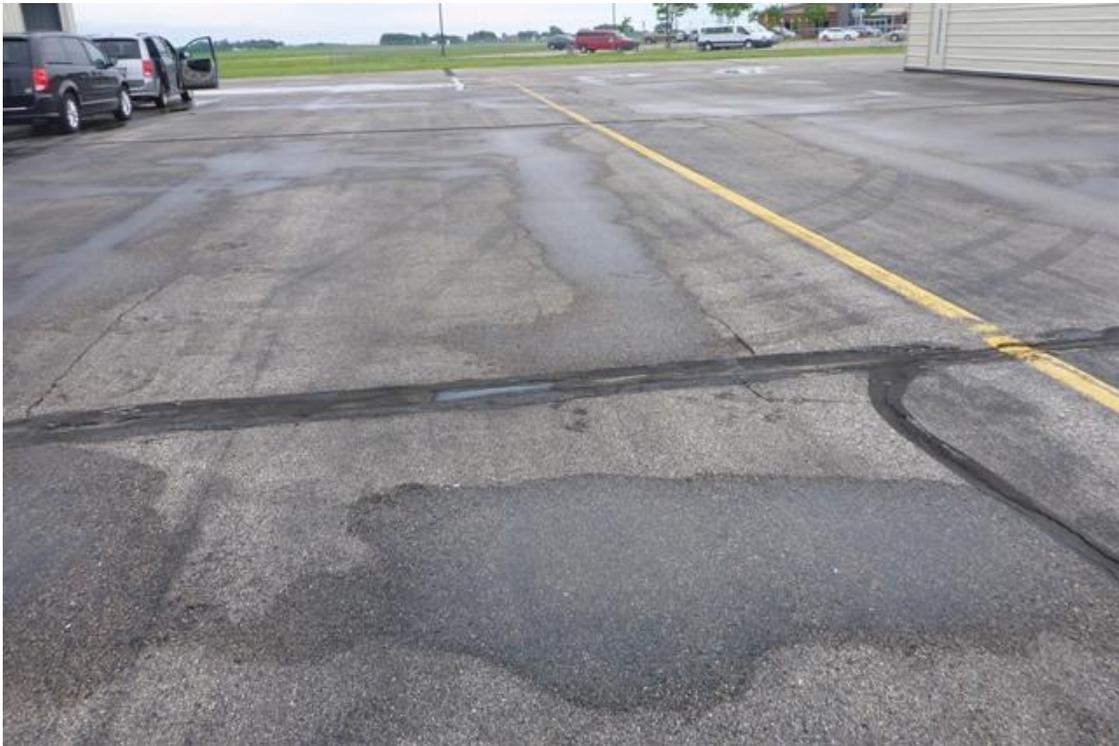
MML TLF 004 (PCI = 82)

TLF	004	AC	15,400	2001	88	82	1	-	100	L&T cracking
TLF	005	AC	15,200	2001	87	83	1	-	100	L&T cracking
