Pavement Condition Report

Wheaton Municipal Airport (ETH)

December 2017

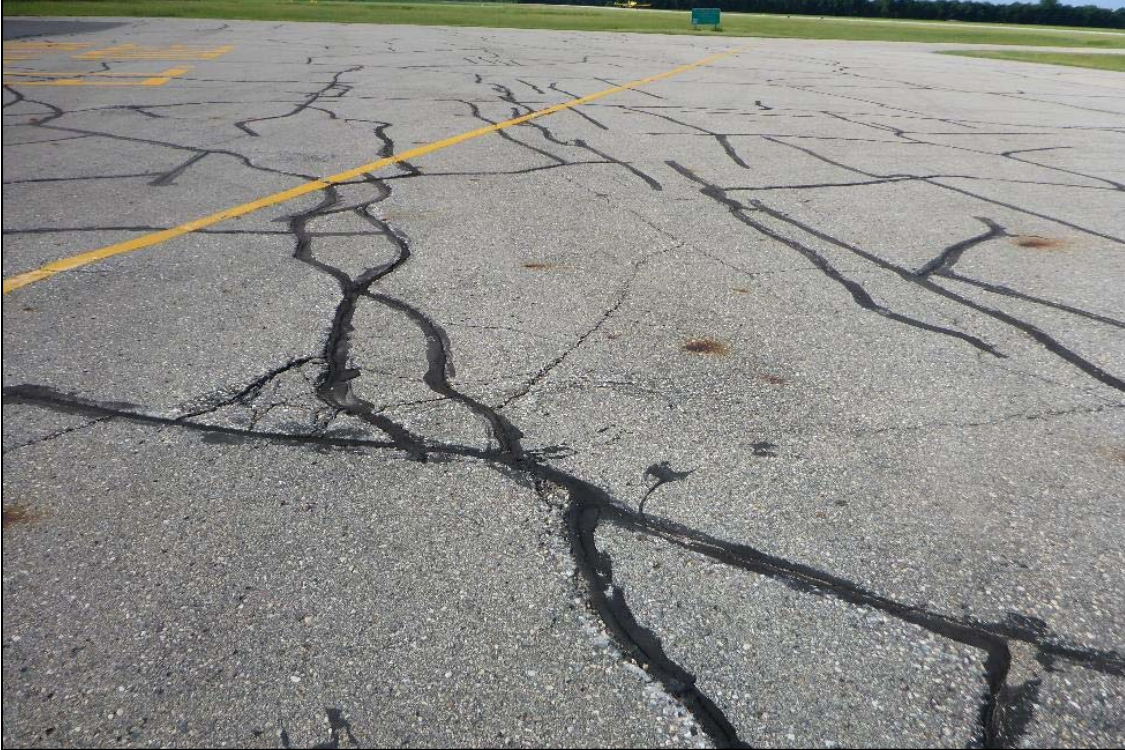
ETH APA 001 (PCI = 62)

Network: ETH			Name: WHEATON			
Branch: APA	Name: APRON A	Use: APRON	Area: 42,500 SqFt			
Section: 001	of 1	From: 100	To: 303	Last Const.: 7/1/2008		
Surface: AC	Family: MN2013 Asphalt Aprons	Zone: W	Category: 1	Rank: S		
Area: 42,500 SqFt	Length: 225 Ft	Width: 150 Ft				
Slabs:	Slab Length: Ft	Slab Width: Ft	Joint Length: Ft			
Shoulder:	Street Type:	Grade: 0	Lanes: 0			
Section Comments:						
Last Insp. Date: 6/17/2017	Total Samples: 9	Surveyed: 4				
Conditions: PCI: 62						
Inspection Comments:						
Sample Number: 100	Type: R	Area: 5000.00 SqFt	PCI: 62			
Sample Comments:						
52	RAVELING	L	200.00 SqFt			
48	L & T CR	L	720.00 Ft			
52	RAVELING	M	60.00 SqFt			
Sample Number: 201	Type: A	Area: 5000.00 SqFt	PCI: 53			
Sample Comments:						
56	SWELLING	L	36.00 SqFt			
56	SWELLING	M	15.00 SqFt			
52	RAVELING	L	150.00 SqFt			
48	L & T CR	M	38.00 Ft			
48	L & T CR	L	780.00 Ft			
Sample Number: 300	Type: R	Area: 5000.00 SqFt	PCI: 63

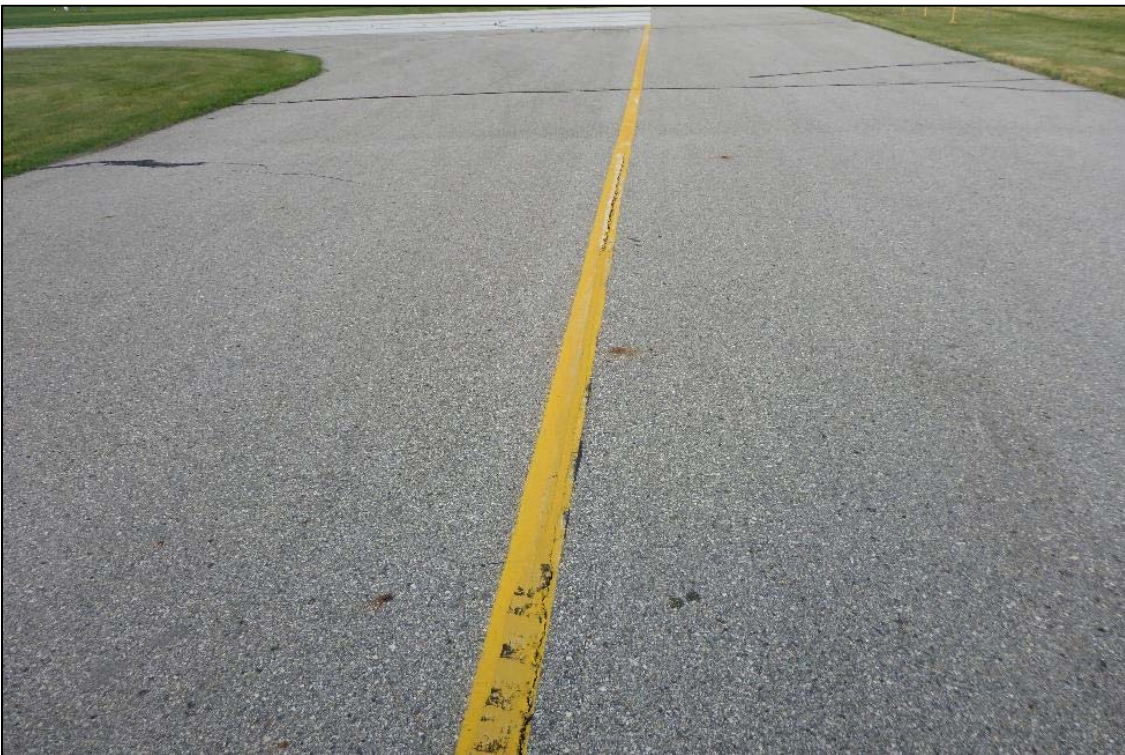
ETH CTA 001 (PCI = 68)

Conditions: PCI: 68

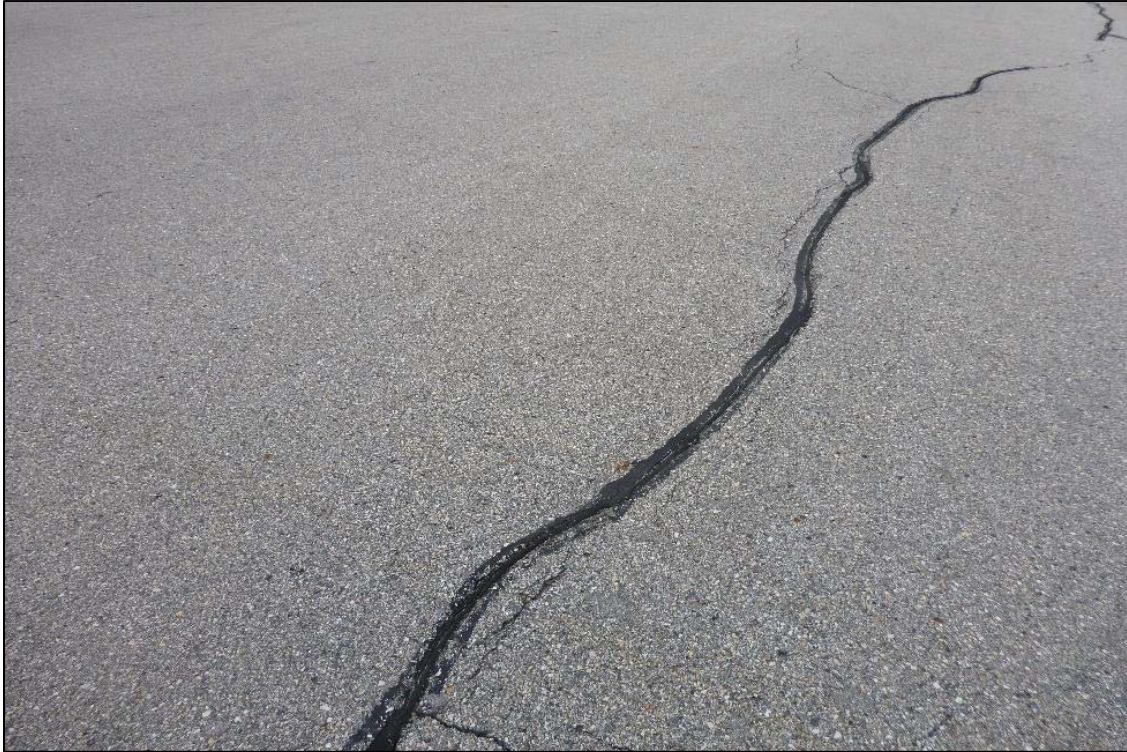
ETH RTA 001 (PCI = 75)

Conditions: PCI: 75

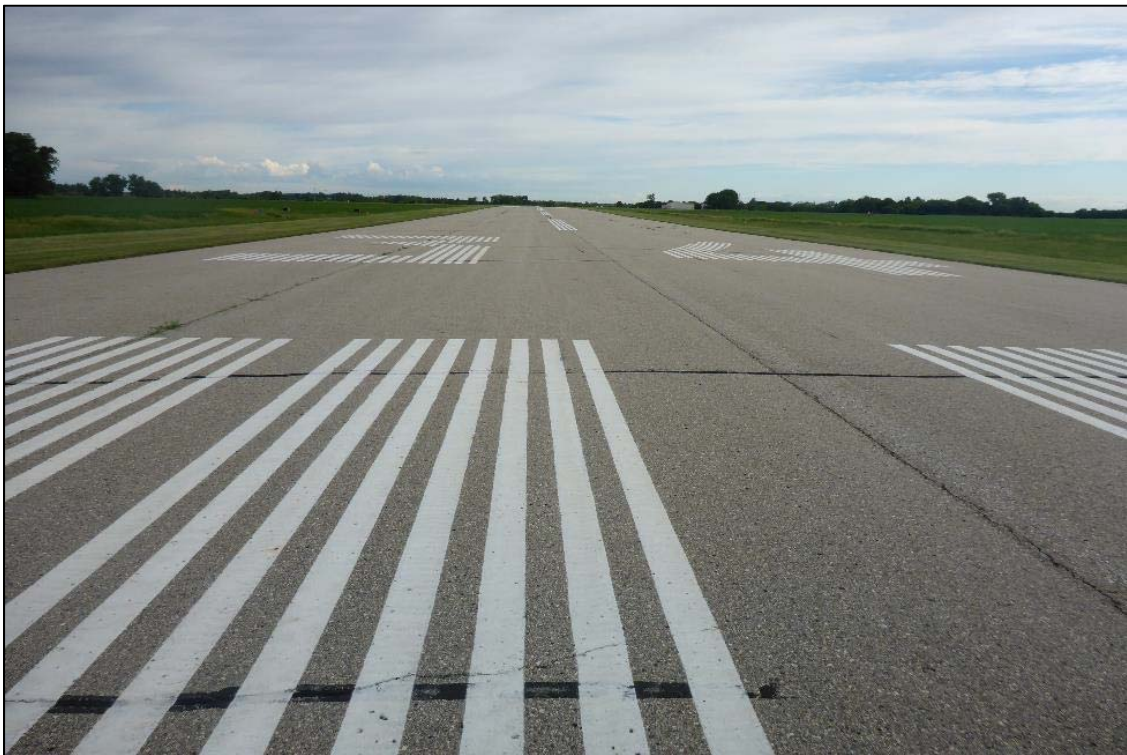
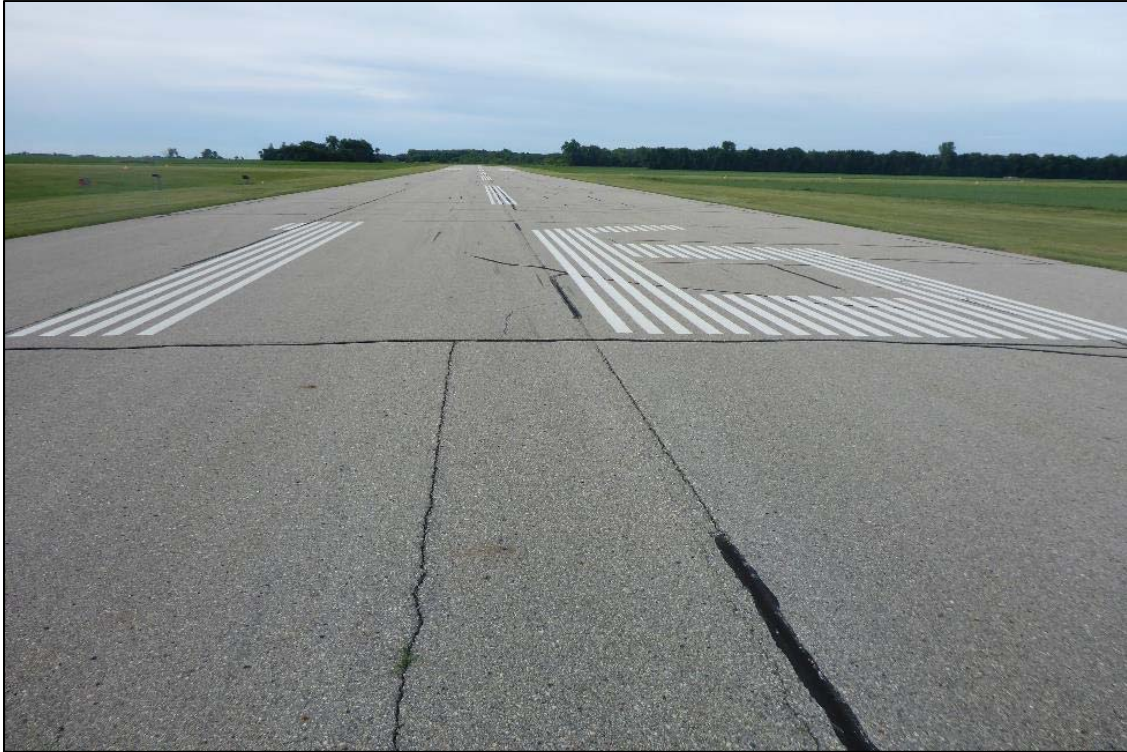
ETH RY1634 001 (PCI = 64)

Network:	ETH	Name:	WHEATON						
Branch:	RY1634	Name:	RUNWAY 16-34	Use:	RUNWAY	Area:	247,500 SqFt		
Section:	001	of 1	From:	100	To:	165	Last Const.: 6/1/2007		
Surface:	AC	Family:	MN2013 Asphalt Runways	Zone:	W	Category:	1	Rank:	P
Area:	247,500 SqFt	Length:	3,300 Ft	Width:	75 Ft				
Slabs:		Slab Length:	Ft	Slab Width:	Ft	Joint Length:	Ft		
Shoulder:		Street Type:		Grade:	0	Lanes:	0		
Section Comments:									
Last Insp. Date:	6/17/2017	TotalSamples:	66	Surveyed:	7				
Conditions:	PCI: 64								
Inspection Comments:									
Sample Number:	106	Type:	R	Area:	3750.00 SqFt	PCI:	62		
Sample Comments:									
56	SWELLING	L	6.00	SqFt					
57	WEATHERING	L	300.00	SqFt					
48	L & T CR	L	115.00	Ft					
48	L & T CR	M	100.00	Ft					
48	L & T CR	M	117.00	Ft					
48	L & T CR	L	121.00	Ft					
57	WEATHERING	L	1000.00	SqFt					
Sample Number:	115	Type:	R	Area:	3750.00 SqFt	PCI:	64		
Sample Comments:									
52	RAVELING	L	350.00	SqFt

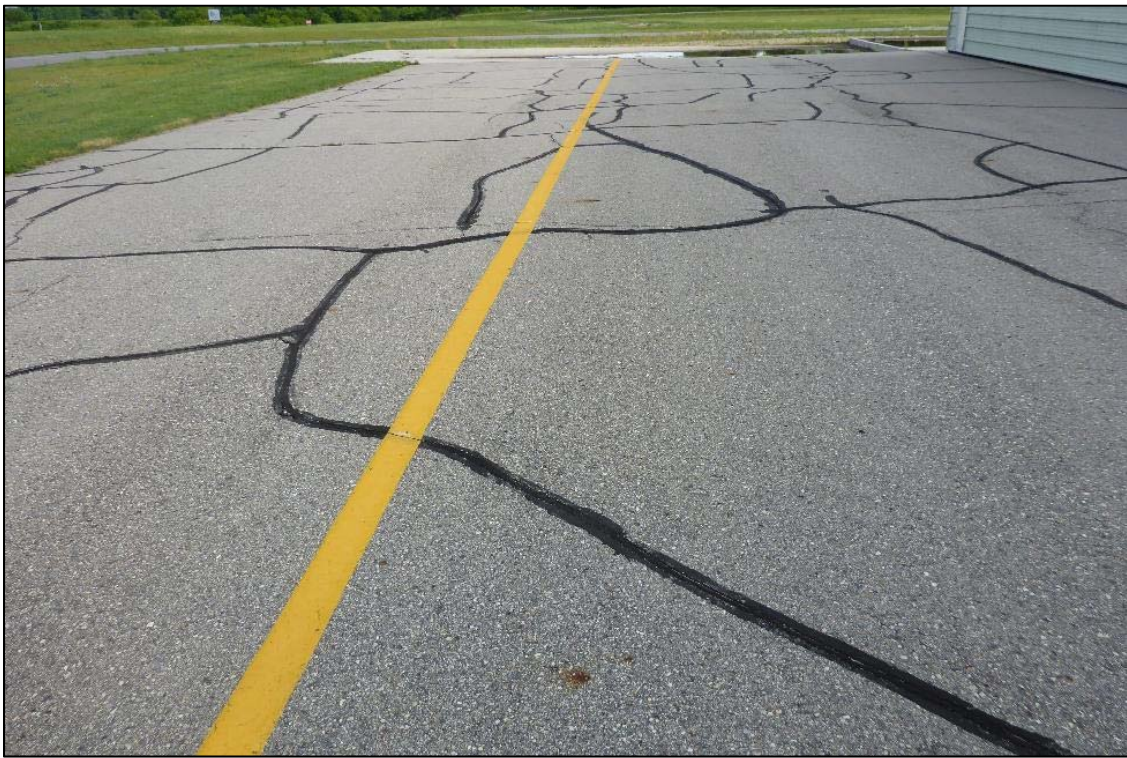
ETH TLA 001 (PCI = 63)

Conditions: PCI: 63

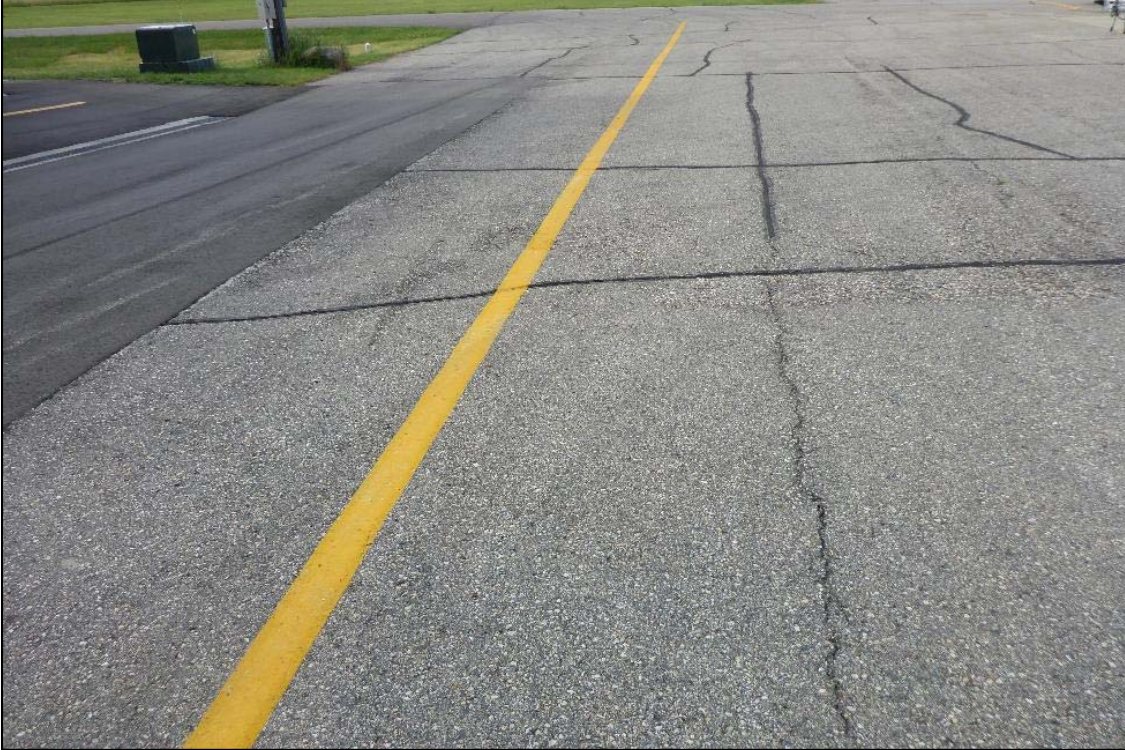
ETH TLA 002 (PCI = 66)

Conditions: PCI: 66
