Pavement Condition Report

Princeton Municipal Airport (PNM)

December 2017

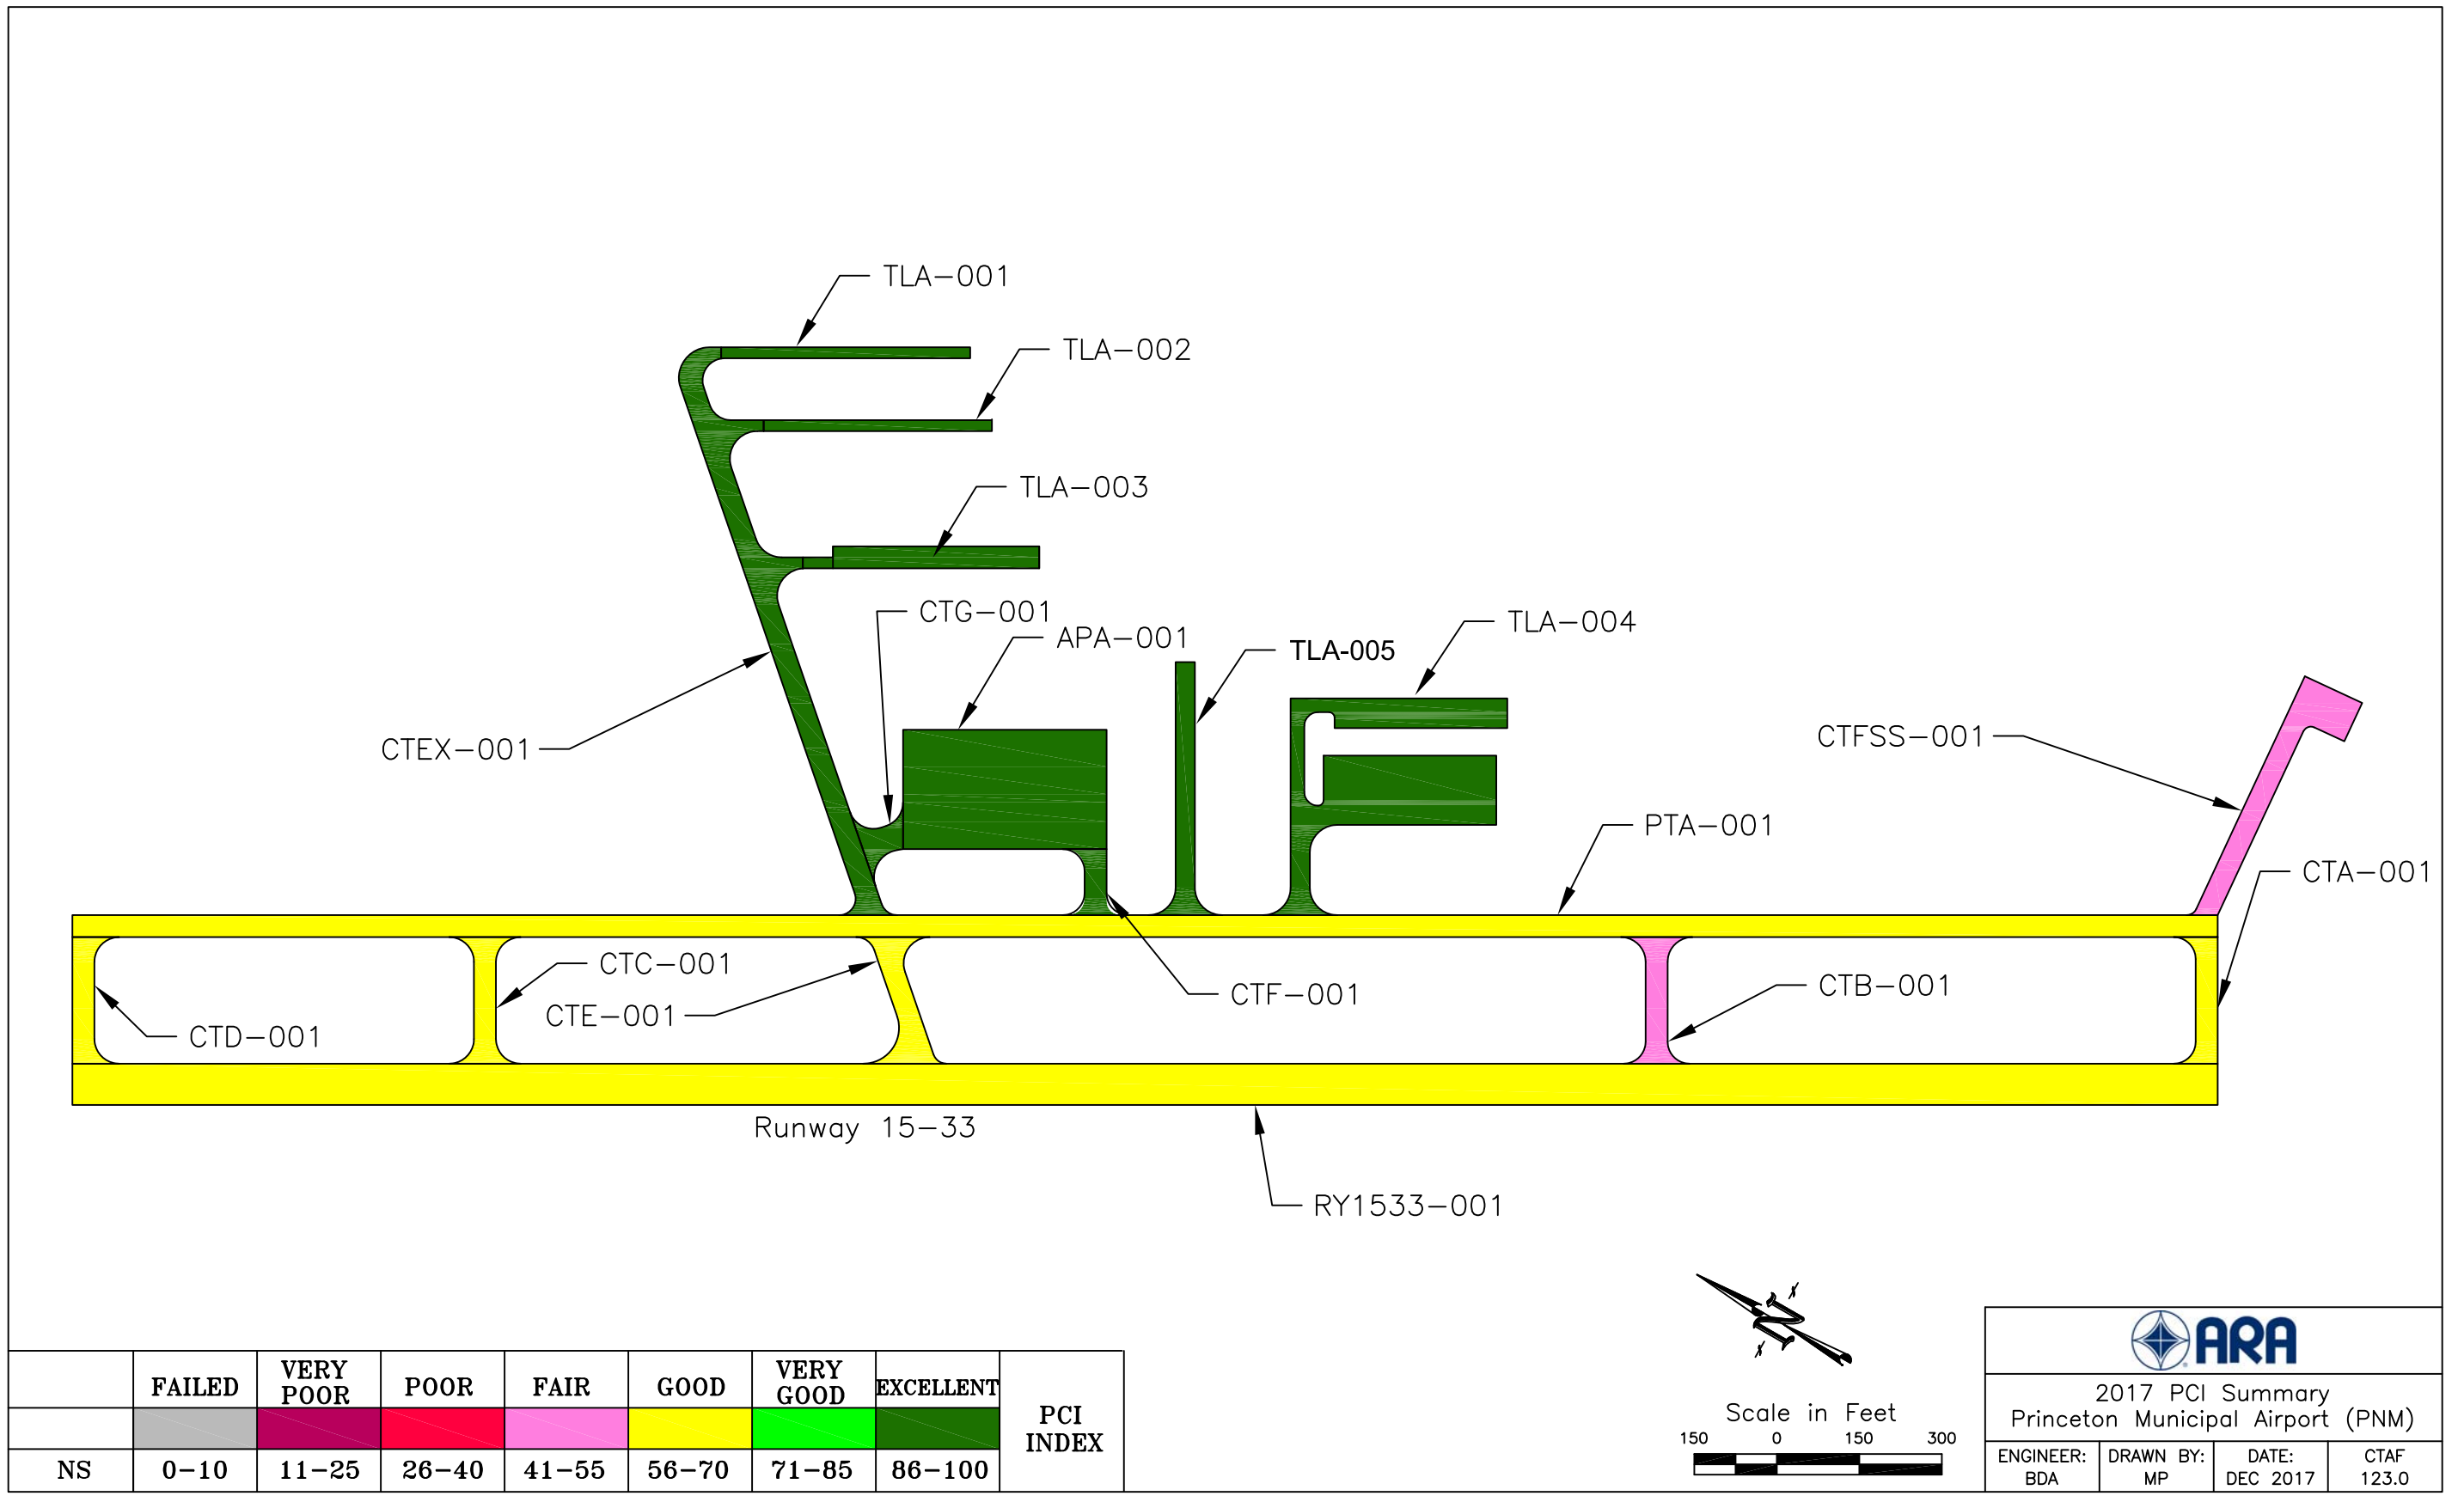
Figure 4. 2017 Pavement Condition Index Rating at Princeton Municipal Airport (PNM).

Figures 5 and 6 present the overall PCI for PNM by area distribution and pavement use, respectively. Table 3 presents the PCI summary for each section at PNM, including the drop in PCI per year. Generally, pavement sections will deteriorate between 1 and 3 PCI points per year. Sections deteriorating at higher rates may need maintenance above the normal application rates and should be closely monitored in case major repairs become necessary earlier than expected.

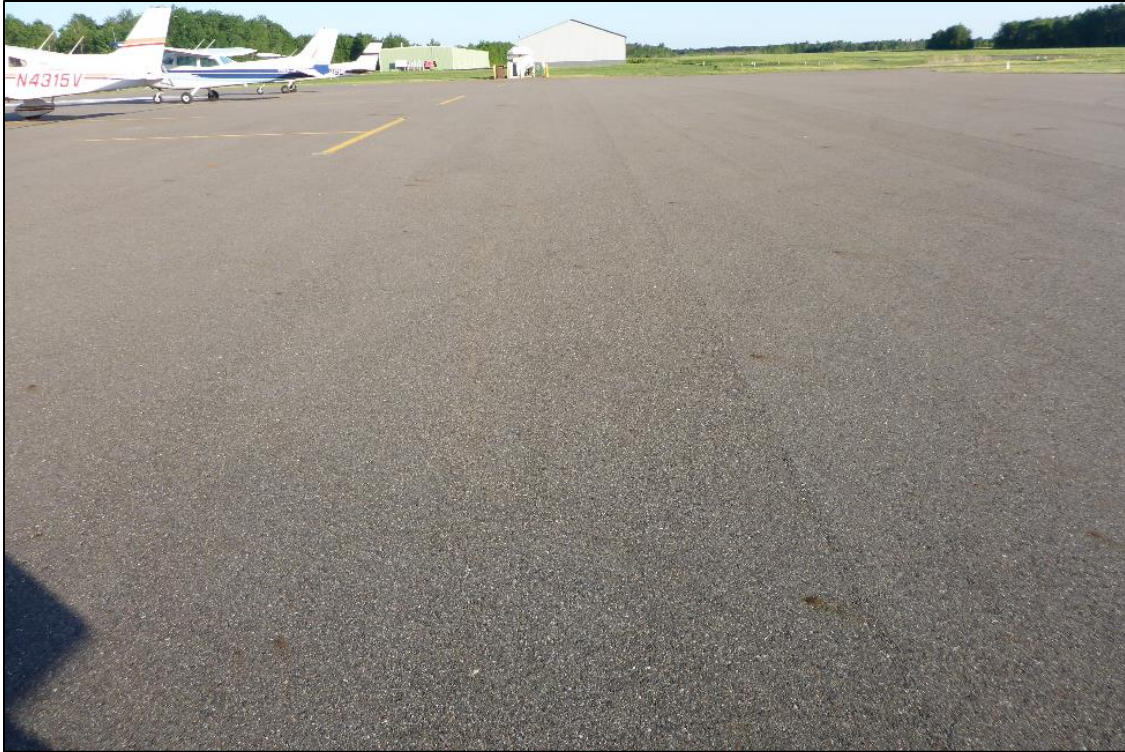
PNM APA 001 (PCI = 95)

Conditions: PCI: 95

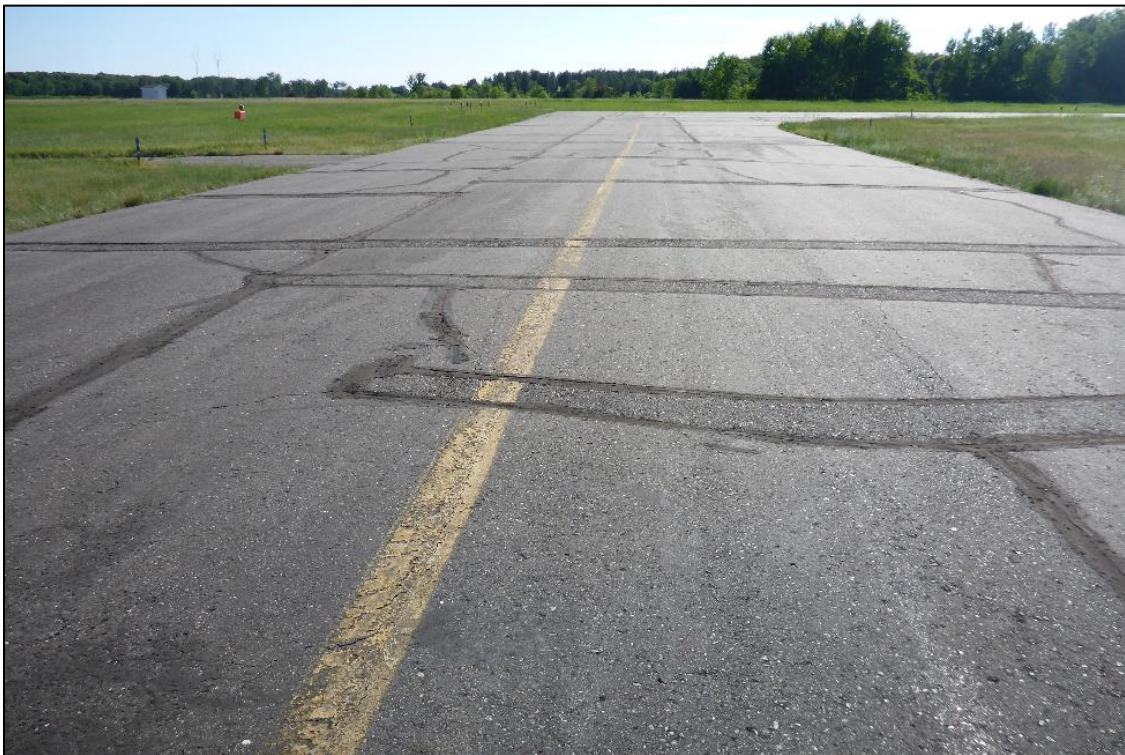
PNM CTA 001 (PCI = 61)

Conditions: PCI: 61

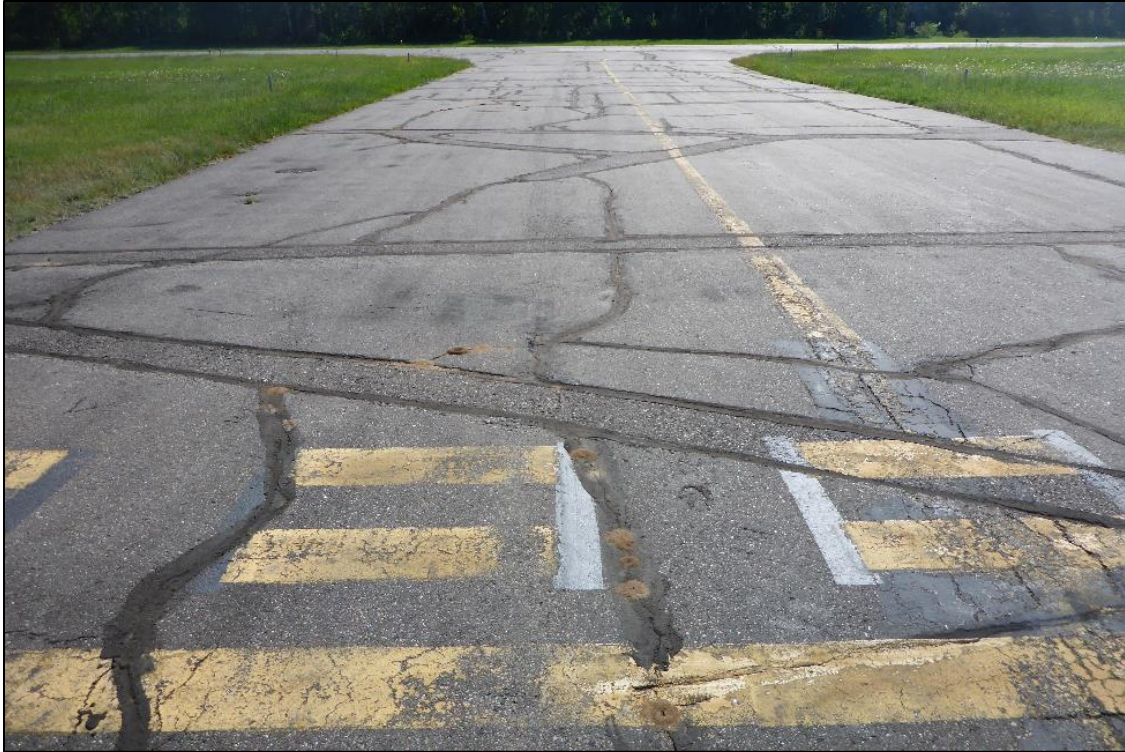
PNM CTB 001 (PCI = 44)

Conditions: PCI: 44

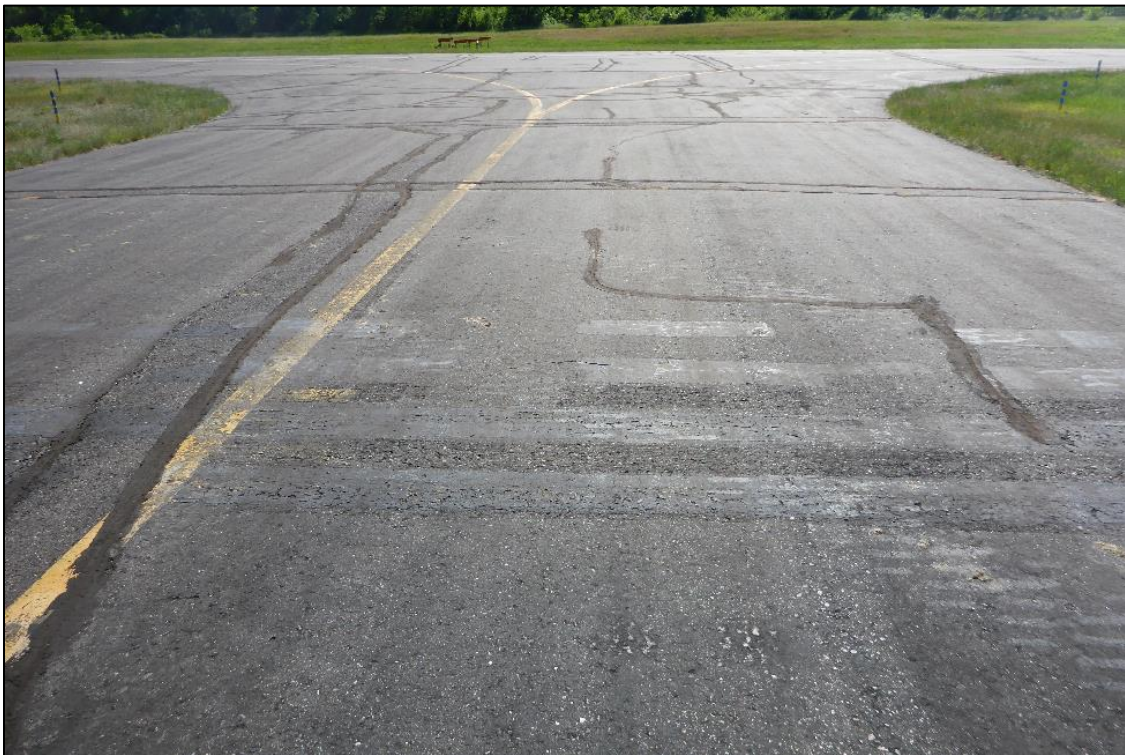
PNM CTC 001 (PCI = 63)

Conditions: PCI: 63

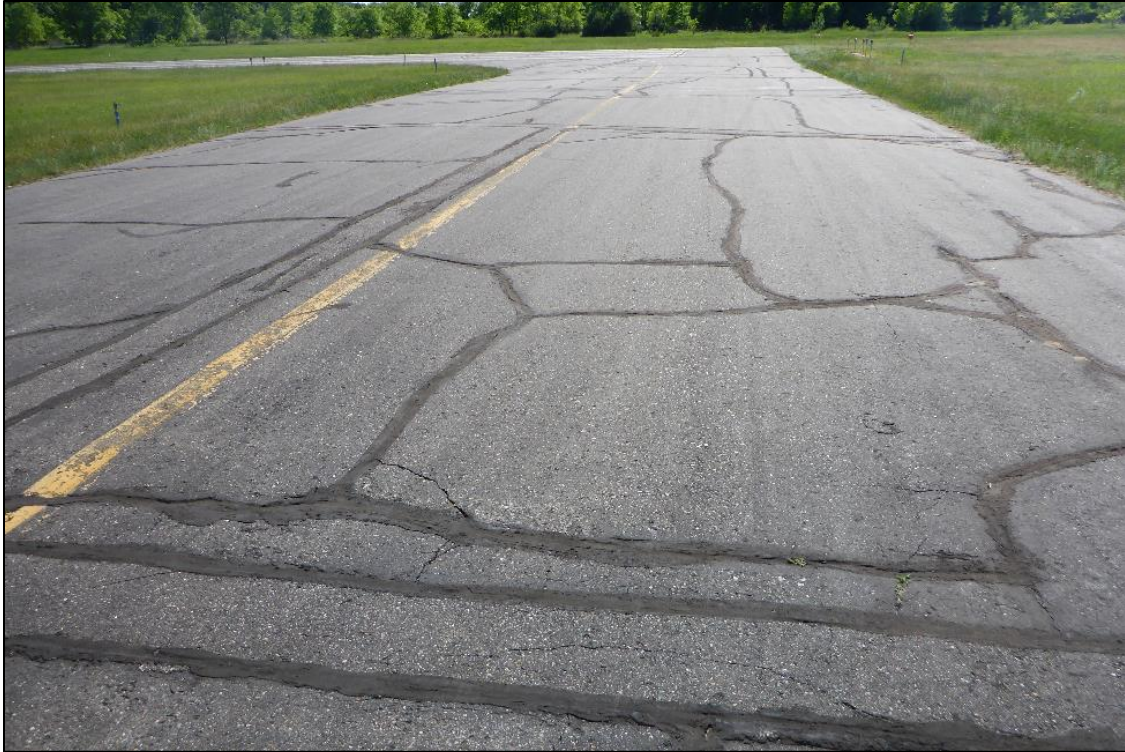
PNM CTD 001 (PCI = 65)

Conditions: PCI: 65

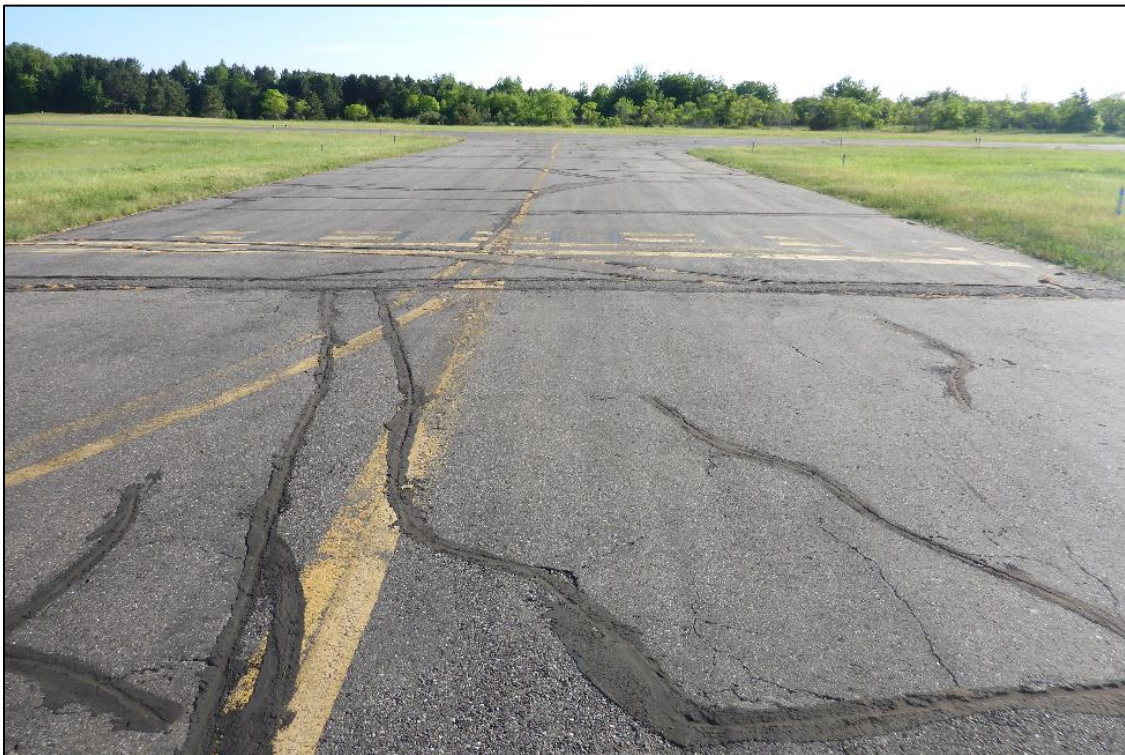
PNM CTE 001 (PCI = 60)

Conditions: PCI: 60

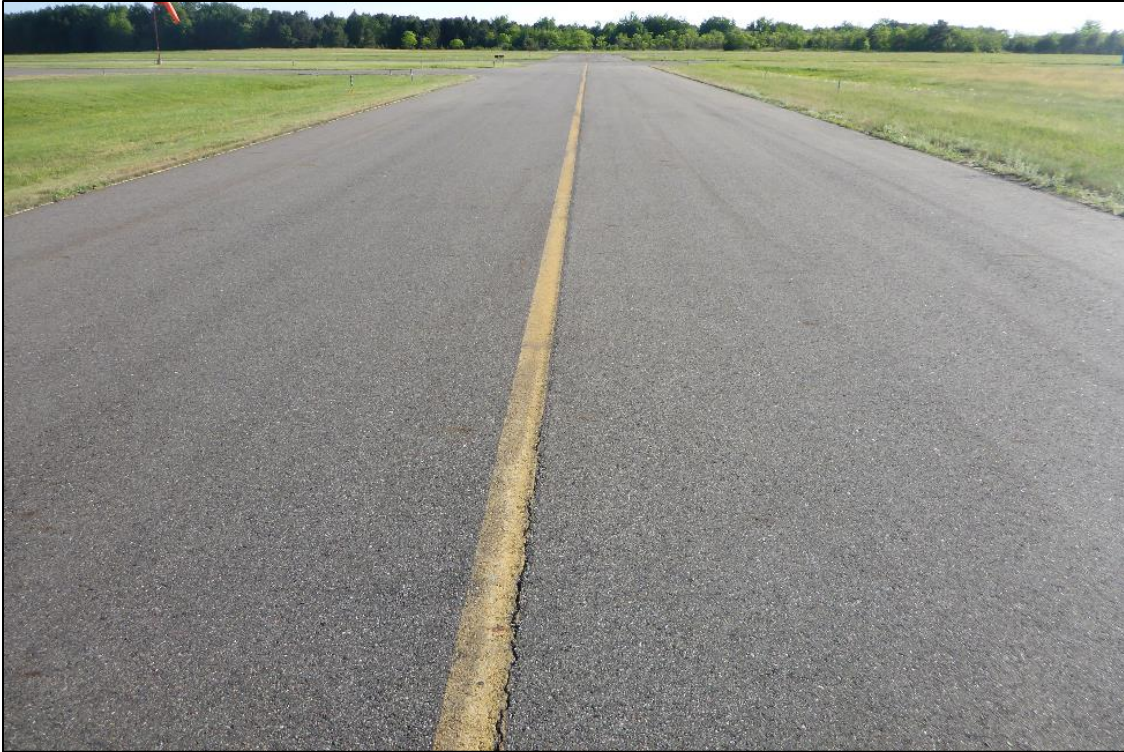
PNM CTEX 001 (PCI = 97)

Network:	PNM	Name:	PRINCETON				
Branch:	CTEX	Name:	Conn TW C extended	Use:	TAXIWAY	Area:	50,900 SqFt
Section:	001	of 1	From:	503	To:	514	Last Const.: 9/30/2013
Surface:	AAC	Family:	MN2013 Asphalt Taxiways	Zone:	E	Category:	1 Rank: P
Area:	50,900 SqFt	Length:	1,205 Ft	Width:	40 Ft		
Slabs:		Slab Length:	Ft	Slab Width:	Ft	Joint Length:	Ft
Shoulder:		Street Type:		Grade:	0	Lanes:	0
Section Comments:							
Last Insp. Date:	6/6/2017	TotalSamples:	12	Surveyed:	3		
Conditions:	PCI: 97						
Inspection Comments:							
Sample Number:	505	Type:	R	Area:	4000.00 SqFt	PCI:	100
Sample Comments:							
<No Distress>							
Sample Number:	509	Type:	R	Area:	4000.00 SqFt	PCI:	94
Sample Comments:							
48	L & T CR	L	58.00	Ft			
Sample Number:	512	Type:	R	Area:	4000.00 SqFt	PCI:	96
Sample Comments:							
48	L & T CR	L	16.00	Ft

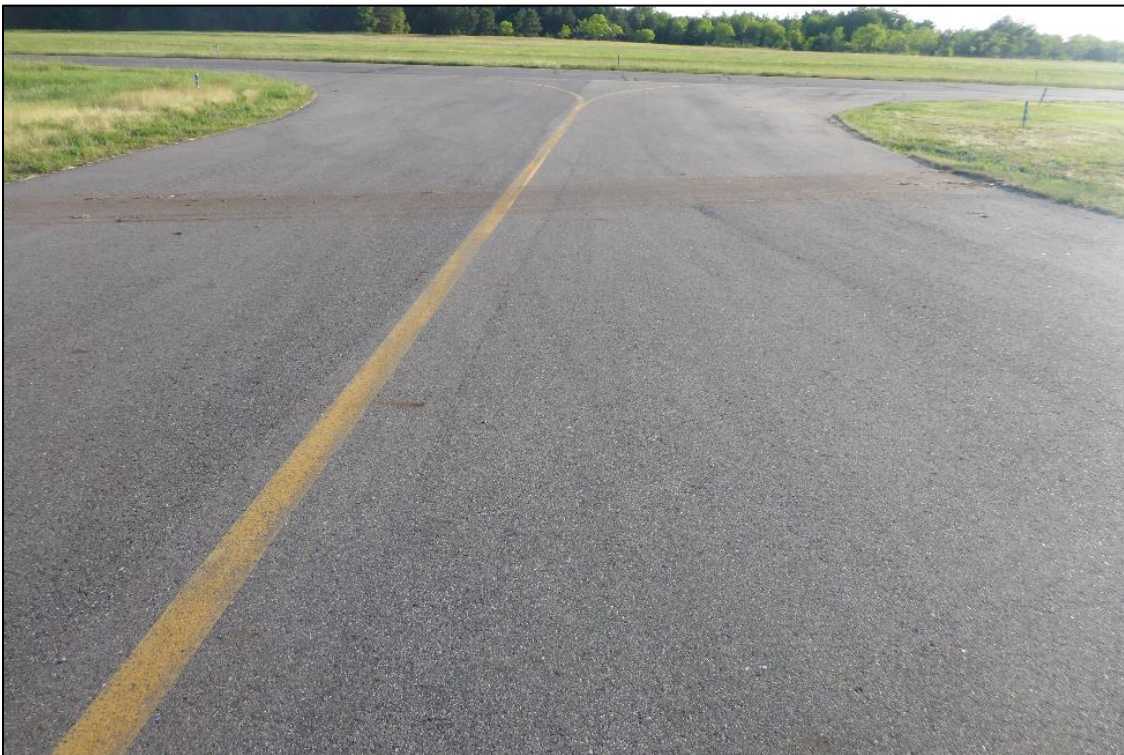
PNM CTF 001 (PCI = 98)

Network:	PNM	Name:	PRINCETON						
Branch:	CTF	Name:	CONNECTING TAXIWAY F	Use:	TAXIWAY	Area:	6,250 SqFt		
Section:	001	of 1	From:	600	To:	600	Last Const.:	9/30/2013	
Surface:	AC	Family:	MN2013 Asphalt Taxiways	Zone:	E	Category:	1	Rank:	P
Area:	6,250 SqFt	Length:	130 Ft	Width:	40 Ft				
Slabs:		Slab Length:	Ft	Slab Width:	Ft	Joint Length:	Ft		
Shoulder:		Street Type:		Grade:	0	Lanes:	0		
Section Comments:									
Last Insp. Date:	6/6/2017	TotalSamples:	1	Surveyed:	1				
Conditions:	PCI: 98								
Inspection Comments:									
Sample Number:	600	Type:	R	Area:	6210.00 SqFt	PCI:	98		
Sample Comments:									
48	L & T CR	L	3.00	Ft

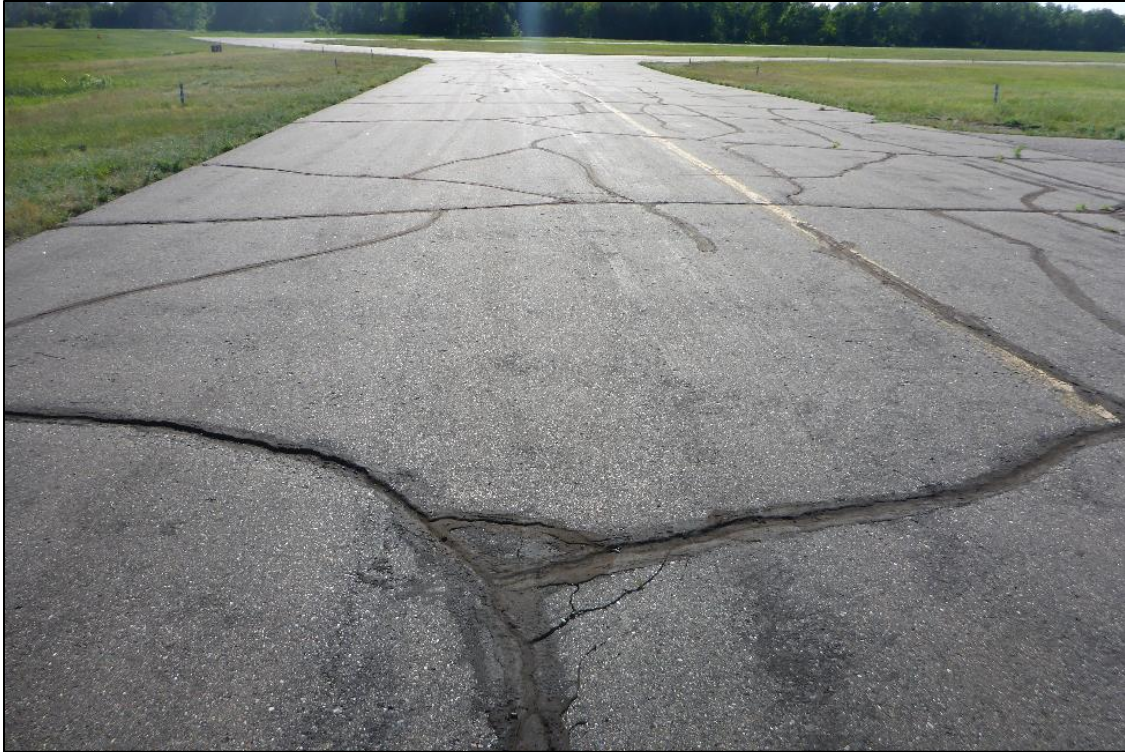
PNM CTFSS 001 (PCI = 46)

Conditions: PCI: 46

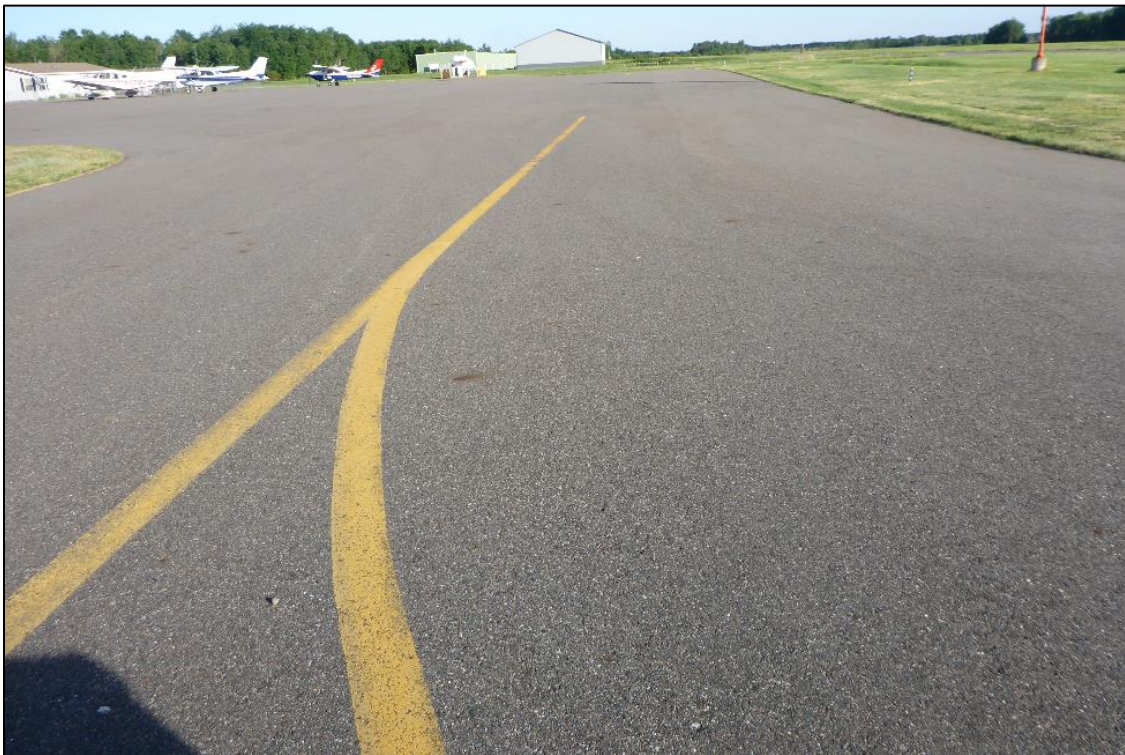
PNM CTG 001 (PCI = 96)

Network:	PNM	Name:	PRINCETON						
Branch:	CTG	Name:	CONNECTING TAXIWAY G	Use:	TAXIWAY	Area:	5,100 SqFt		
Section:	001	of 1	From:	700	To:	700	Last Const.:	9/30/2013	
Surface:	AC	Family:	MN2013 Asphalt Taxiways	Zone:	E	Category:	1	Rank:	P
Area:	5,100 SqFt	Length:	95 Ft	Width:	40 Ft				
Slabs:		Slab Length:	Ft	Slab Width:	Ft	Joint Length:	Ft		
Shoulder:		Street Type:		Grade:	0	Lanes:	0		
Section Comments:									
Last Insp. Date:	6/6/2017	TotalSamples:	1	Surveyed:	1				
Conditions:	PCI: 96								
Inspection Comments:									
Sample Number:	700	Type:	R	Area:	5075.00 SqFt	PCI:	96		
Sample Comments:									
48	L & T CR	L	38.00	Ft

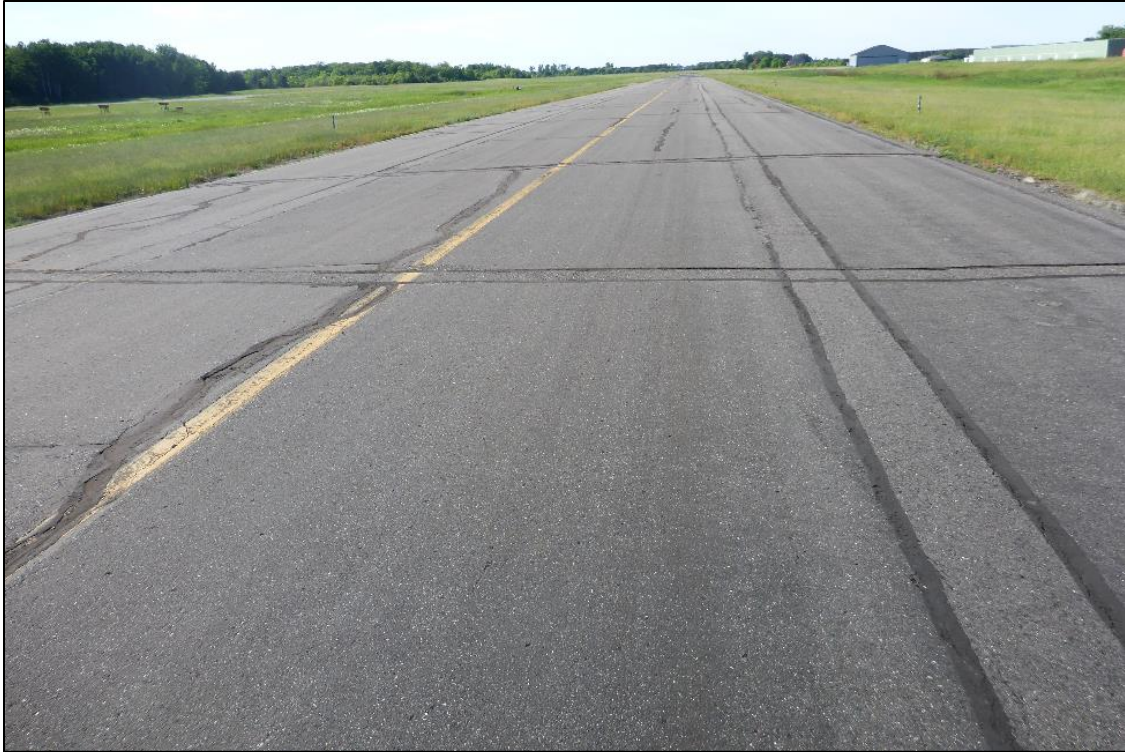
PNM PTA 001 (PCI = 58)

Network:	PNM	Name:	PRINCETON						
Branch:	PTA	Name:	PARALLEL TAXIWAY A	Use:	TAXIWAY	Area:	156,000 SqFt		
Section:	001	of 1	From:	100	To:	138	Last Const.:	9/30/1986	
Surface:	AC	Family:	MN2013 Asphalt Taxiways	Zone:	E	Category:	1	Rank:	P
Area:	156,000 SqFt	Length:	3,900 Ft	Width:	40 Ft	Joint Length:	Ft		
Slabs:		Slab Length:	Ft	Slab Width:	Ft	Joint Length:	Ft		
Shoulder:		Street Type:		Grade:	0	Lanes:	0		
Section Comments:									
Last Insp. Date:	6/6/2017	Total Samples:	39	Surveyed:	7				
Conditions:	PCI: 58								
Inspection Comments:									
Sample Number:	104	Type:	R	Area:	4000.00 SqFt	PCI:	68		
Sample Comments:									
50	PATCHING	L		480.00	SqFt				
48	L & T CR	M		73.00	Ft				
48	L & T CR	L		377.00	Ft				
Sample Number:	114	Type:	R	Area:	4000.00 SqFt	PCI:	43		
Sample Comments:									
41	ALLIGATOR CR	M		236.00	SqFt				
48	L & T CR	M		112.00	Ft				
48	L & T CR	M		209.00	Ft				
Sample Number:	119	Type:	R	Area:	4000.00 SqFt	PCI:	68

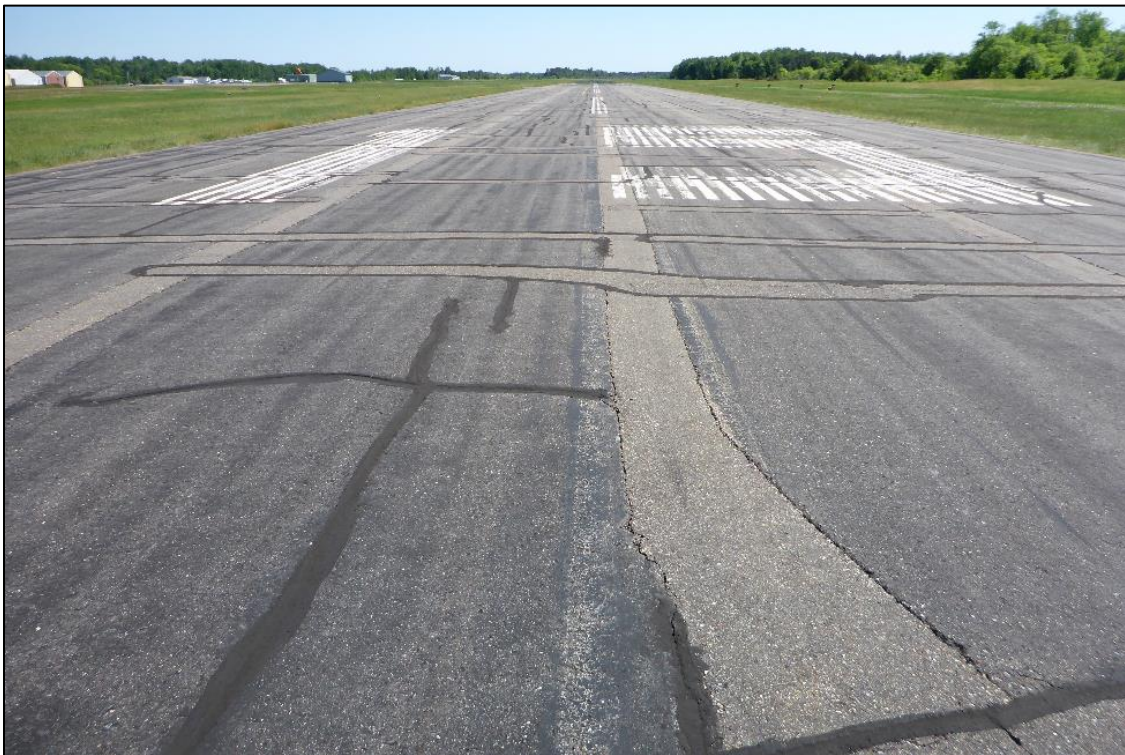
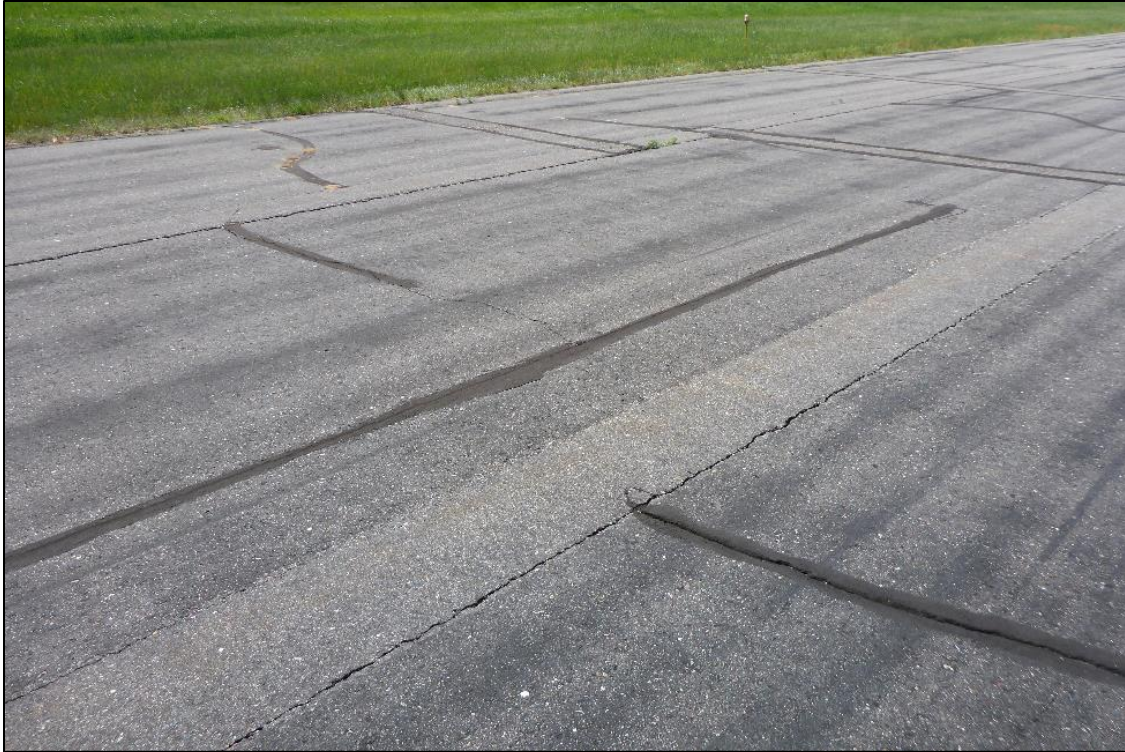
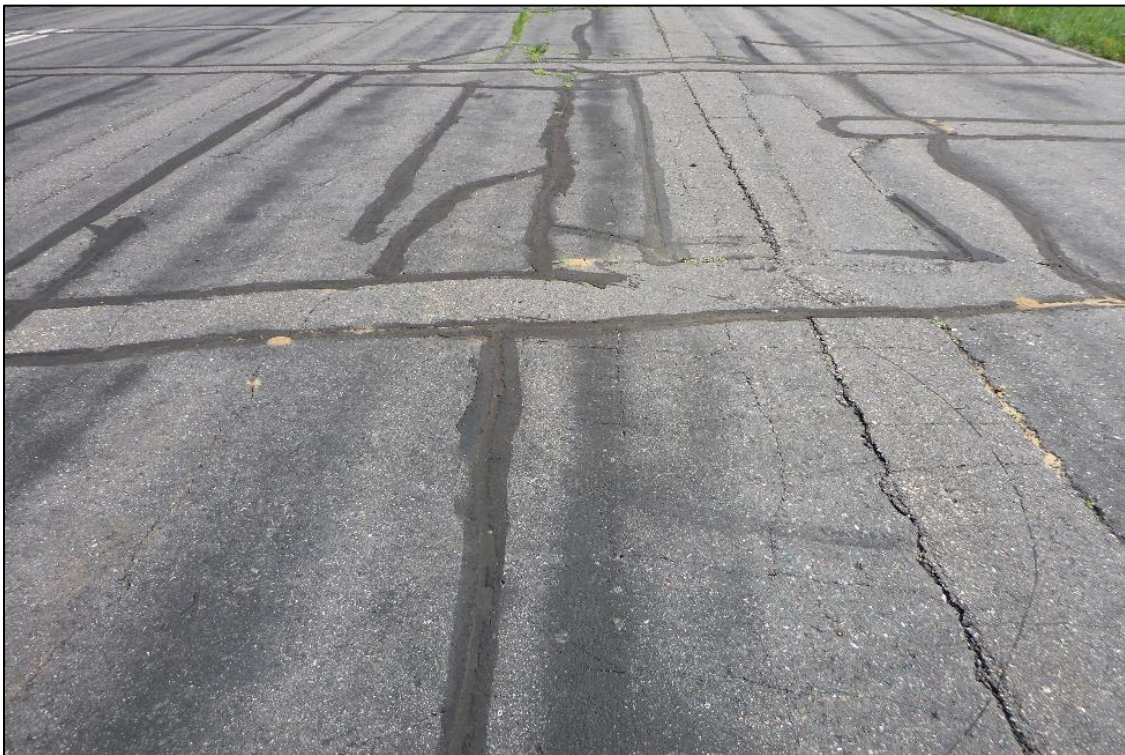
PNM RY1533 001 (PCI = 63)

Network:	PNM	Name:	PRINCETON						
Branch:	RY1533	Name:	RUNWAY 15-33	Use:	RUNWAY	Area:	292,500 SqFt		
Section:	001	of 1	From:	100	To:	177	Last Const.:	9/30/1986	
Surface:	AC	Family:	MN2013 Asphalt Runways	Zone:	E	Category:	1	Rank:	P
Area:	292,500 SqFt	Length:	3,900 Ft	Width:	75 Ft				
Slabs:	Slab Length:	Ft	Slab Width:	Ft	Joint Length:	Ft			
Shoulder:	Street Type:		Grade:	0	Lanes:	0			
Section Comments:									
Last Insp. Date:	6/6/2017	TotalSamples:	78	Surveyed:	8				
Conditions:	PCI: 63								
Inspection Comments:									
Sample Number:	104	Type:	R	Area:	3750.00 SqFt	PCI:	75		
Sample Comments:									
50	PATCHING	L		700.00	SqFt				
48	L & T CR	L		109.00	Ft				
Sample Number:	114	Type:	R	Area:	3750.00 SqFt	PCI:	27		
Sample Comments:									
50	PATCHING	L		700.00	SqFt				
48	L & T CR	L		578.00	Ft				
41	ALLIGATOR CR	L		35.00	SqFt				
41	ALLIGATOR CR	M		170.00	SqFt				
43	BLOCK CR	H		80.00	SqFt				
53	RUTTING	M		8.00	SqFt

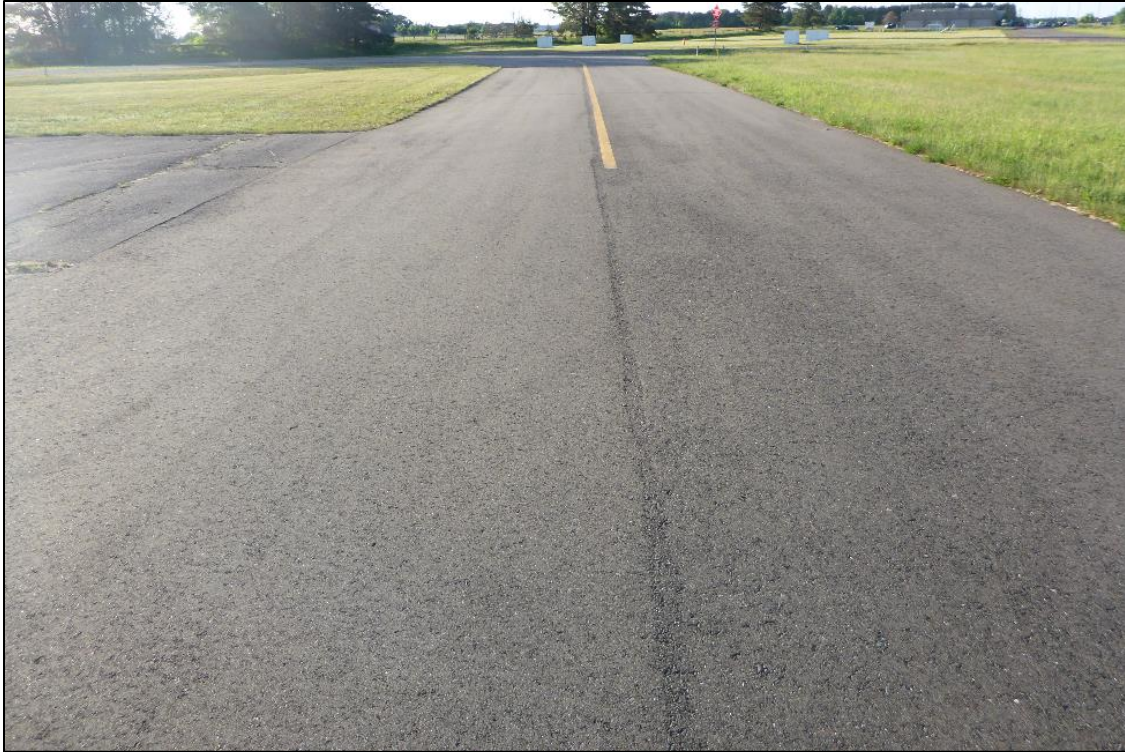
PNM TLA 001 (PCI = 100)

Conditions: PCI: 100

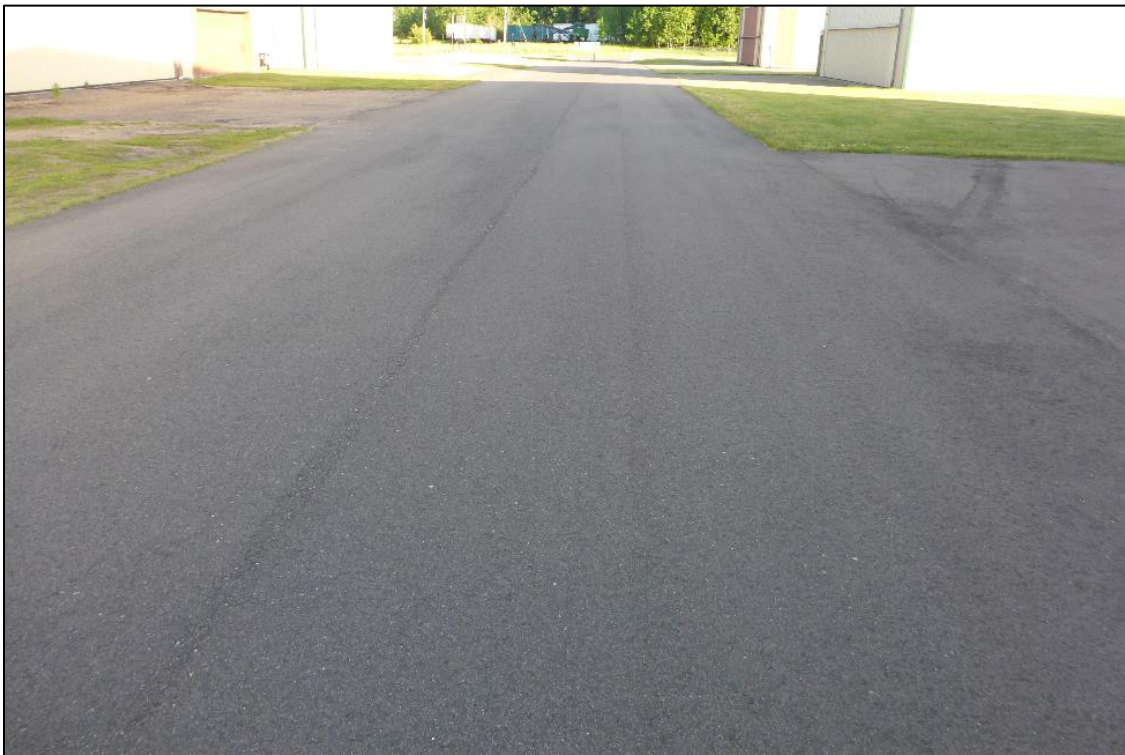
PNM TLA 002 (PCI = 100)

Conditions: PCI: 100

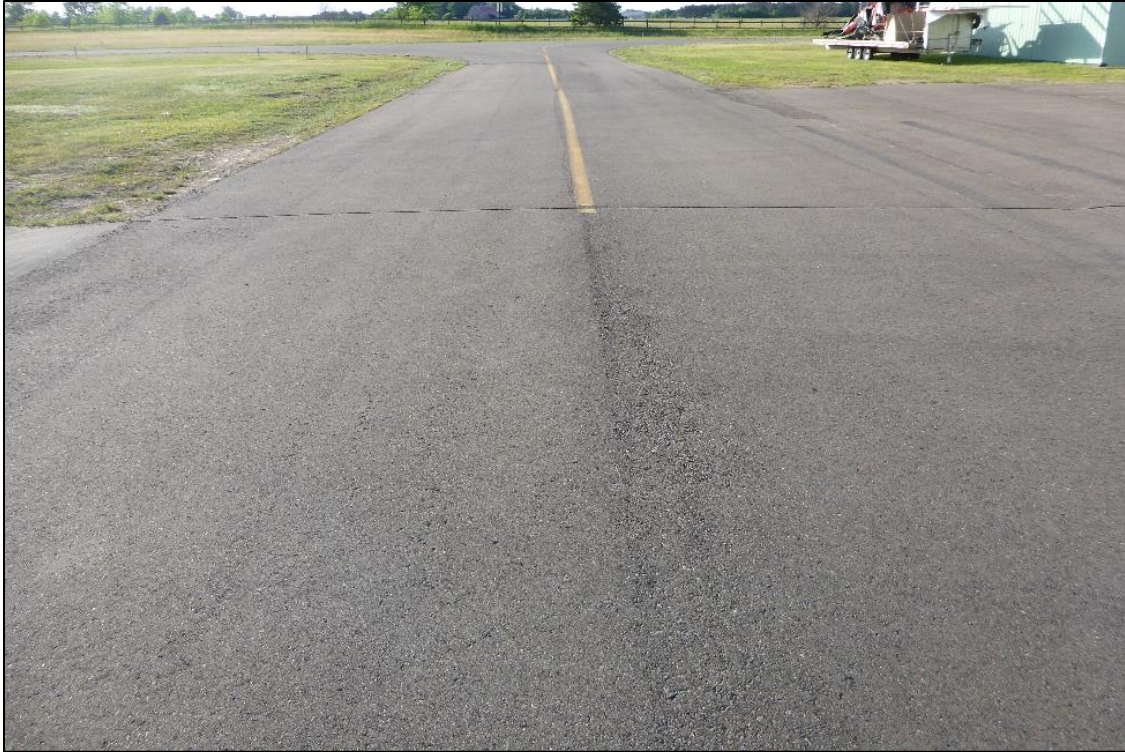
PNM TLA 003 (PCI = 98)

Network:	PNM	Name:	PRINCETON						
Branch:	TLA	Name:	TAXILANE A	Use:	TAXILANE	Area:	120,450 SqFt		
Section:	003	of 5	From:	100	To:	101	Last Const.:	6/30/2015	
Surface:	AC	Family:	MN2013 Asphalt Taxilanes	Zone:	E	Category:	1	Rank:	T
Area:	16,100 SqFt	Length:	500 Ft	Width:	40 Ft				
Slabs:		Slab Length:	Ft	Slab Width:	Ft	Joint Length:	Ft		
Shoulder:		Street Type:		Grade:	0	Lanes:	0		
Section Comments:									
Last Insp. Date:	6/6/2017	TotalSamples:	4	Surveyed:	2				
Conditions:	PCI: 98								
Inspection Comments:									
Sample Number:	102	Type:	R	Area:	4000.00 SqFt	PCI:	96		
Sample Comments:									
48	L & T CR	L	12.00	Ft					
Sample Number:	103	Type:	R	Area:	4000.00 SqFt	PCI:	100		
Sample Comments:									
<No Distress>

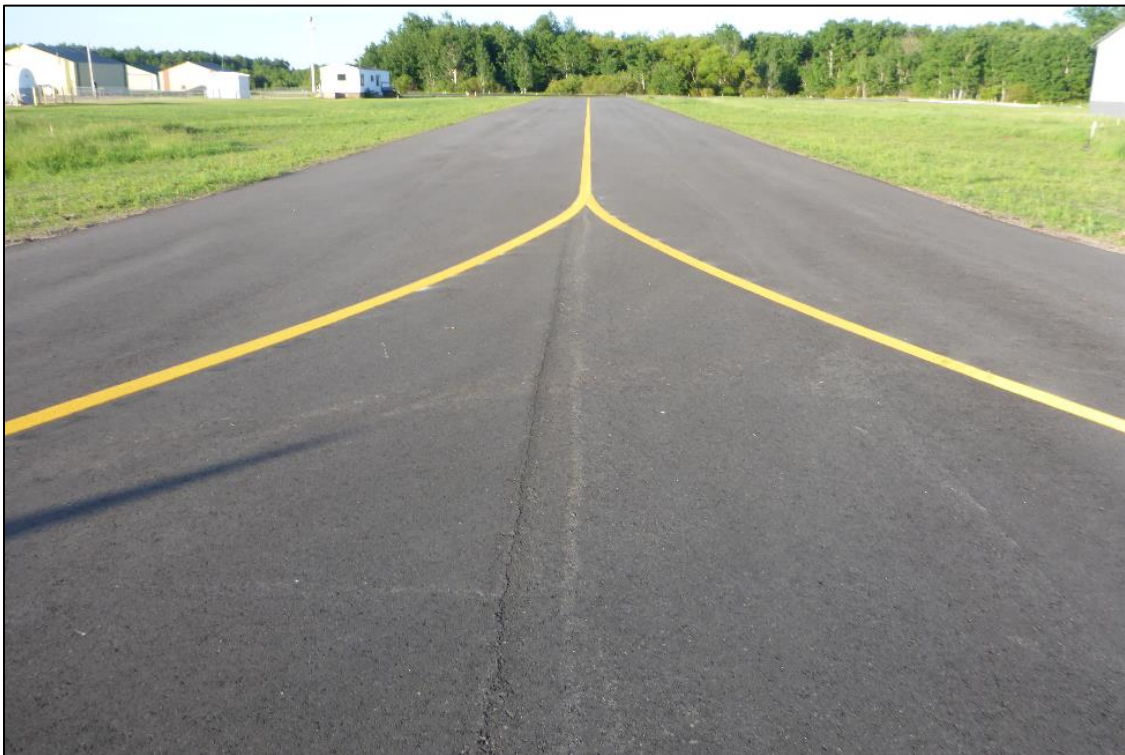
PNM TLA 005 (PCI = 100)

Conditions: PCI: 100
