Pavement Condition Report

Duluth International Airport (DLH)

December 2018

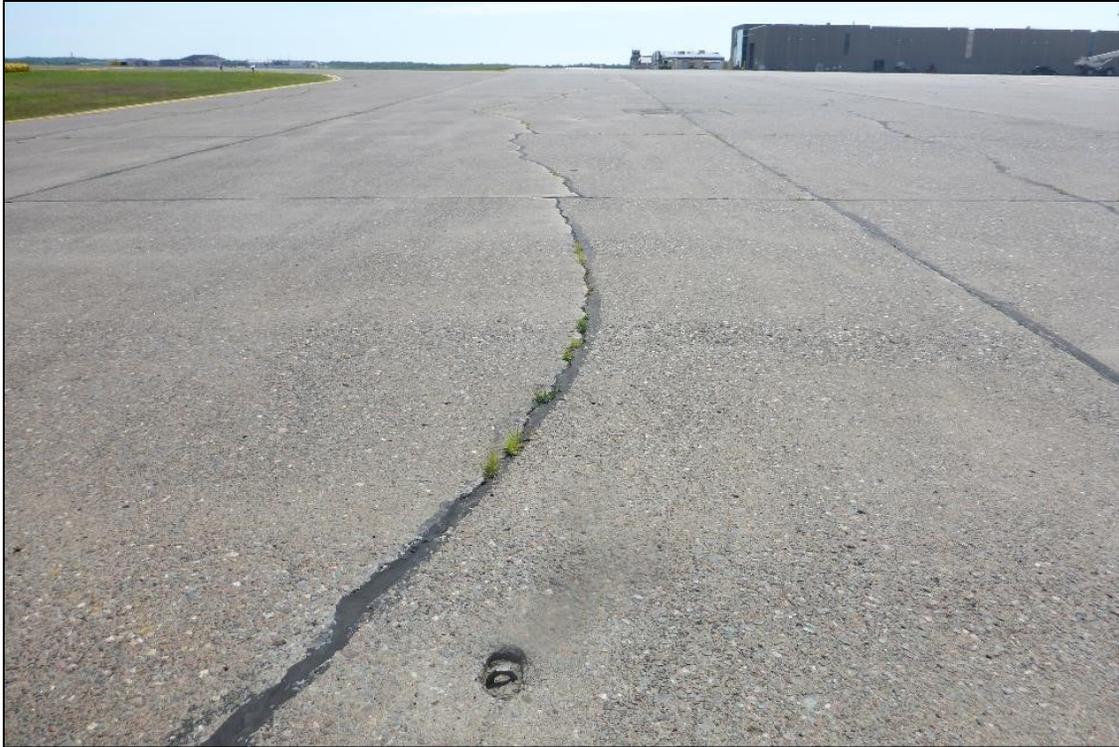
DLH APGA 007 (PCI = 8)

APGA	007	PCC	79,200	1957	21	8	1.5	58	7	Joint seal damage, Joint spalling, Large patch, Linear cr, Shattered slab
APGA	008	PCC	172,000	1955	69	64	.6	19	20	Corner spalling, Faulting, Joint seal damage, Joint spalling, Large patch, Linear cr, Shattered slab, Shrinkage cr, Small patch
APGA	009	PCC	149,200	1955	51	48	.8	72	16	Corner break, Corner spalling, Faulting, Joint seal damage, Large patch, Linear cr, Shattered slab, Shrinkage cr
APGA	010	AC	54,900	2004	61	56	3.2	-	100	L&T cr, Weathering
APGA	011	AC	35,500	1996	69	62	1.7	10	89	Alligator cr, Depression, L&T cr, Patching, Raveling, Weathering
APGA	012	PCC	86,600	1956	51	47	.9	77	19	Corner break, Joint seal damage, Joint spalling, Linear cr, Shattered slab
APGA	013	AC	14,200	2007	84	60	3.7	15	85	Alligator cr, L&T cr, Raveling

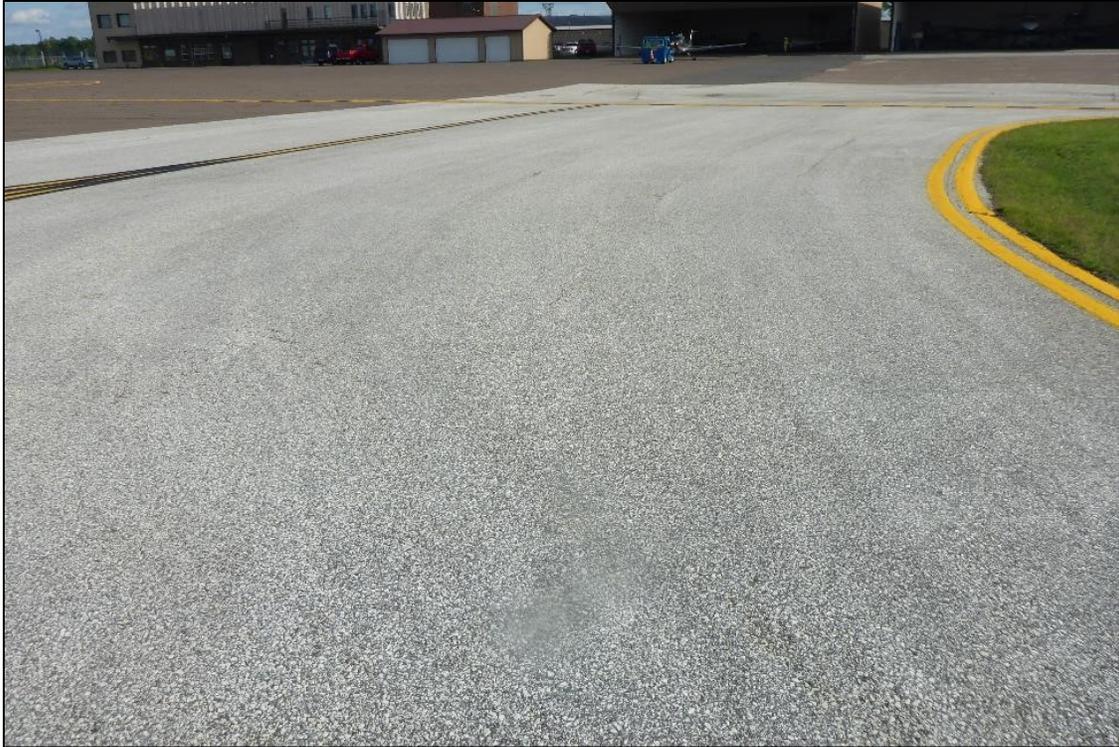
DLH CTA3 001 (PCI = 79)

CTA3	001	AC	19,500	1963	78	79	.4	-	100	L&T cr, Weathering
CTA3	002	AC	20,600	1963	39	37	1.1	19	61	Alligator cr, L&T cr, Raveling, Swelling, Weathering
CTA3	003	AC	15,100	1963	60	59	.7	-	100	L&T cr, Weathering
CTA5	001	AC	44,800	1974	55	44	1.3	10	90	Alligator cr, Block cr, Joint reflection cr, L&T cr, Weathering
CTB	001	PCC	345,200	1994	90	86	.6	68	8	Corner break, Corner spalling, Joint seal damage, Joint spalling, Linear cr, Shattered slab, Small patch
CTC1	001	AC	5,200	2009	92	84	1.8	-	81	L&T cr, Swelling, Weathering
CTD	001	AC	114,000	1974	32	34	1.5	-	100	Block cr, Depression, L&T cr, Patching, Raveling, Weathering
CTD	002	AC	25,300	1974	81	82	.4	-	100	L&T cr, Weathering
PTA	001	AC	165,300	1992	33	32	2.6	27	73	Alligator cr, Block cr, L&T cr, Patching, Raveling, Weathering

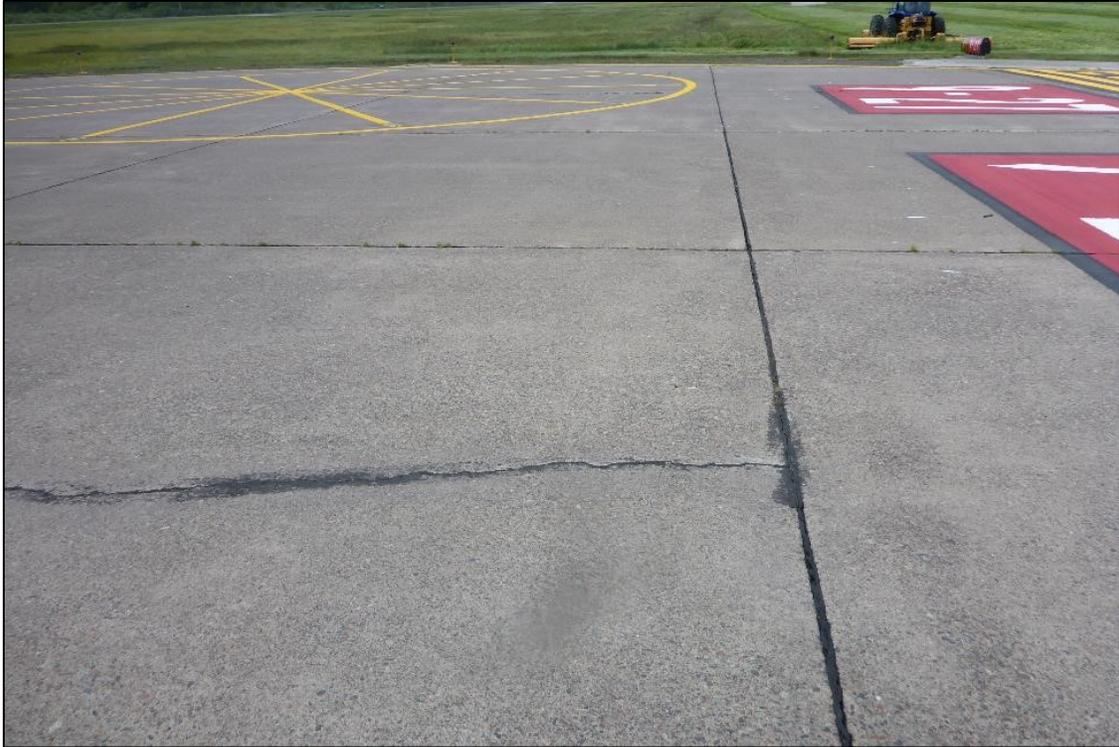
DLH RPA1 001 (PCI = 77)

RPA1	001	PCC	24,300	1978	87	77	.6	25	38	Joint seal damage, Joint spalling, Linear cr
RPE	001	PCC	28,000	1964	61	48	1.0	89	-	Large patch, Linear cr, Small patch
RPW	001	PCC	105,000	1992	59	60	1.5	49	17	Corner break, Durability cr, Joint seal damage, Large patch, Linear cr, Shattered slab, Shrinkage cr, Small patch
RY321	001	AC	70,000	2009	93	84	1.8	-	100	L&T cr, Raveling, Weathering
RY321	002	AC	35,000	2009	88	85	1.7	-	100	L&T cr, Weathering
RY321	003	AC	48,700	2017	-	79	12.6 ⁹	-	100	L&T cr, Raveling, Weathering
RY321	004	AC	100,000	2009	89	84	1.8	-	100	L&T cr, Weathering
RY321	005	AC	50,000	2009	87	81	2.1	-	100	L&T cr, Weathering
RY321	006	AC	24,350	2017	-	86	8.4 ¹⁰	-	100	L&T cr, Raveling, Weathering
RY321	007	AC	334,950	2009	87	82	2.0	-	100	L&T cr, Weathering
RY321	008	AC	167,500	2009	86	81	2.1	-	100	L&T cr, Weathering

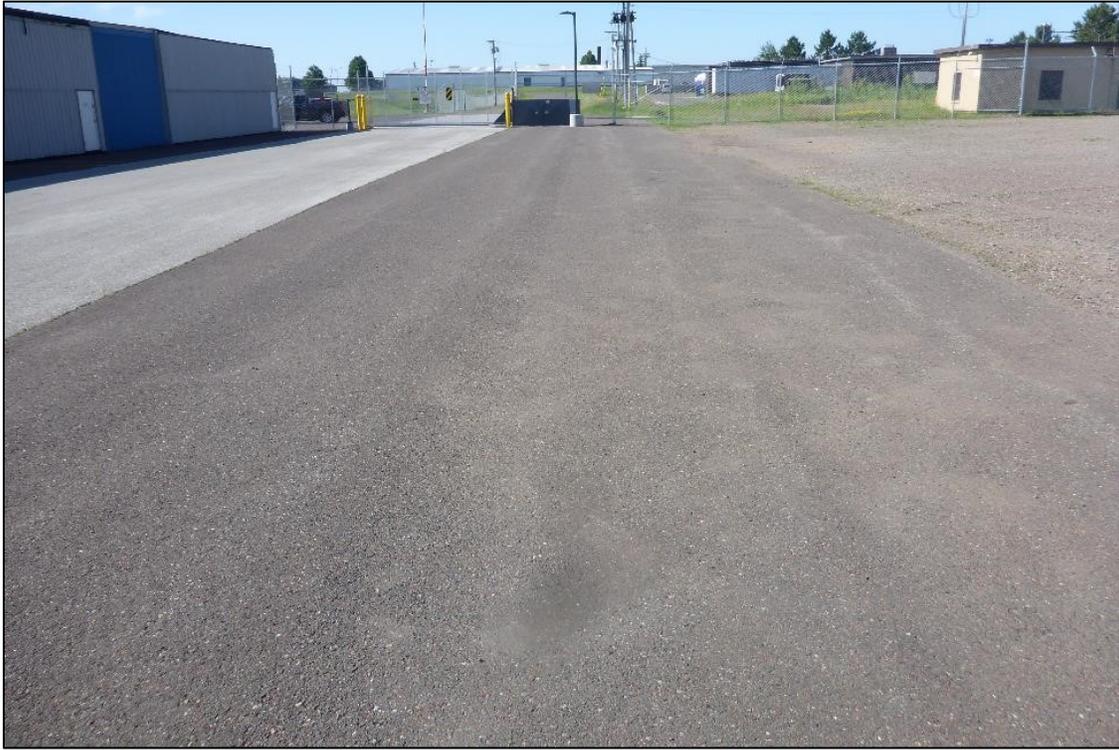
DLH TLA 005 (PCI = 72)

Branch ID	Section ID	Surface type ¹	Section area (SF)	LCD ²	2015 PCI	2018 PCI	Drop in PCI/Yr ³	% Deduct due to		Distress types
								Load ⁴	Climate ⁵	
RY927	001	PCC	742,500	2018	-	100	-	-	-	Corner break
RY927	002	PCC	495,000	2018	-	100	-	-	-	Linear cr
RY927	004	PCC	189,000	1958	87	70	.5	24	16	Corner spalling, Joint seal damage, Large patch, Linear cr, Small patch
RY927	005	PCC	94,500	1958	79	74	.4	4	6	ASR, Corner spalling, Joint seal damage, Large patch, Linear cr, Small patch
RY927	007	PCC	100,000	1958	70	48	.9	8	10	Joint seal damage, Large patch, Linear cr, Small patch
RY927	008	PCC	50,000	1958	69	63	.6	-	13	Joint seal damage, Large patch, Small patch
TLA	001	PCC	63,500	2008	100	100	-	-	-	-
TLA	002	AC	17,300	2008	96	86	1.4	39	40	Alligator cr, Bleeding, L&T cr, Swelling
TLA	003	AC	14,000	2008	96	89	1.1	-	100	L&T cr, Weathering
TLA	005	AC	4,100	1996	75	72	1.3	-	93	L&T cr, Oil Spillage, Raveling, Weathering
