# Pavement Condition Report

## St Cloud Regional Airport (STC)

**December 2018**

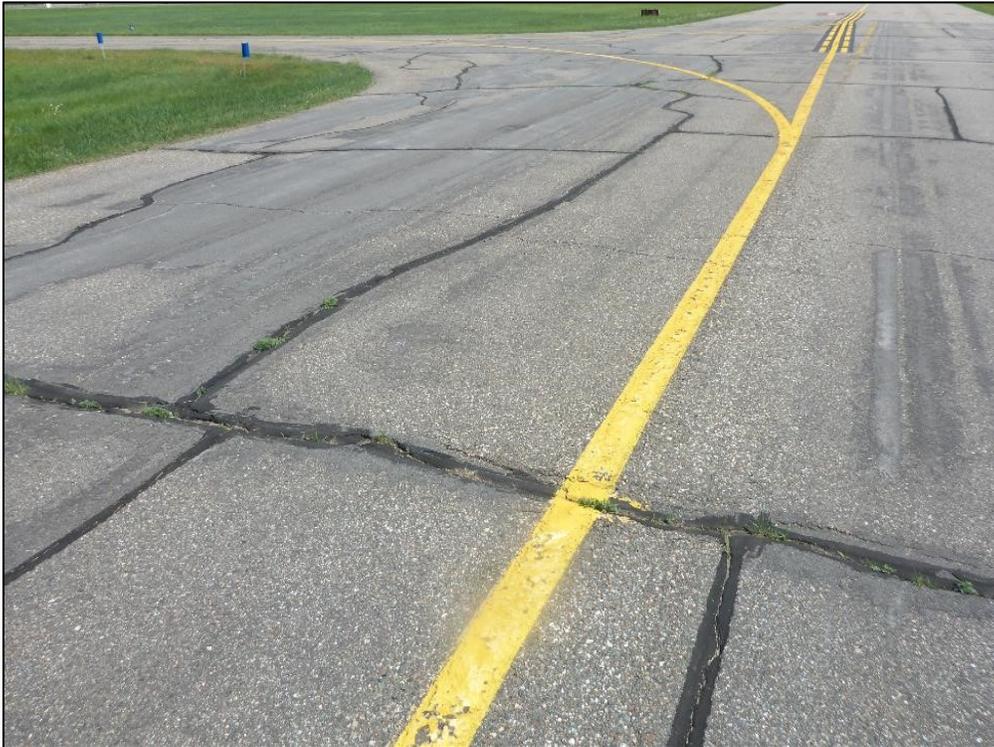
STC CTD1 002 (PCI = 48)

CTD1	001	AC	17,100	2013	100	92	1.5	-	100	L&T cr, Weathering
CTD1	002	AAC	7,700	1985	50	48	1.6	20	80	Alligator cr, L&T cr, Raveling, Weathering
CTD1	003	AC	3,750	2001	74	64	2.1	-	100	L&T cr, Raveling, Weathering
CTD2	001	AC	17,400	2013	100	94	1.2	-	100	Weathering
CTE	001	PCC	38,400	2001	95	94	.4	-	77	Corner spalling, Joint seal damage
PPTC	001	PCC	66,700	2001	98	92	.5	-	65	Joint seal damage, Joint spalling
PPTE	001	AC	55,000	1985	59	59	1.2	30	70	Alligator cr, L&T cr
PPTE	002	AAC	2,580	2001	66	66	2.0	-	100	L&T cr, Raveling, Weathering
PTA	001	PCC	418,100	2001	98	98	.1	-	51	Corner spalling, Joint seal damage, Joint spalling
PTA	002	PCC	52,000	2017	-	100	-	-	-	-
PTD	001	AC	52,890	1985	46	38	1.9	43	57	Alligator cr, Depression, L&T c, Patching, Weathering
PTD	002	AAC	3,320	2001	74	67	2.0	-	100	L&T cr, Weathering
PTD	003	PCC	53,550	2001	97	96	.2	-	40	Corner spalling, Joint seal damage, Joint spalling

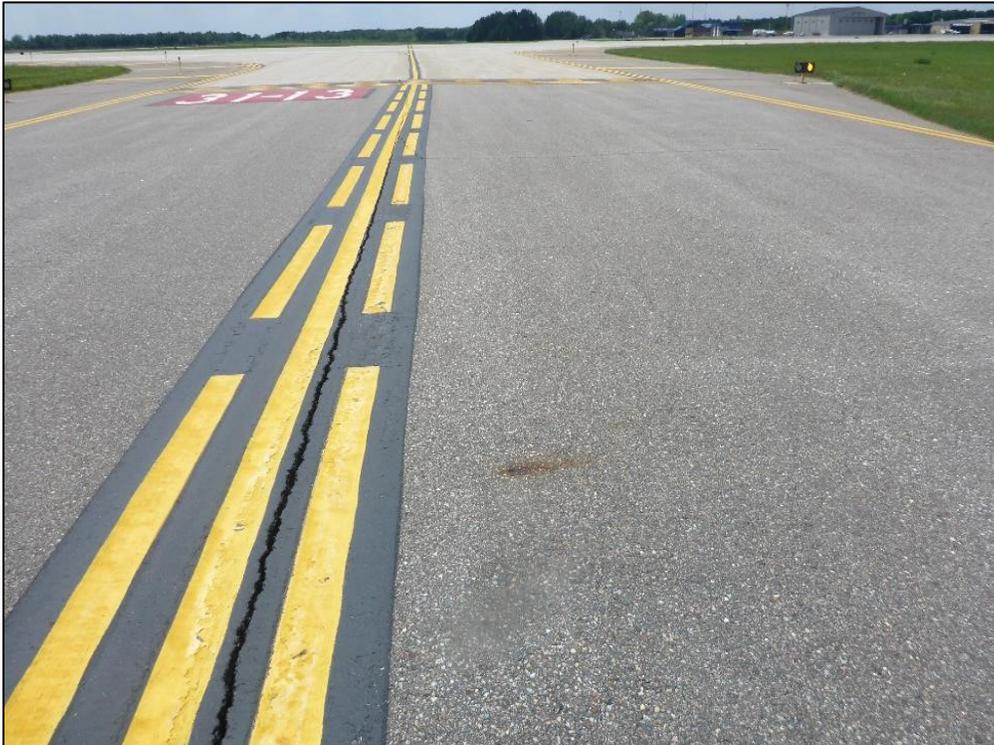
STC PTD 004 (PCI = 67)

Branch ID	Section ID	Surface type <sup>1</sup>	Section area (SF)	LCD <sup>2</sup>	2015 PCI	2018 PCI	Drop in PCI/Yr <sup>3</sup>	% Deduct due to		Distress types
								Load <sup>4</sup>	Climate <sup>5</sup>	
PTD	004	AC	6,125	2001	74	67	2.0	-	100	L&T cr, Weathering
PTD	005	AC	42,750	1985	50	48	1.6	24	76	Alligator cr, L&T cr, Patching, Raveling, Weathering
RP1	001	PCC	22,800	2001	100	98	.1	-	100	Joint seal damage
RP2	001	PCC	23,620	2001	100	100	-	-	-	-
RY1331	001	PCC	315,000	2001	95	96 <sup>6</sup>	.2	-	90	Joint seal damage, Joint spalling, Small patch
RY1331	002	PCC	420,000	2001	95	95	.3	-	72	Corner spalling, Joint seal damage, Small patch
RY1331	003	PCC	315,000	2001	95	94	.4	-	70	Corner spalling, Faulting, Joint seal damage, Joint spalling, small patch
RY1331	004	PCC	22,500	2017	-	100	-	-	-	-
RY1331	005	PCC	3,000	2017	-	100	-	-	-	-
RY1331	006	PCC	22,500	2017	-	100	-	-	-	-
RY523	001	AC	61,250	2013	100	94	1.2	-	100	L&T cr, Weathering

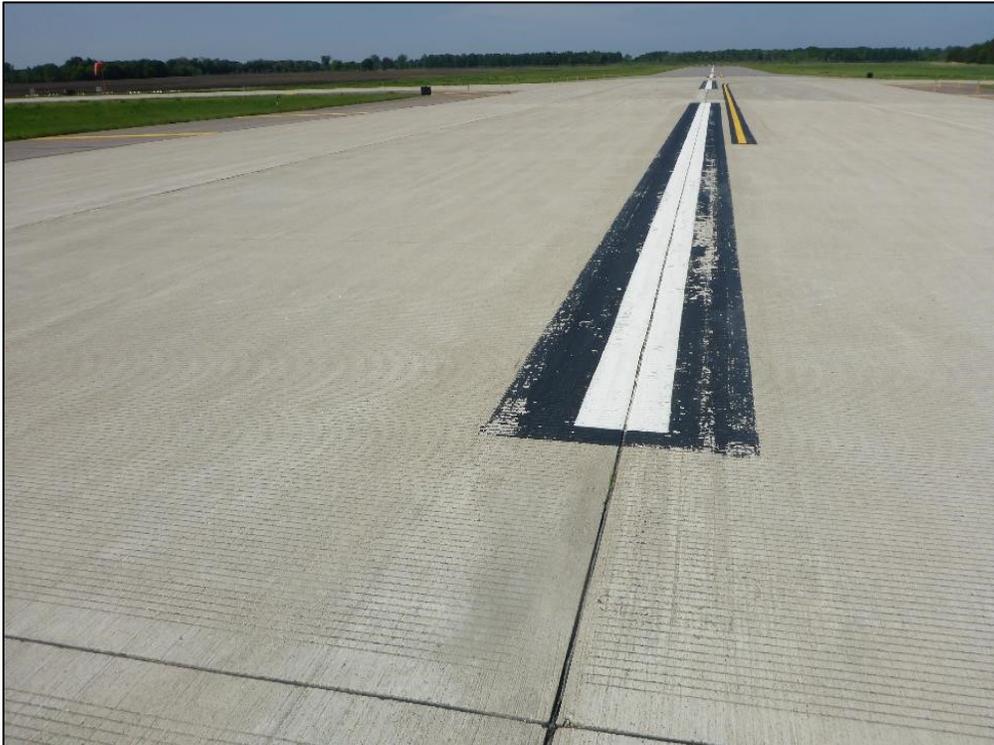
STC RY523 003 (PCI = 95)

RY523	003	PCC	74,300	2001	95	95	.3	-	86	Corner spalling, Joint seal damage
RY523	004	AC	106,250	2013	100	92	1.5	-	100	L&T cr, Weathering
TLA	001	AAC	100,000	2018	-	100	-	-	-	-

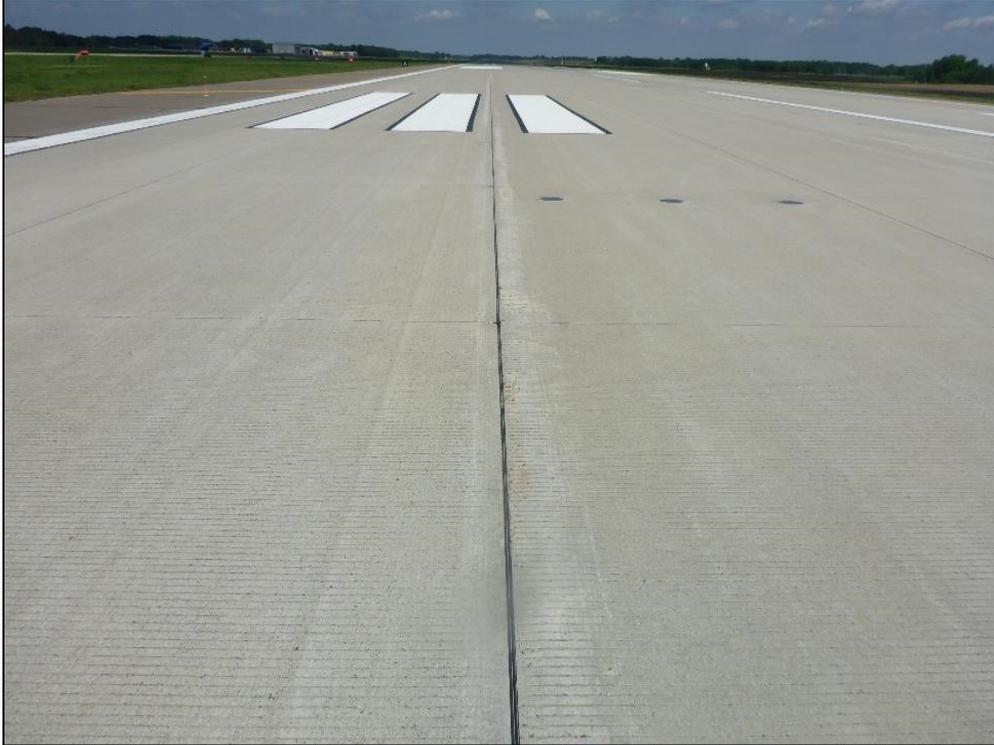
STC RY1331 001 (PCI = 96)

<sup>6</sup>Increase in PCI in section RY1331-001 due to patching that occurred in 2016
