MnDOT ADA Training

Compliance Checklists 2016

ADA Compliance Checklist Guidance [Curb Ramps]

ADA Compliance Checklist Guidance [APS] (Accessible Pedestrian Signals)

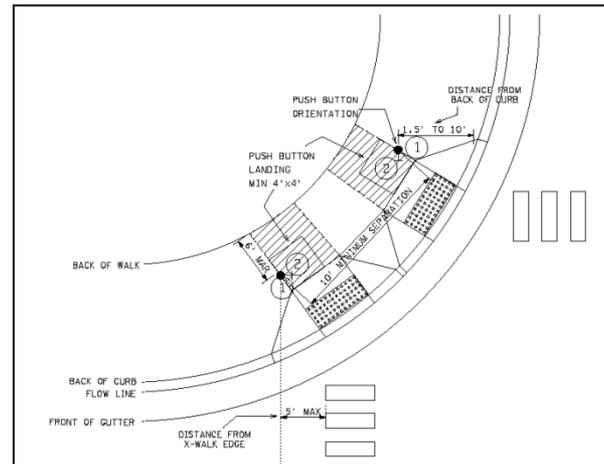
Figure 1: APS Guidance (1)

The bubble note in each figure represents the required data on the APS compliance checklist form.

Numbers on figure and on the APS form	DESCRIPTION
1	Push button orientation
2	Push button landing
3	Distance from crosswalk edge
4	Distance from back of curb
5	Distance between push buttons
9	Maintenance access route (MAR)
10	Distance of push button(s) to front and back of landing

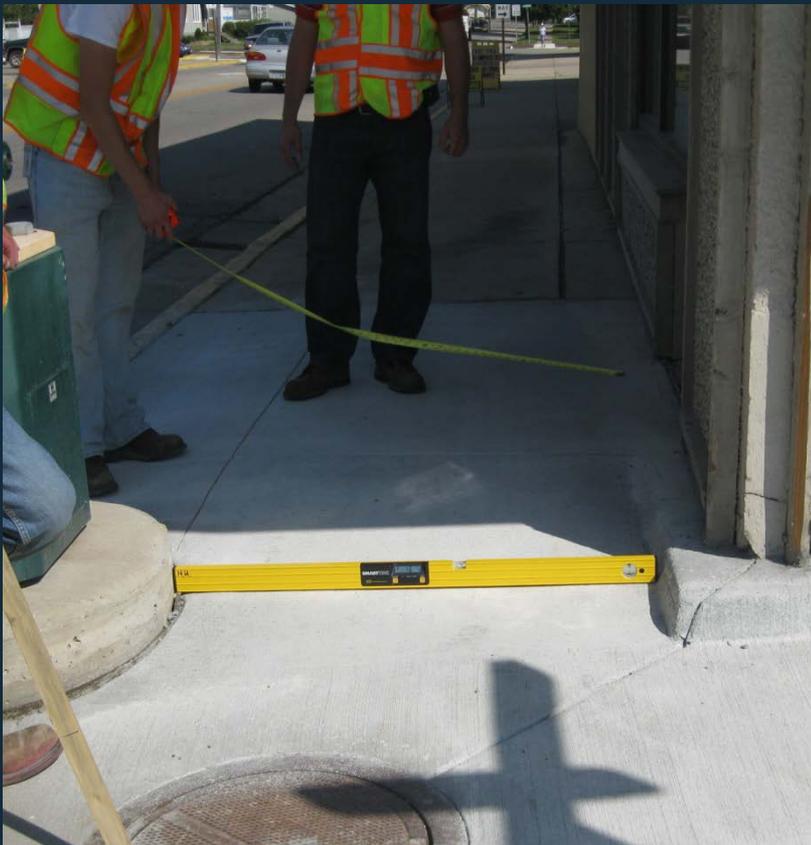
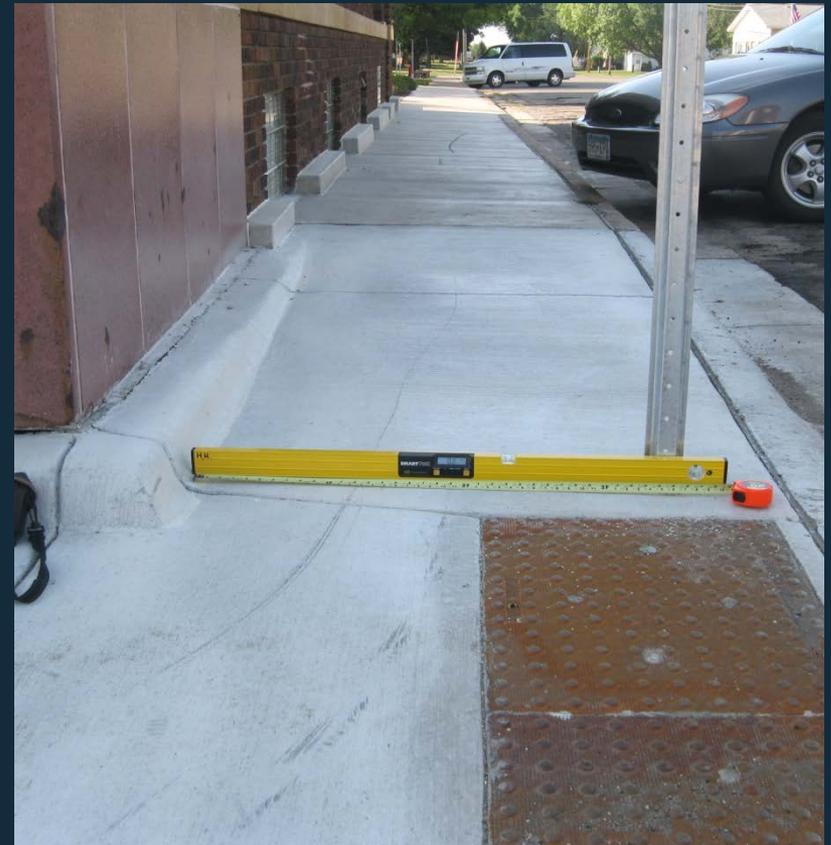
(1) PAR

1) Minimum 4 ft. wide Pedestrian Access Route (PAR) with maximum cross slope of 2%

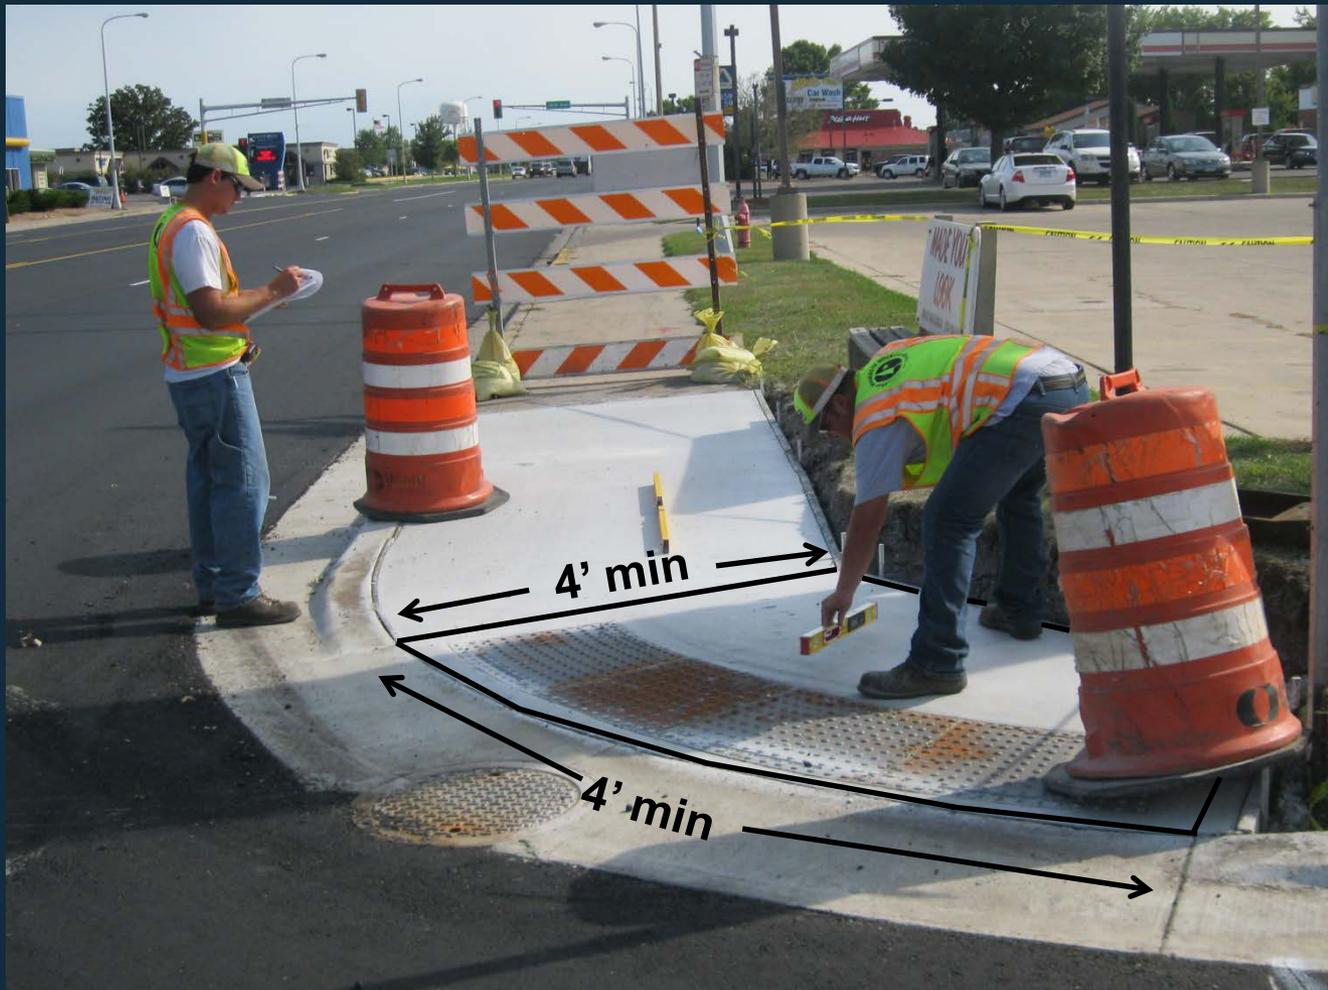
2) Landing dimensions are a minimum 4' x 4' and perpendicular grade breaks.

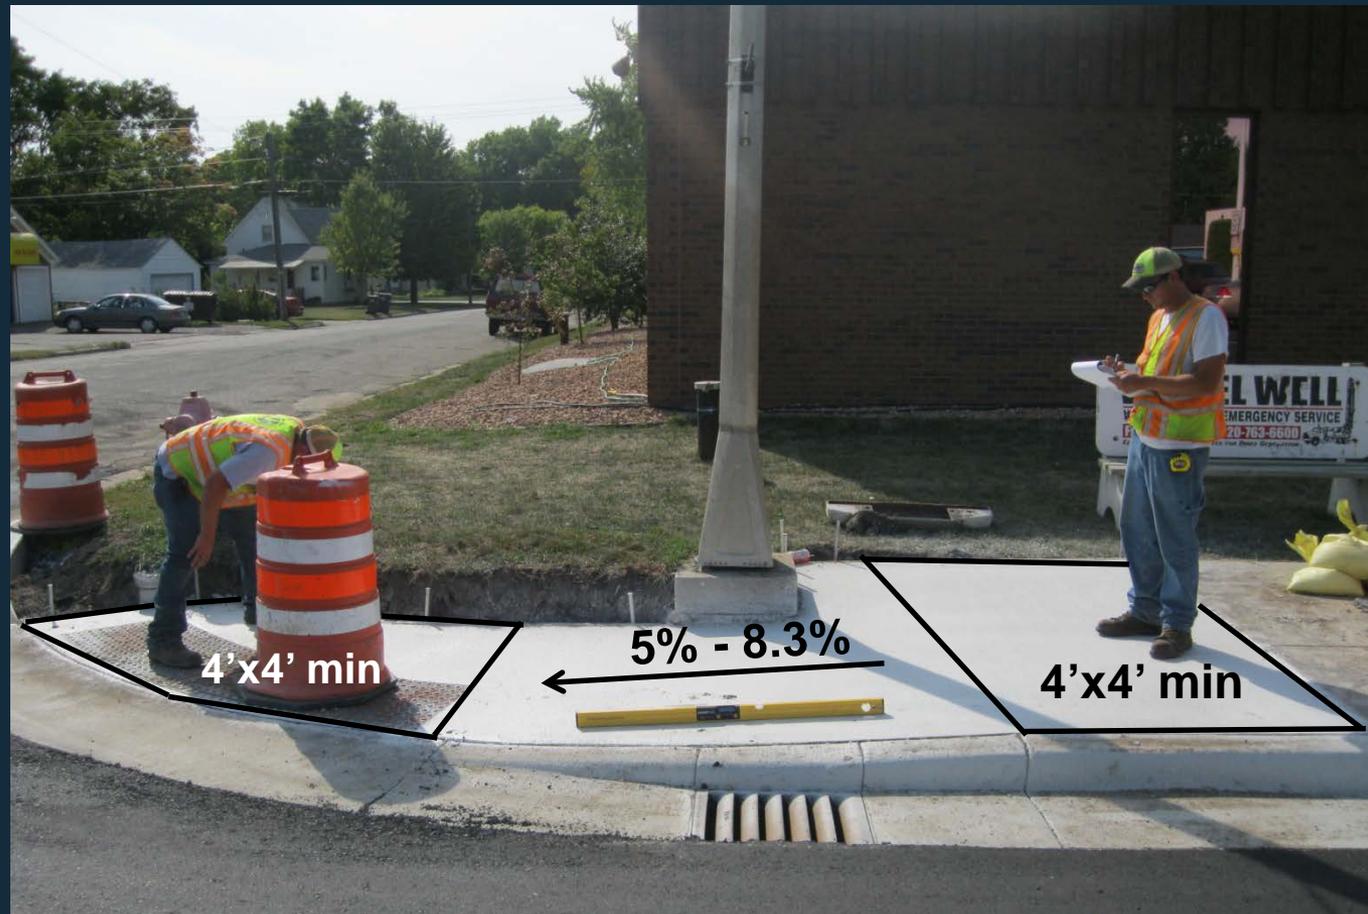
3) Landings are located at the top of each ramp. Is it over 5%? Is there a change in direction? Are there inverse grades approaching the landing?

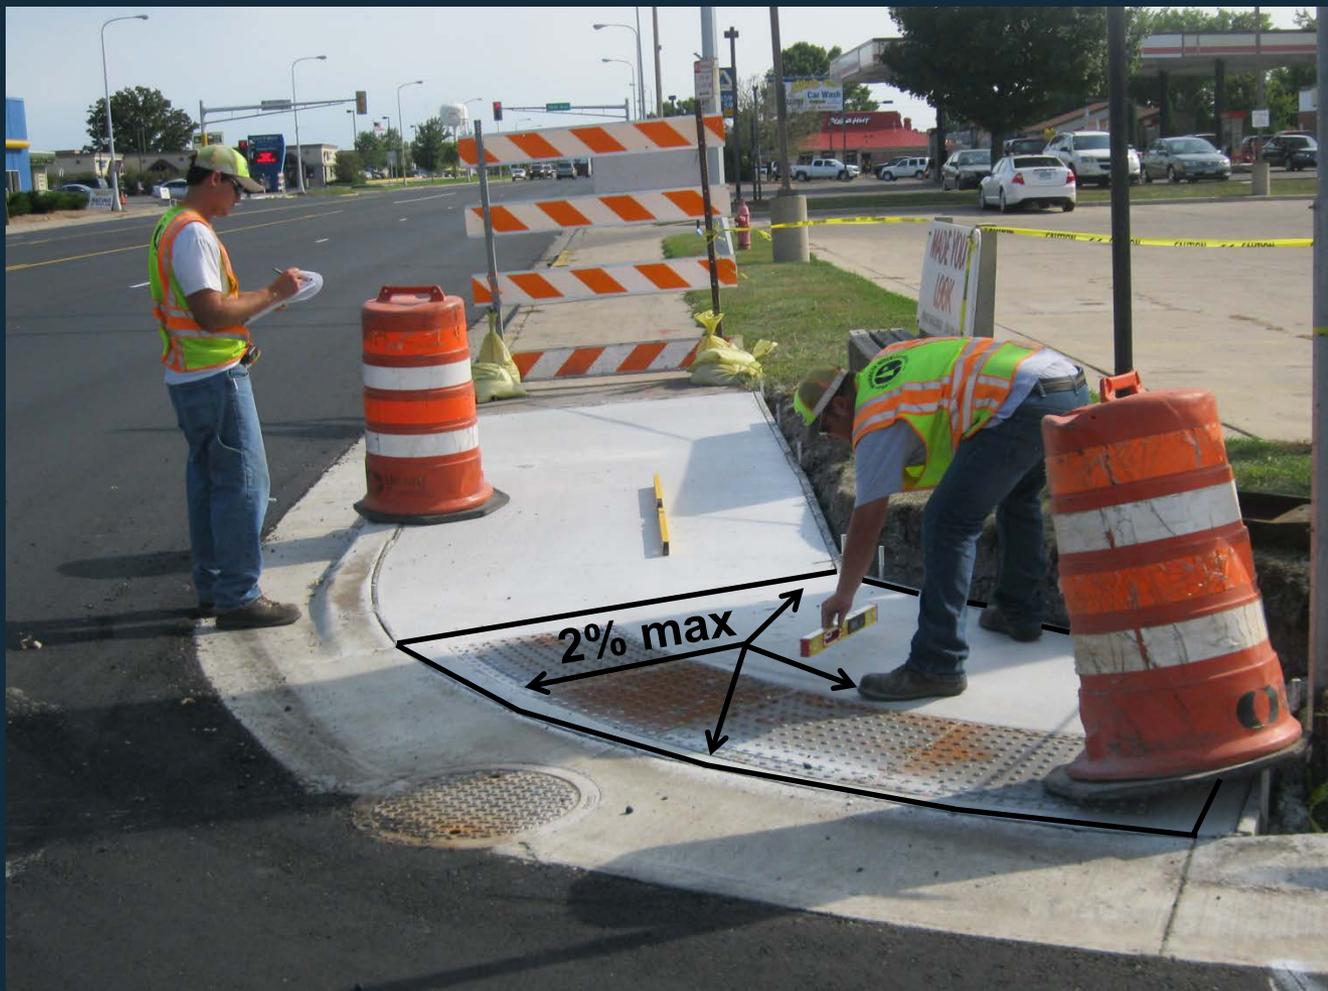
4) Record landing slopes (max. 2% in any direction)

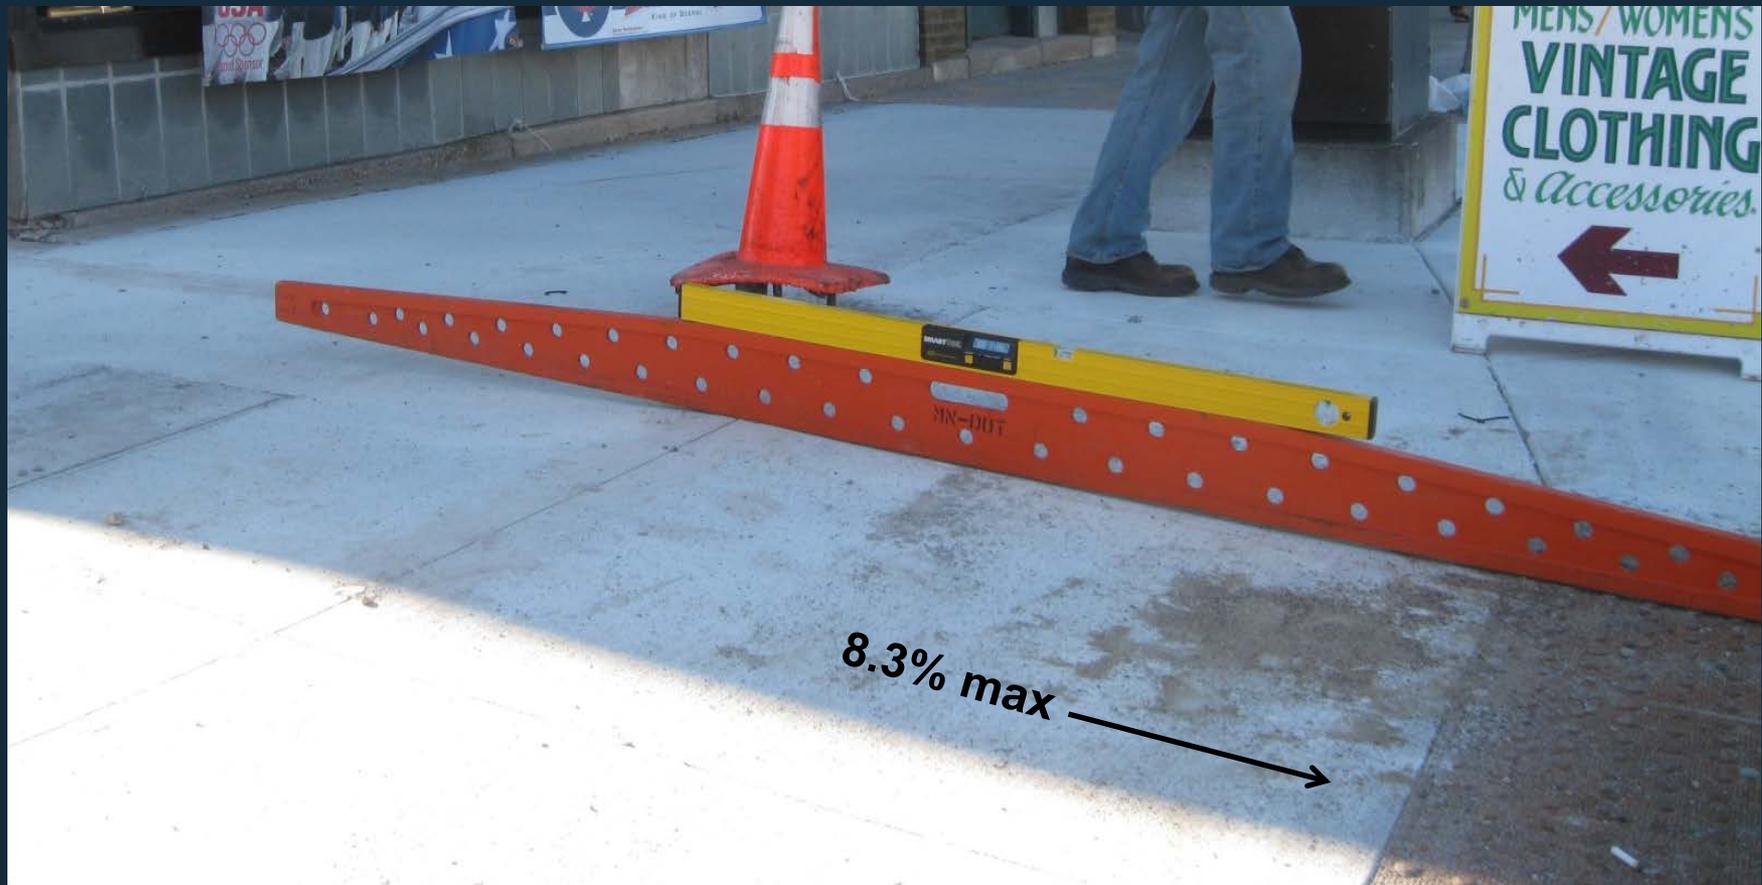
5) Ramp's running slope must be less than or equal to 8.3%.

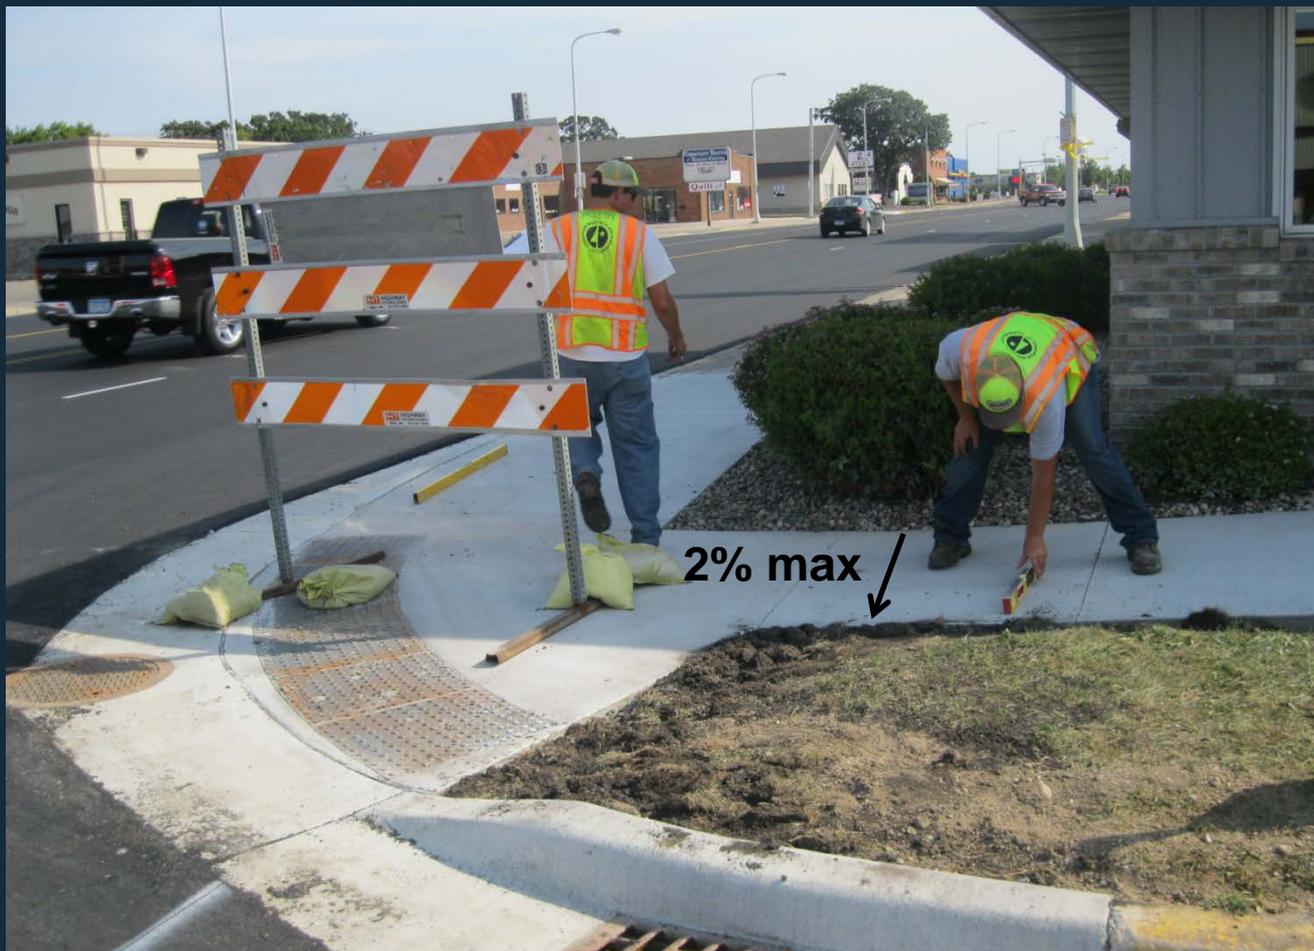
6) Ramp's cross slope must be 2% maximum.

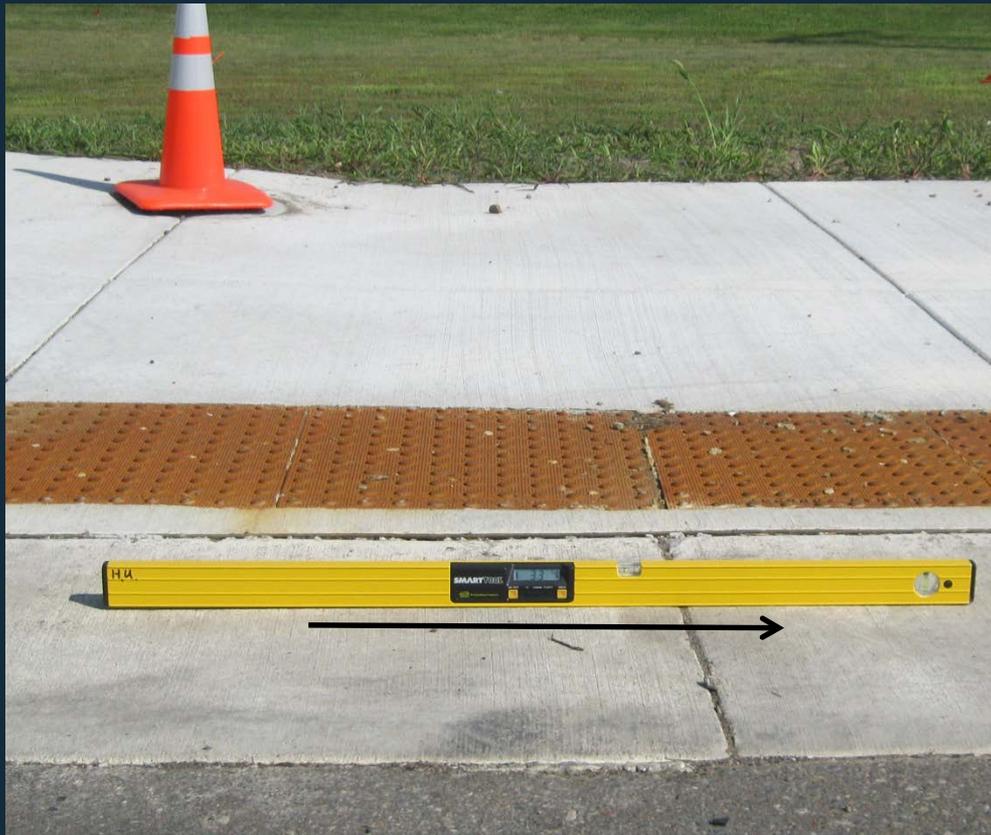
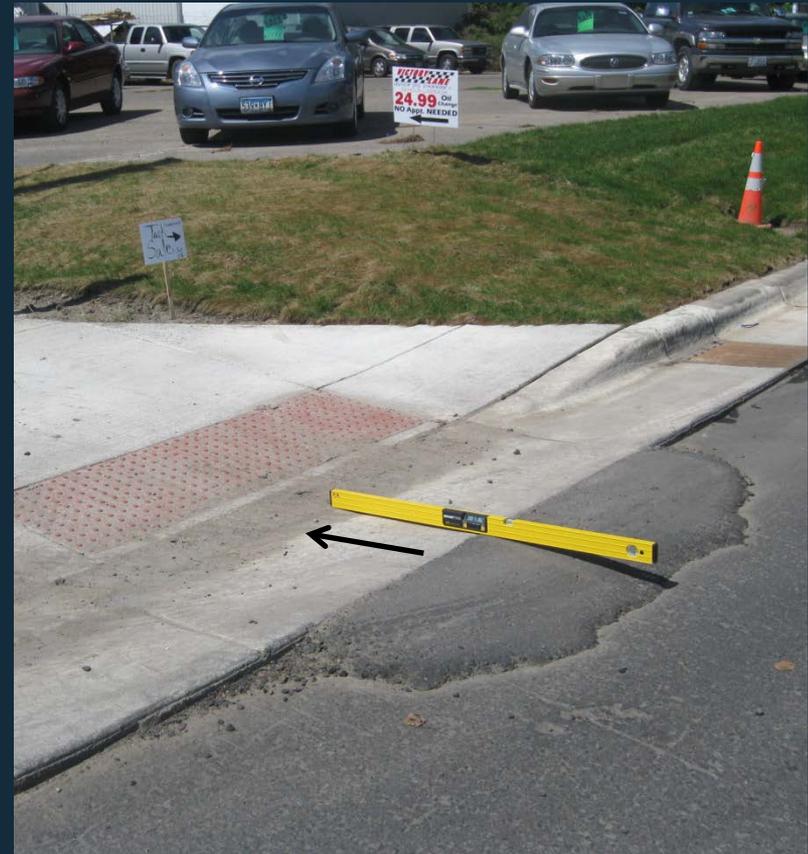
7 & 8) Record gutter flow line slope and inslope.

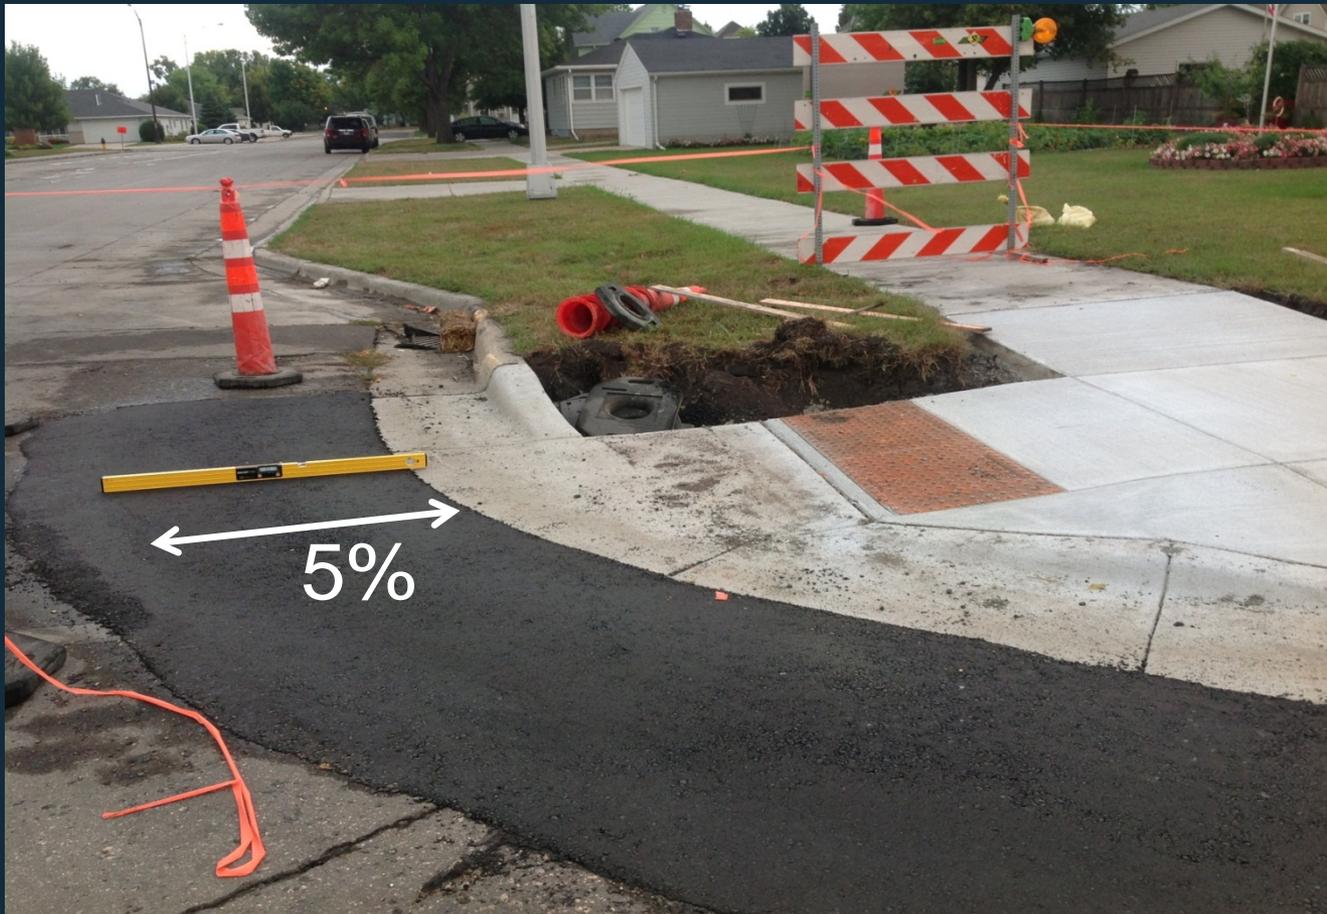
9) Roadway Cross slope is measured perpendicular to curb flow line or edge of roadway and should not exceed 5% at pedestrian crossings.

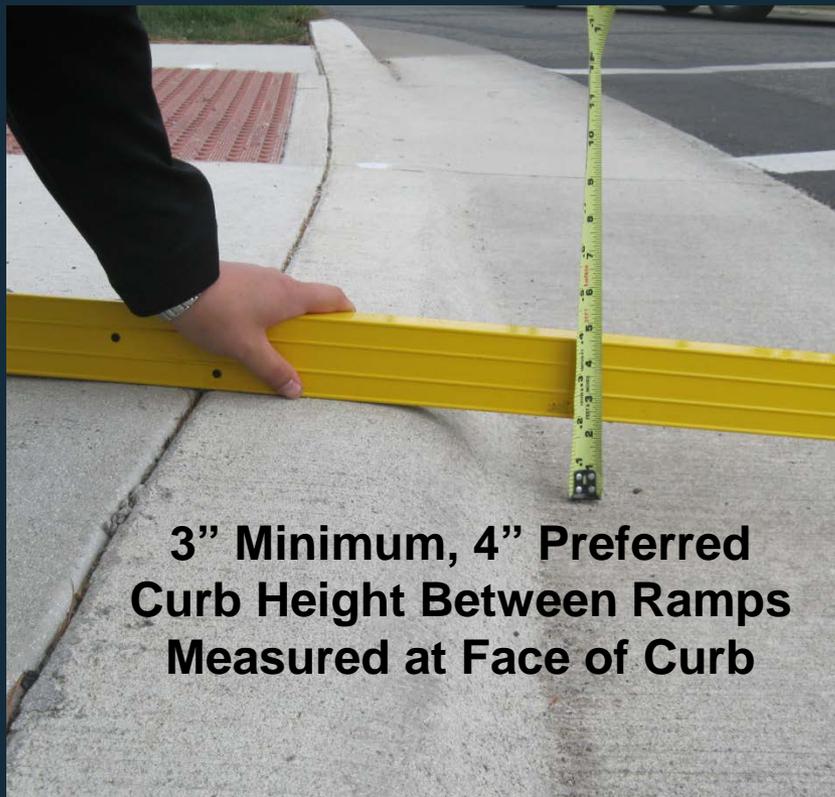
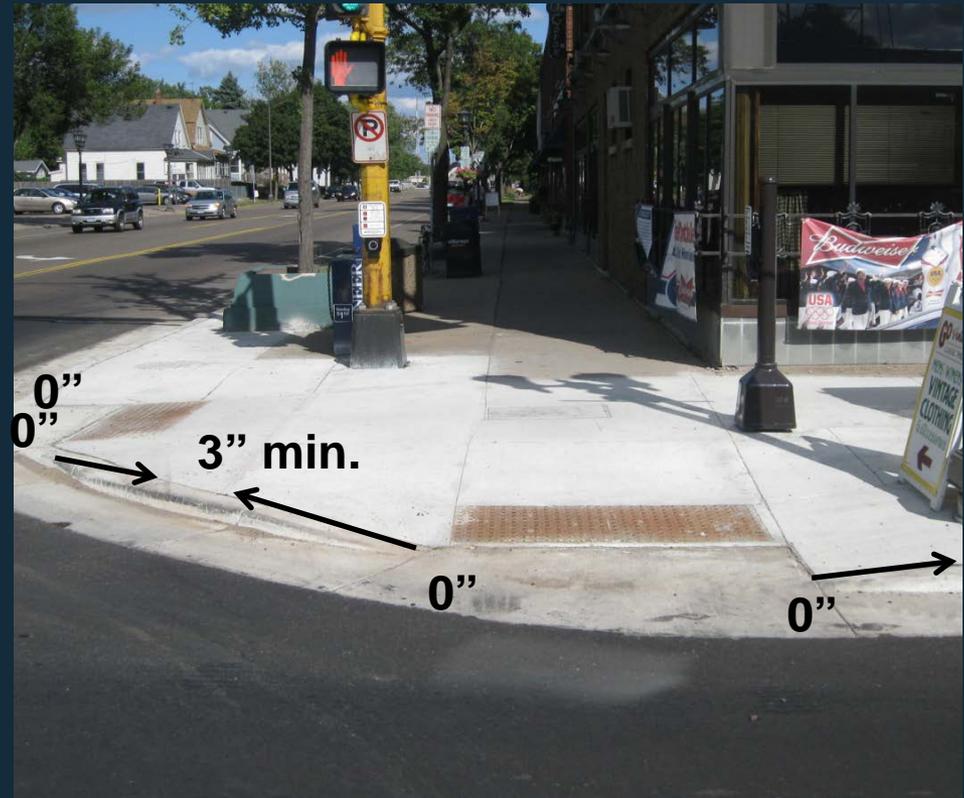
10) Curb tapers are considered a detectable edge when tapers start within 3" of truncated domes and rise to a minimum 3" curb height.

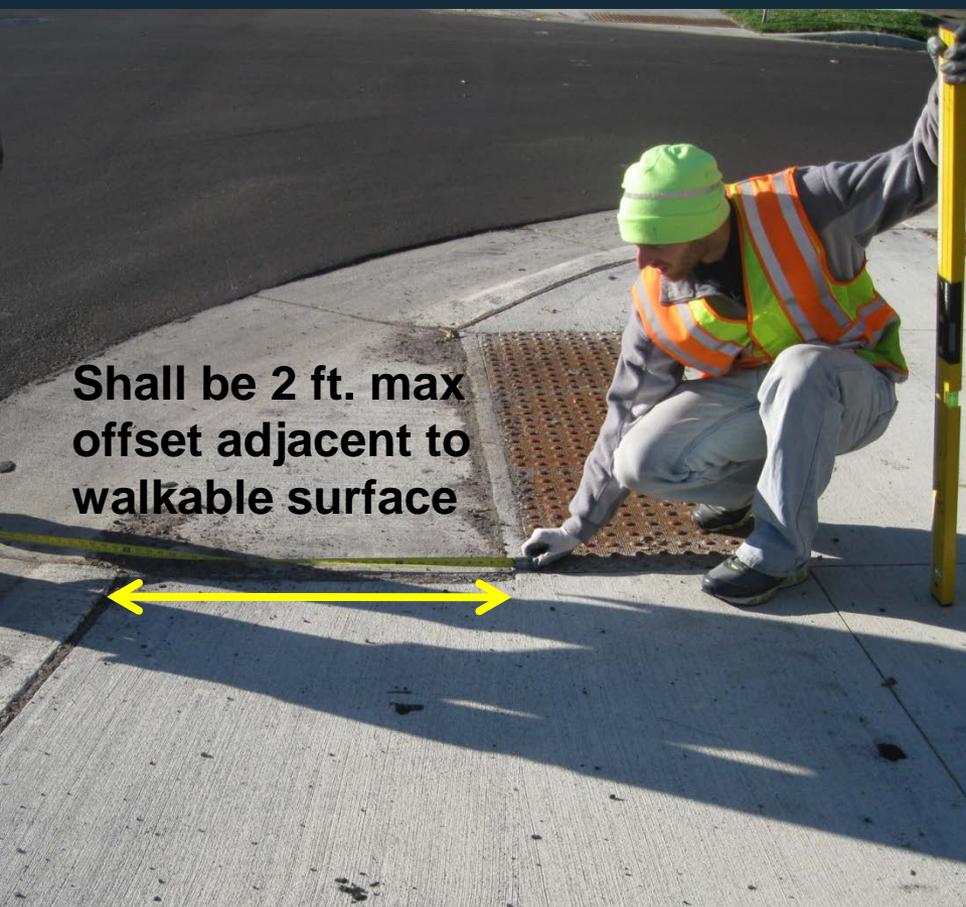
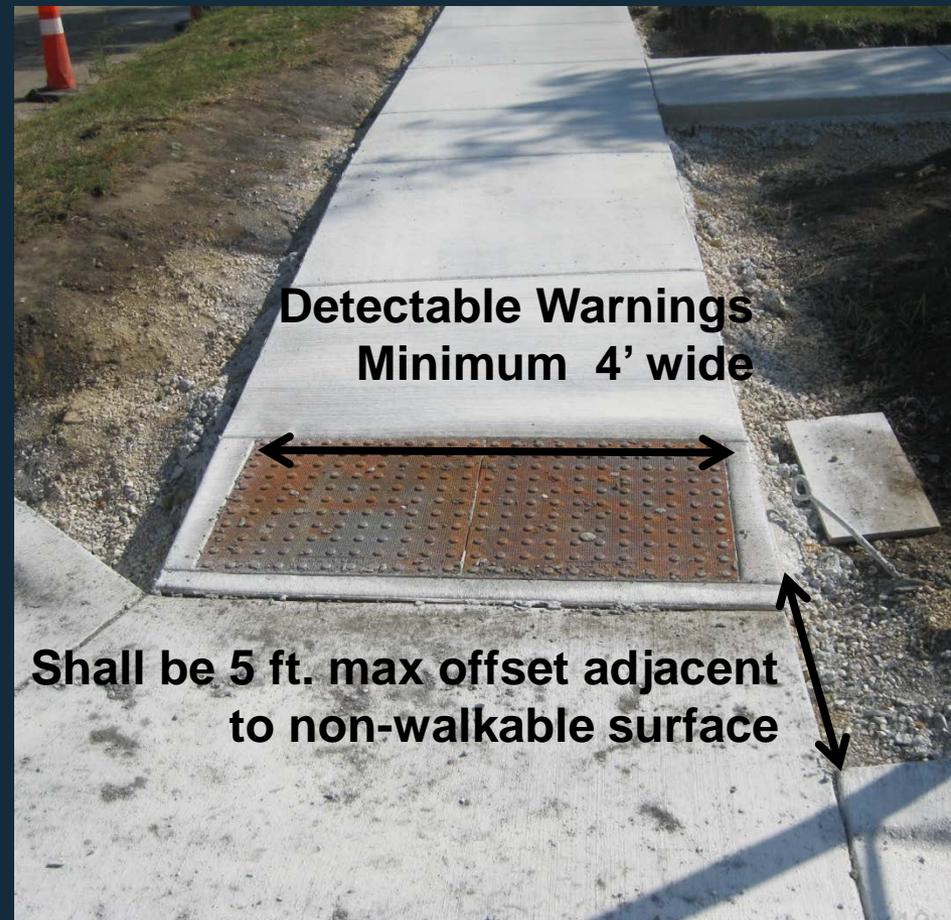
10) Truncated domes cover the entire curb opening and meet setback criteria.

Shall be 2 ft. max offset adjacent to walkable surface

Detectable Warnings
Minimum 4' wide

Shall be 5 ft. max offset adjacent to non-walkable surface

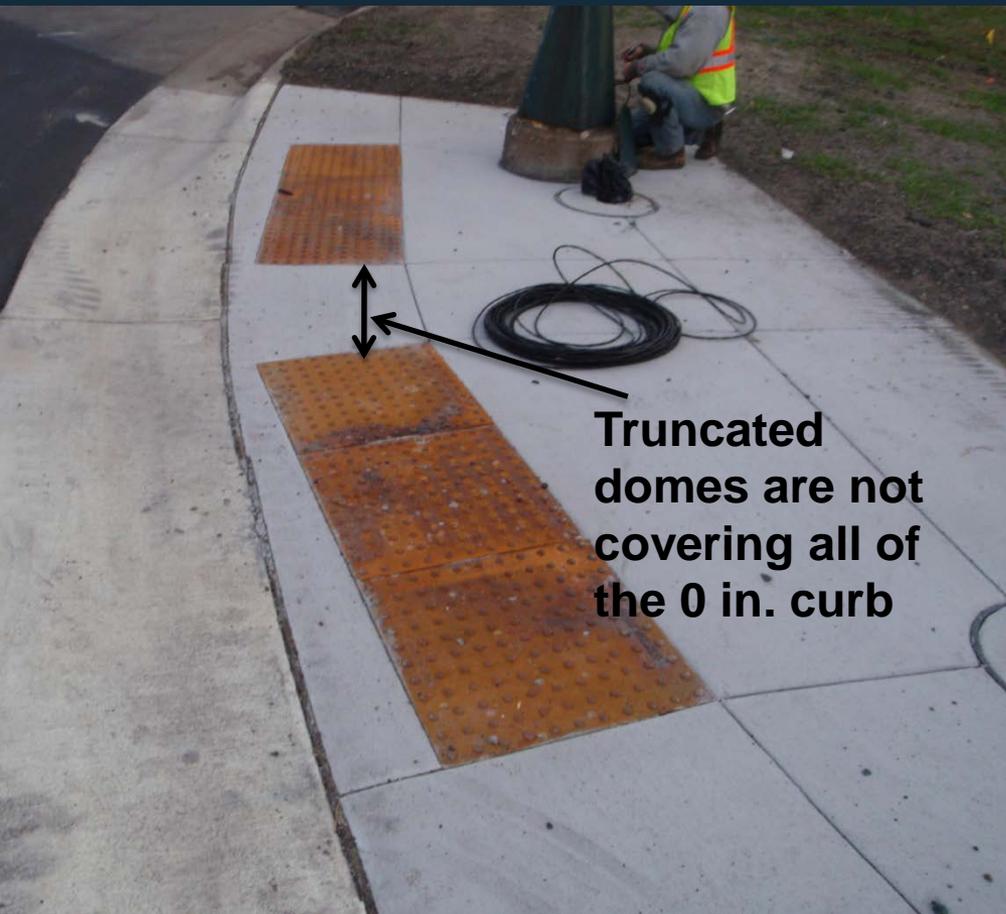
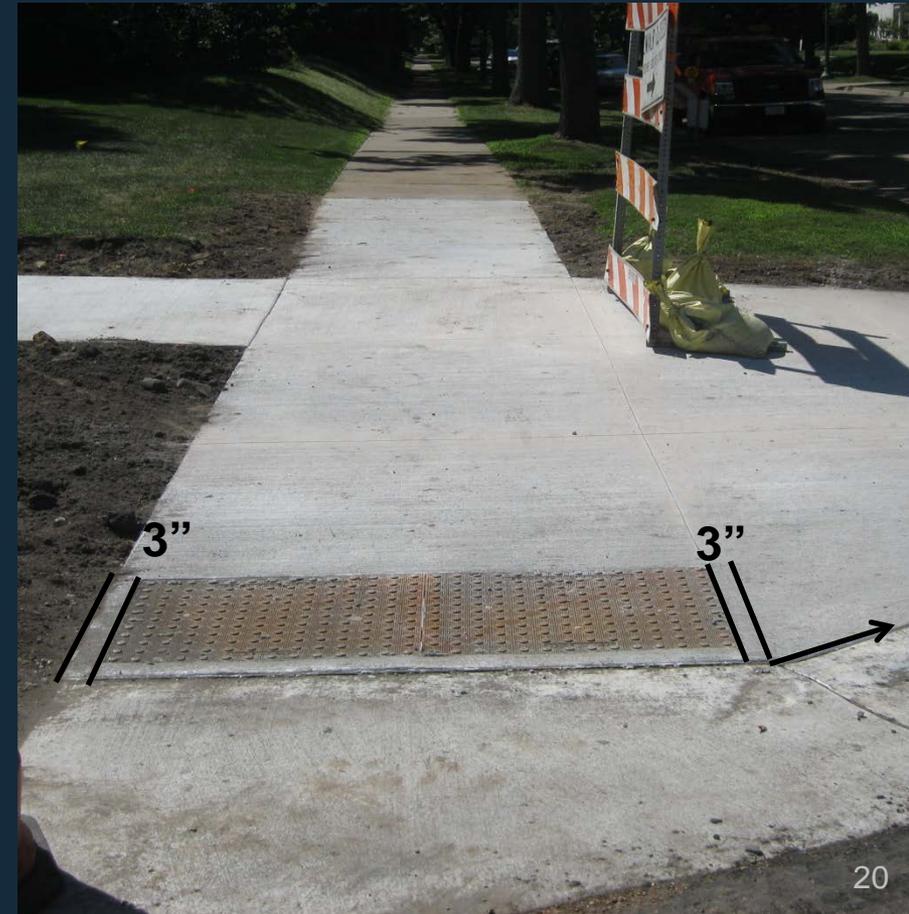
10) Truncated domes shall extend full width of the ramp landing or Blended transition within 3" on either end

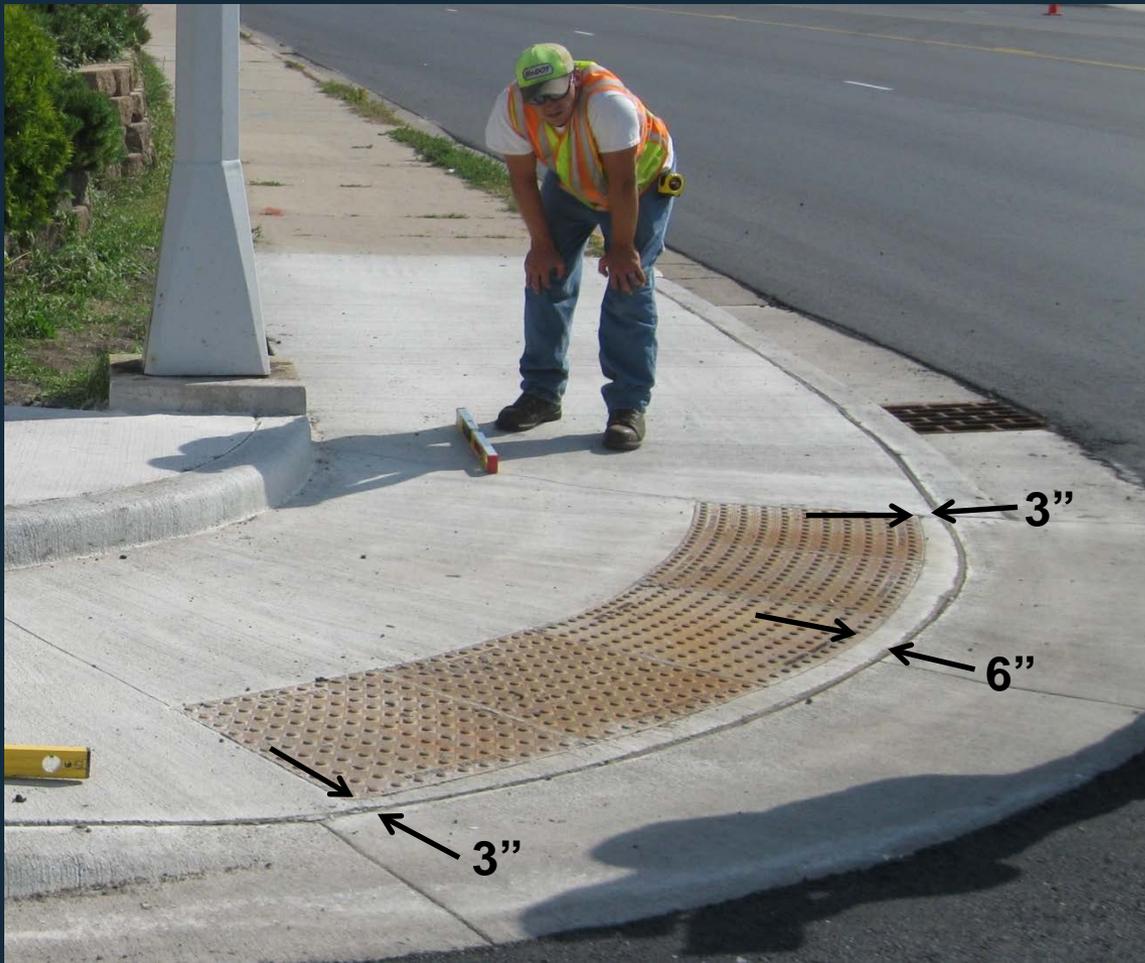
10) Radial Detectable warnings shall be set back 3" to 6" from back of curb.

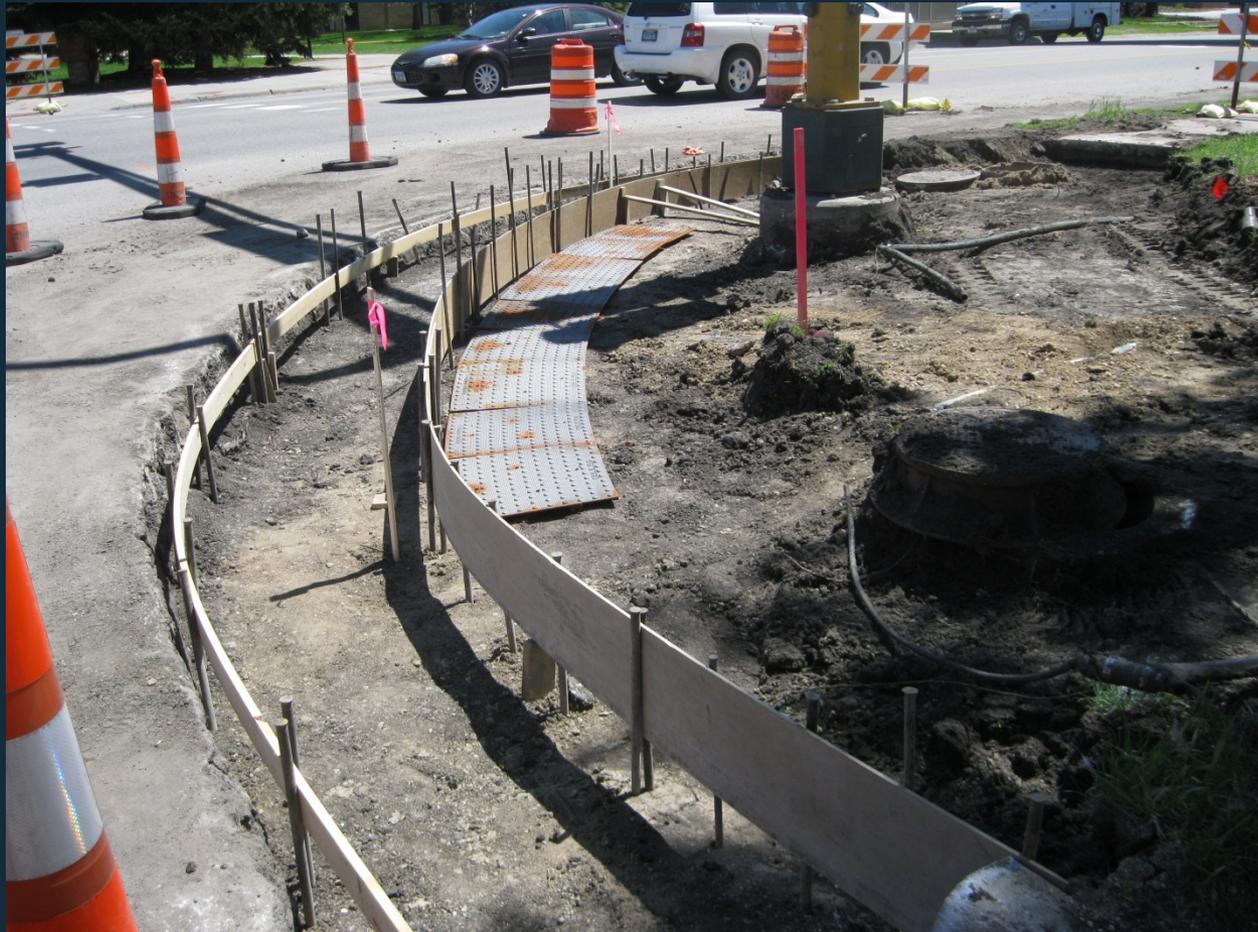
10) Radial Detectable warnings shall be set back 3" to 6" from back of curb.

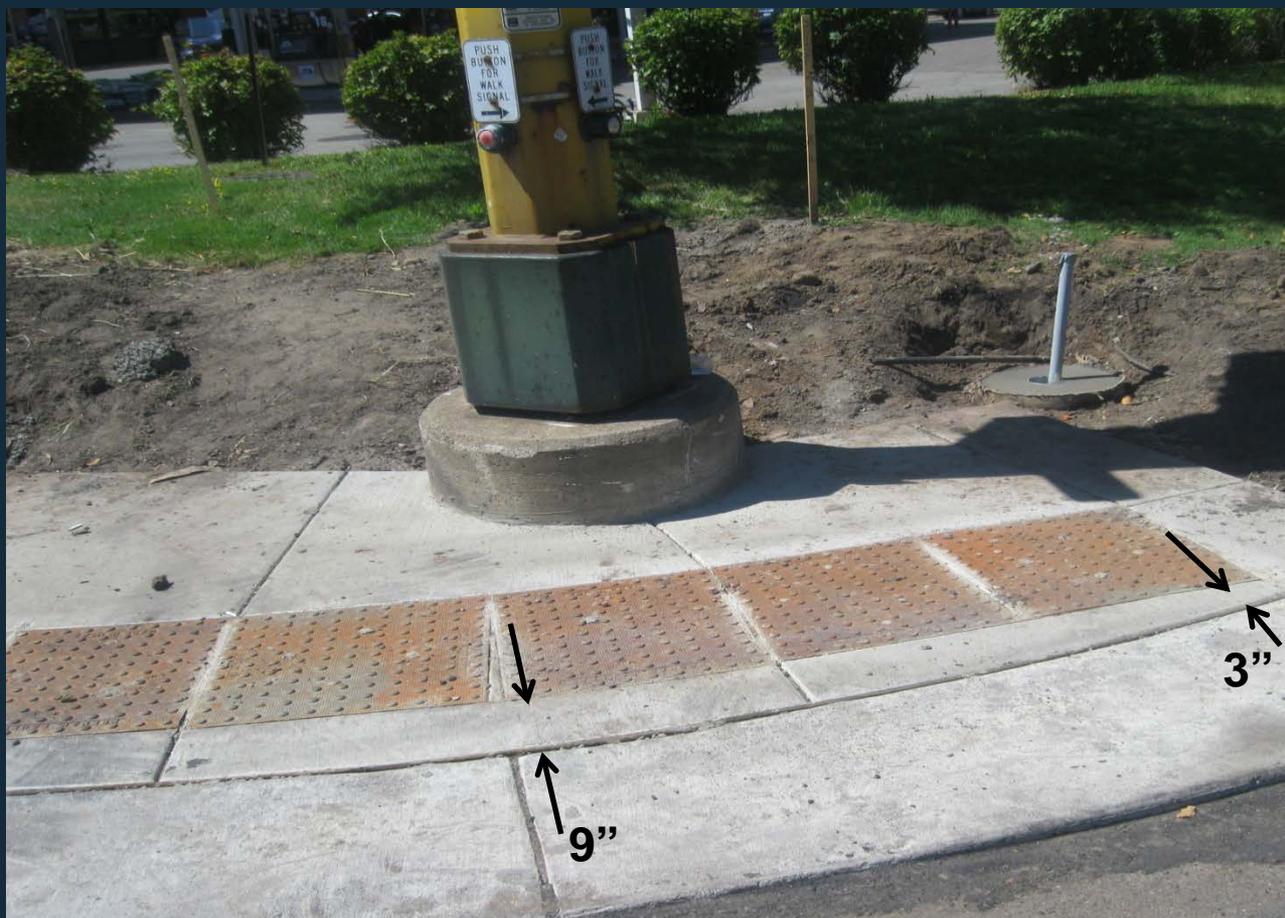
10) Whenever rectangular domes are placed around a radius, they may be set back up to 9" in the middle and 3" at the corners.

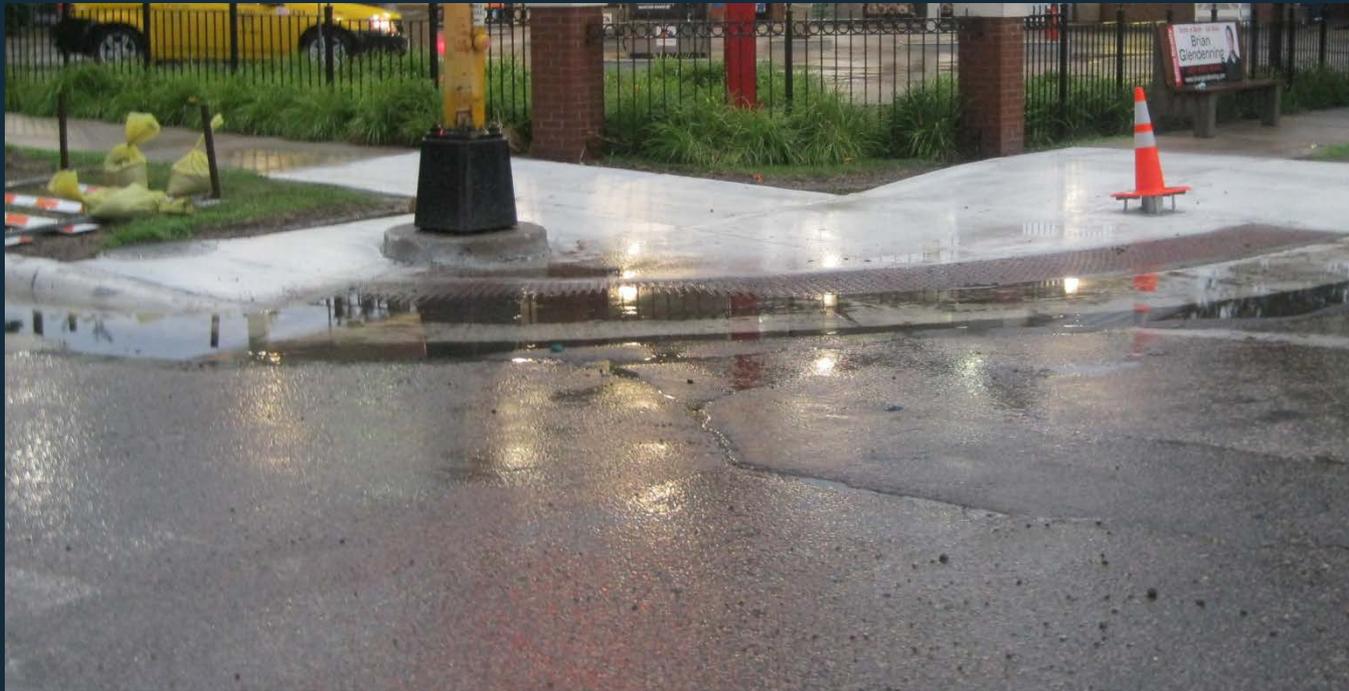
11) Check gutter line and ramps are draining properly and not holding water. Check after rain event.

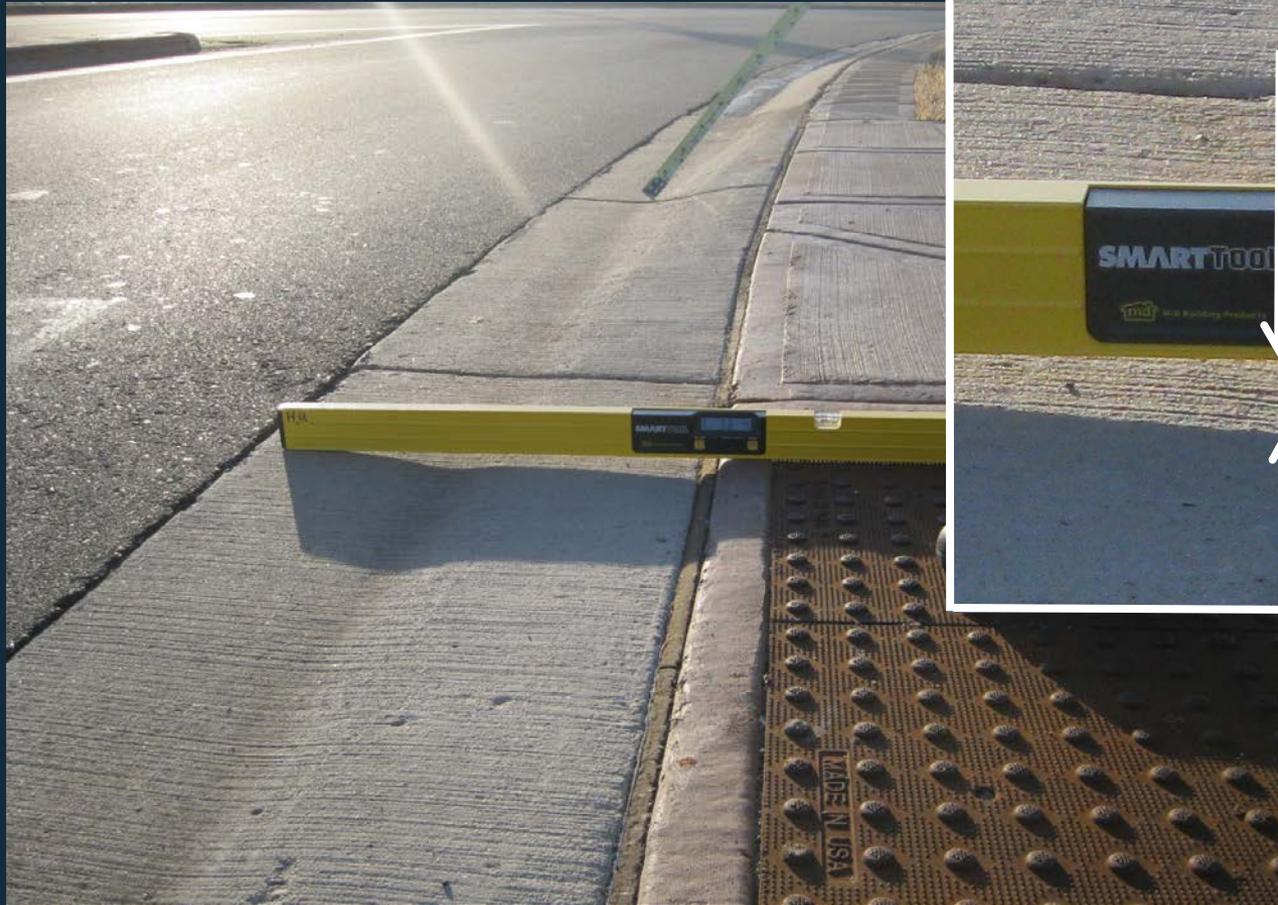
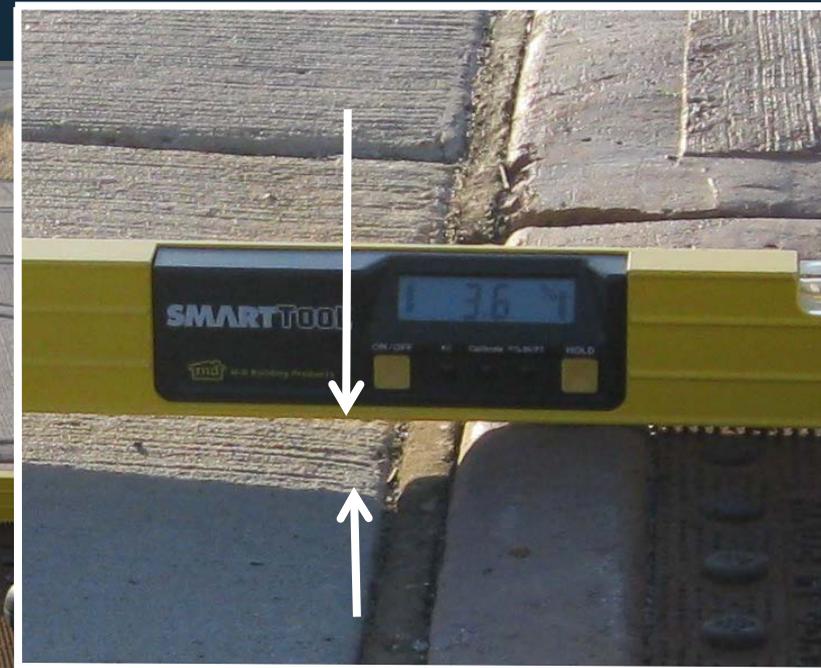
12) (1803) No vertical discontinuities greater than $\frac{1}{4}$ inch anything over $\frac{1}{2}$ inch and the panel should be replaced.
