MnDOT ADA Training

Compliance Checklists 2016

ADA Compliance Checklist Guidance [Curb Ramps]

ADA Compliance Checklist Guidance [APS] (Accessible Pedestrian Signals)

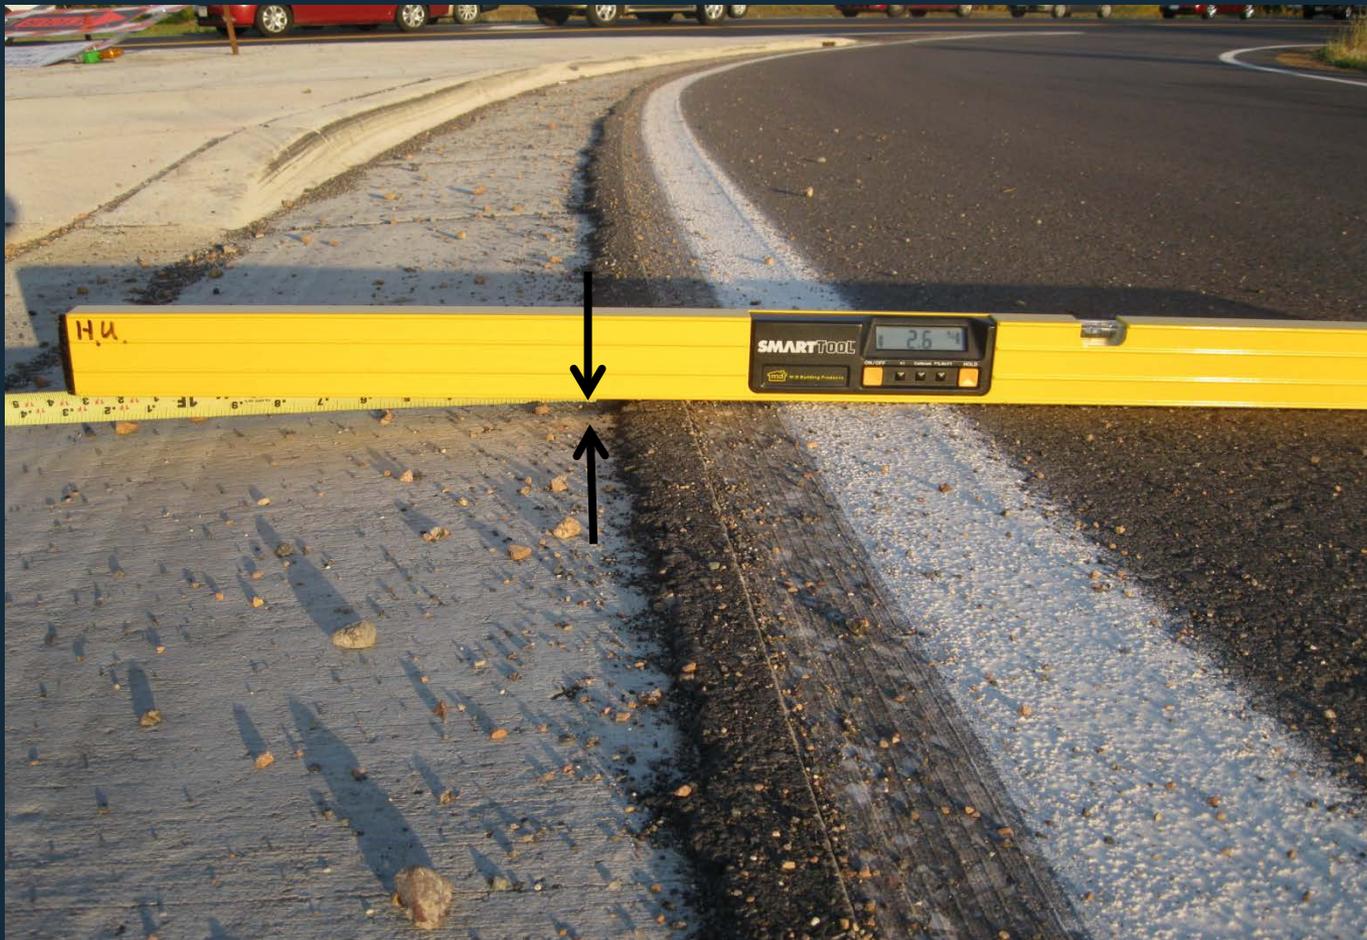
12) No vertical discontinuities greater than $\frac{1}{4}$ inch

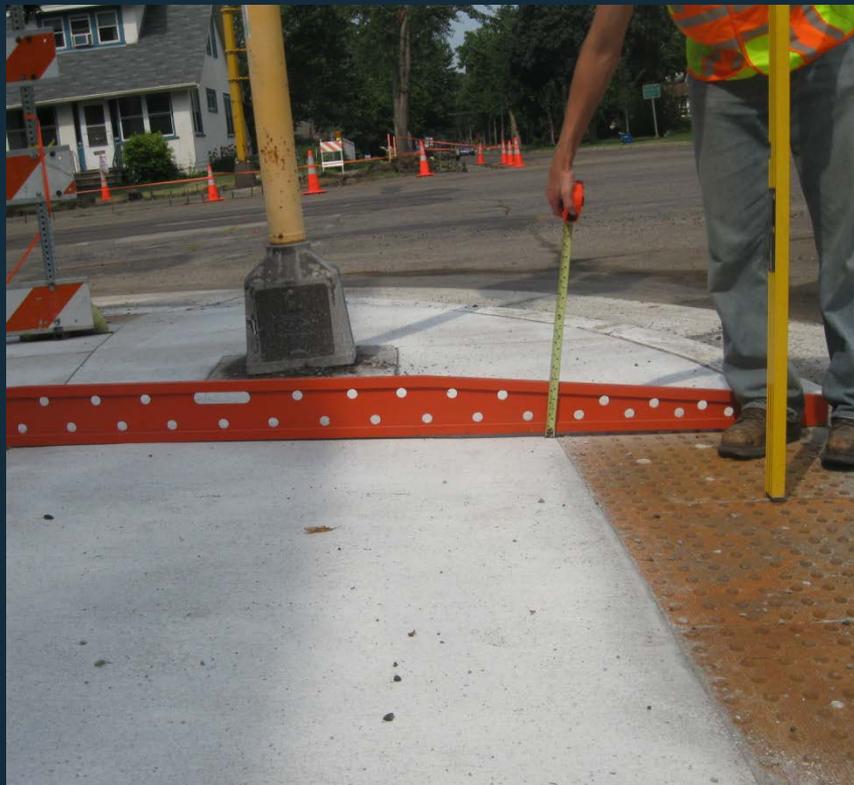
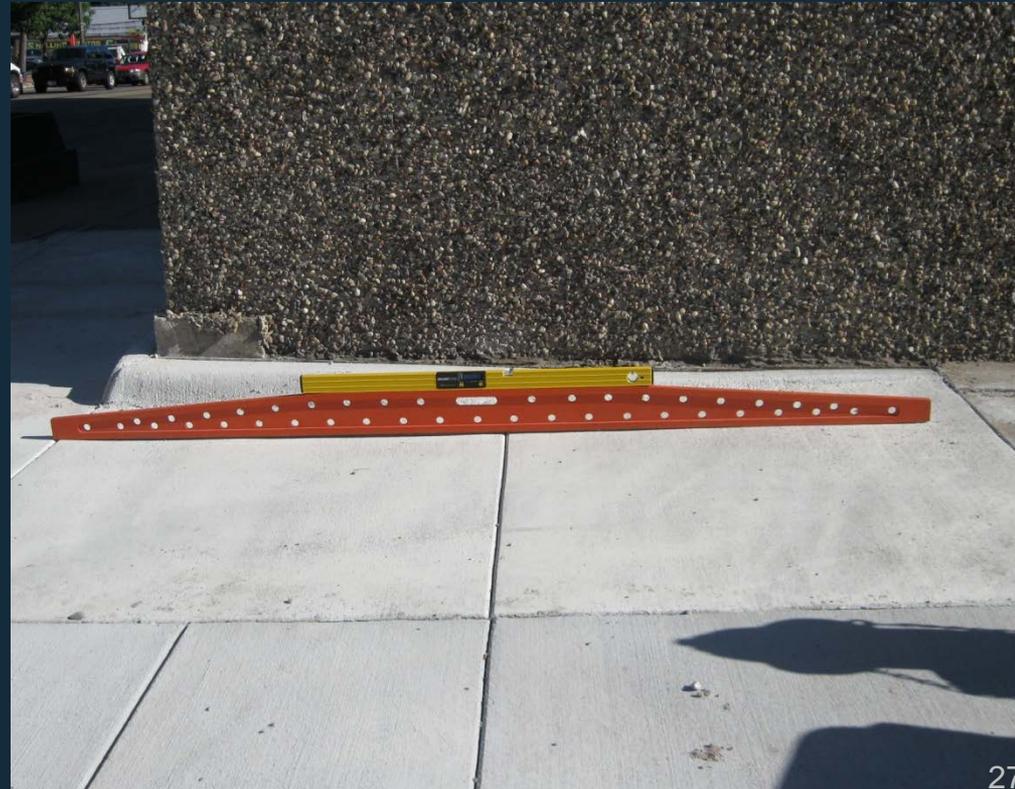
13) Spec 2521.3: The Engineer will use a 10' straight edge to measure the surface. The department considers deviations greater than $\frac{3}{16}$ in. and deviations in formed concrete greater than $\frac{1}{2}$ in. from the required location as unacceptable work. Remove and replace unacceptable work as directed by the Engineer.

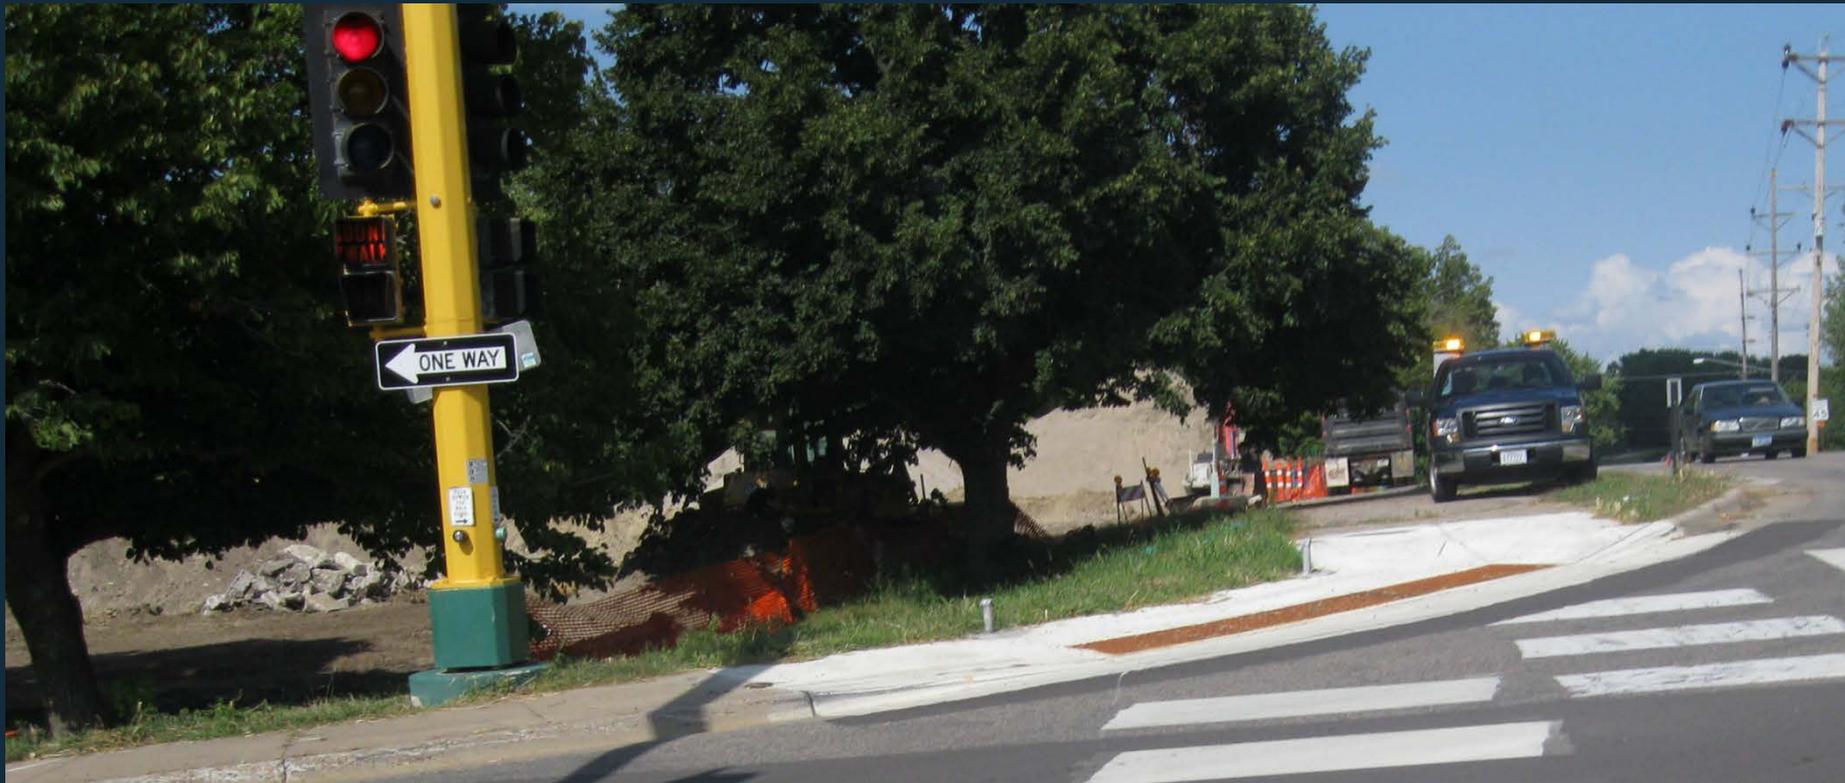
A) Topography : Elevated road slopes or steep existing flow lines. Secondary landing could not be constructed within 30 ft. of initial landing.

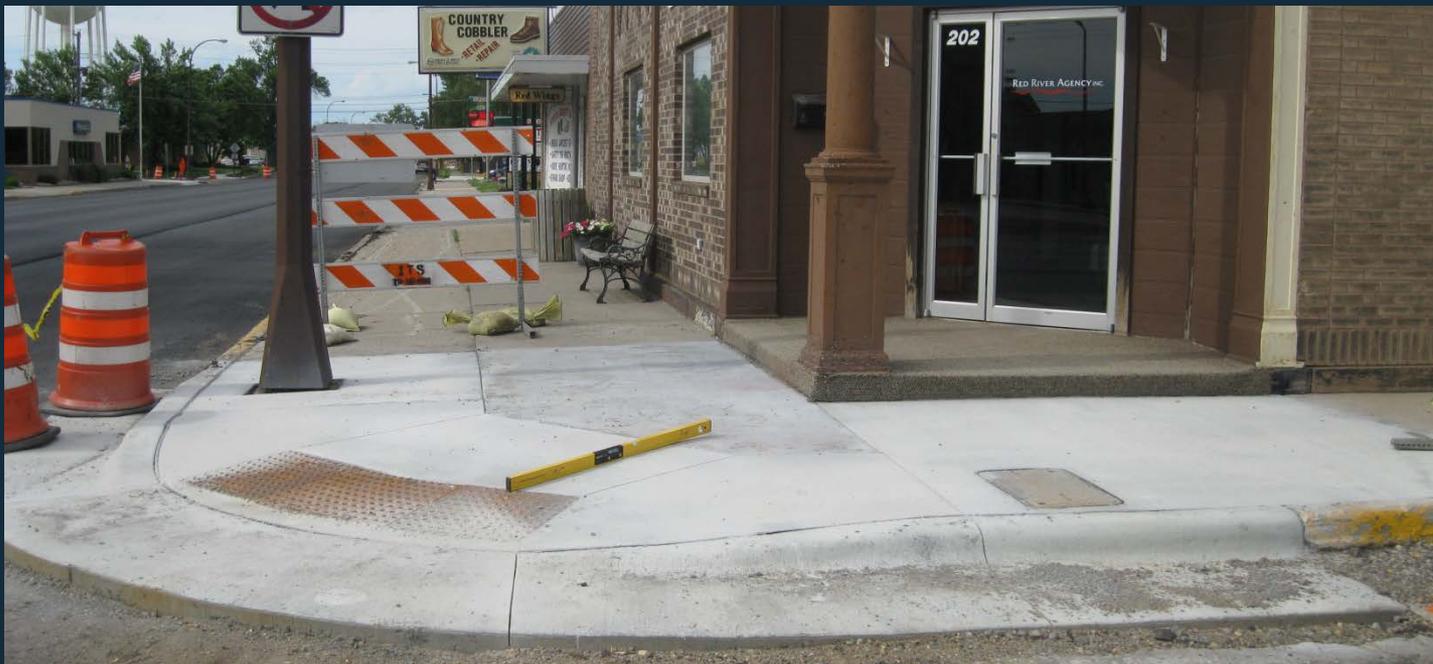
B) Structures : Ramp could not be constructed compliant due to existing structures such as buildings, steps, street signs ect...

Example: walkway attempting to tie into nearby entrance / steps and reducing space for compliant curb ramp construction.

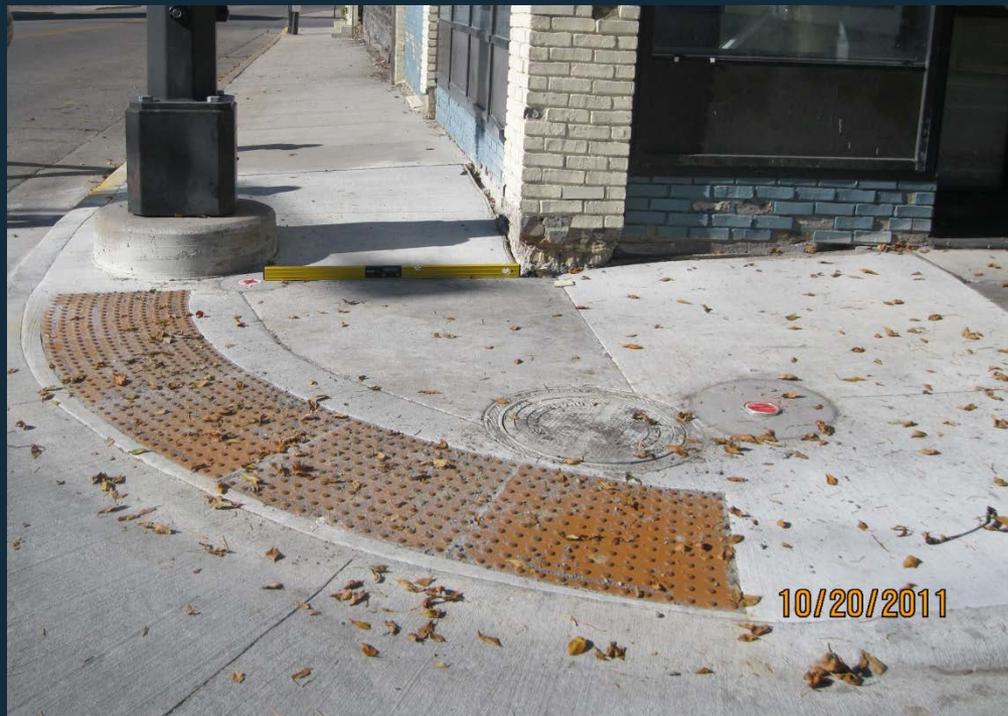
C) Utilities: Existing utilities that could not be moved

- Both surface and underground utilities such as power poles, fire hydrants, street lights, signal poles, manholes, vaults ect...

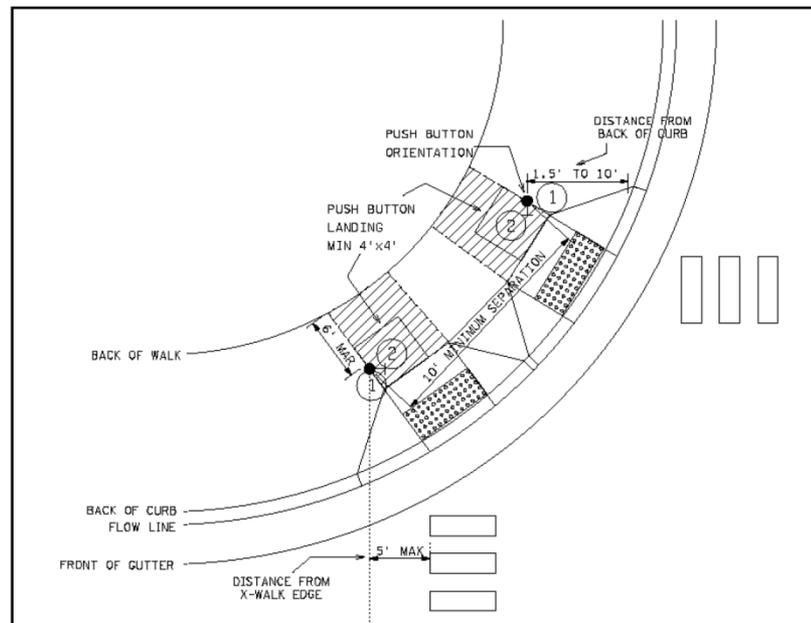
Figure 1: APS Guidance (1)

The bubble note in each figure represents the required data on the APS compliance checklist form.

Numbers on figure and on the APS form	DESCRIPTION
1	Push button orientation
2	Push button landing
3	Distance from crosswalk edge
4	Distance from back of curb
5	Distance between push buttons
9	Distance of push button(s) to front and back of landing
10	Maintenance access route (MAR)

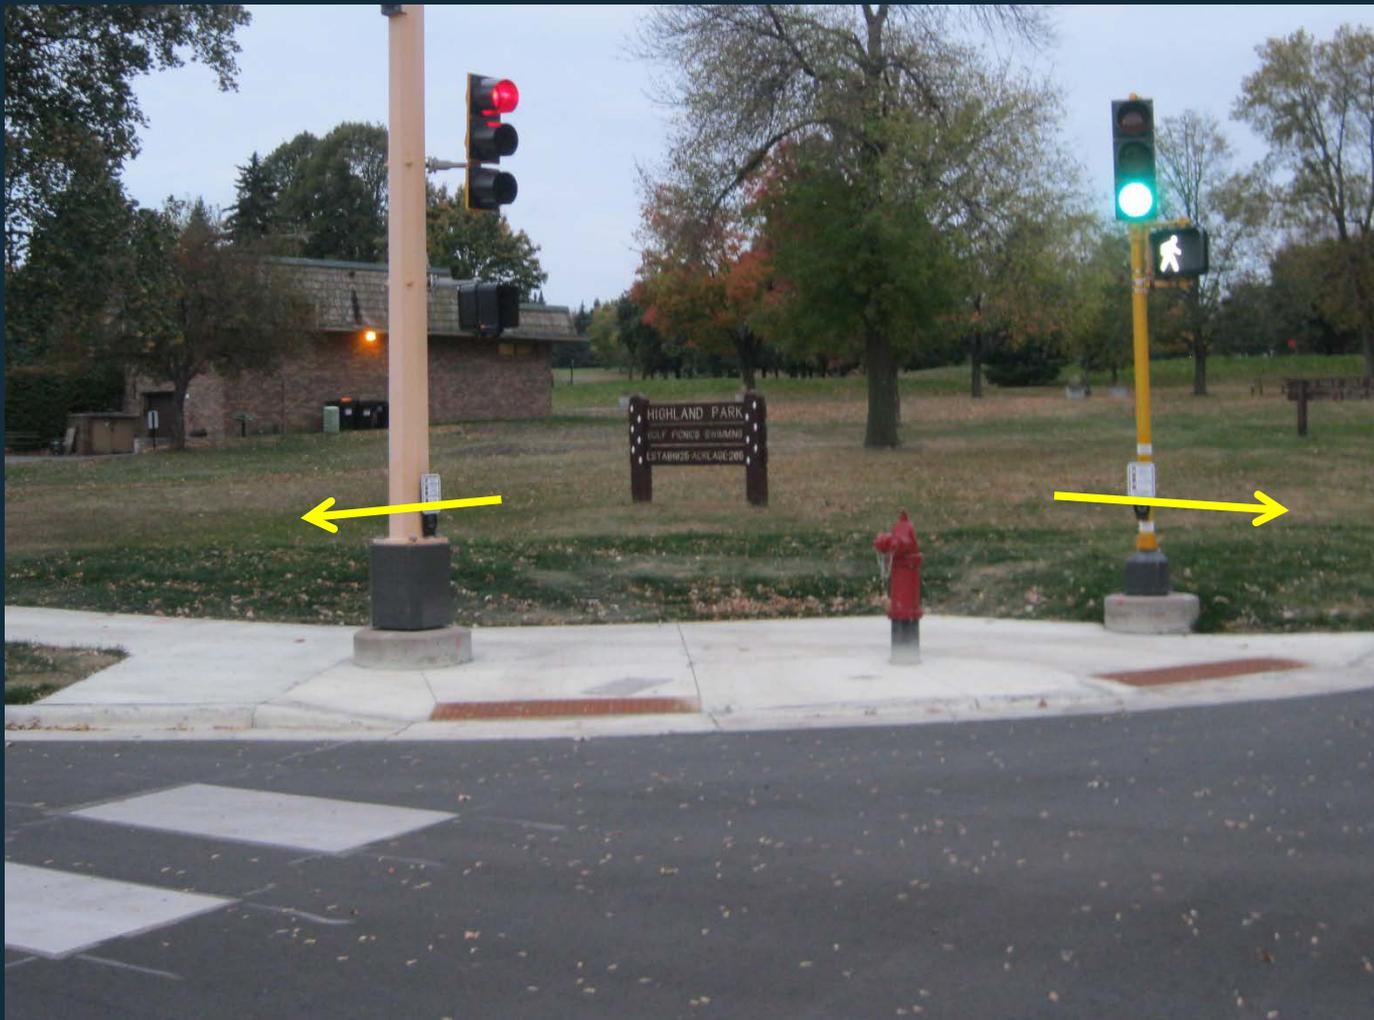
1) Push buttons stations are properly placed and the push button faces are oriented properly.

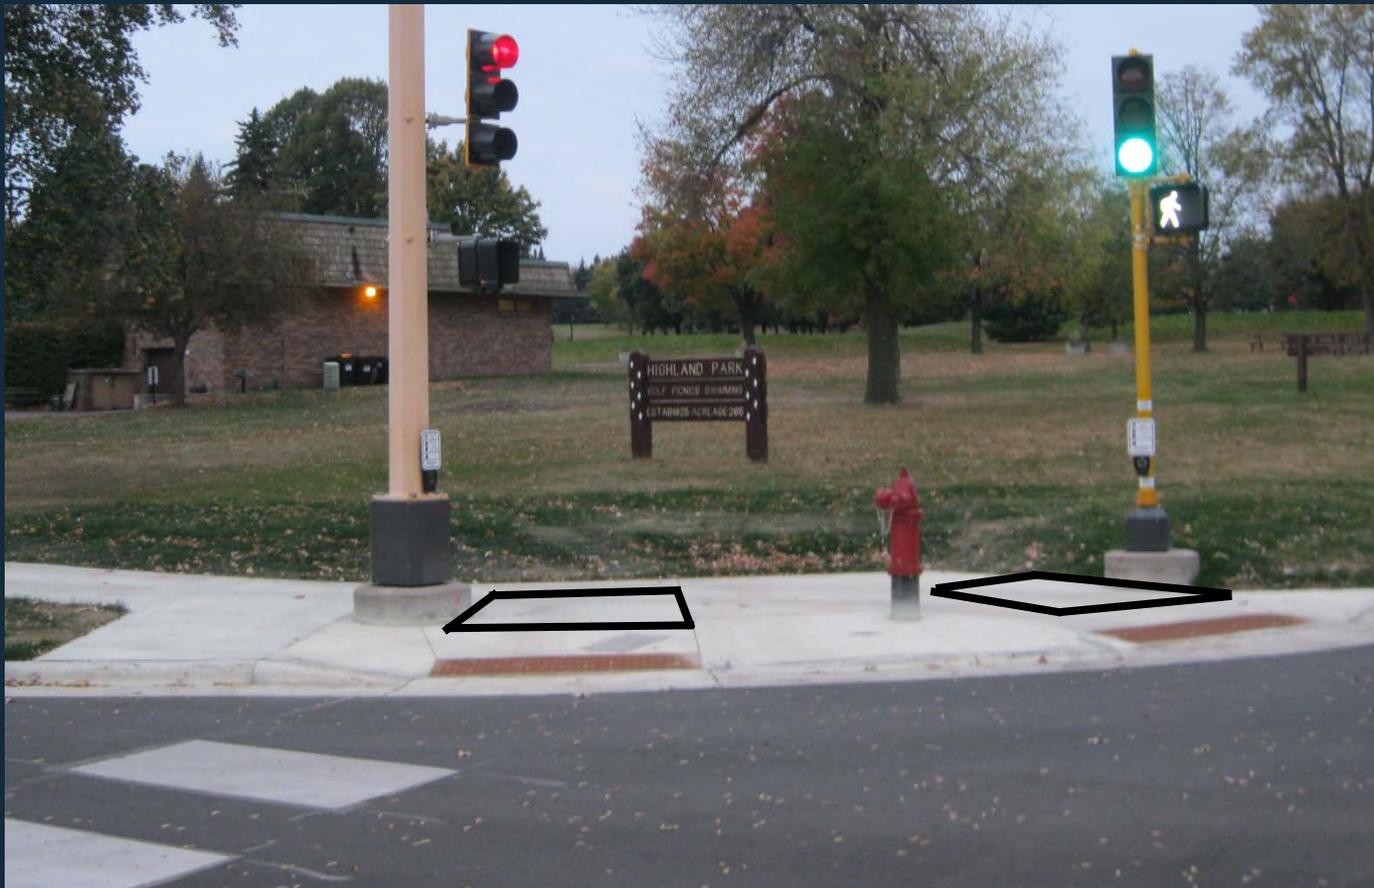
2) There must be a 4' x 4' landing adjacent to the push button.

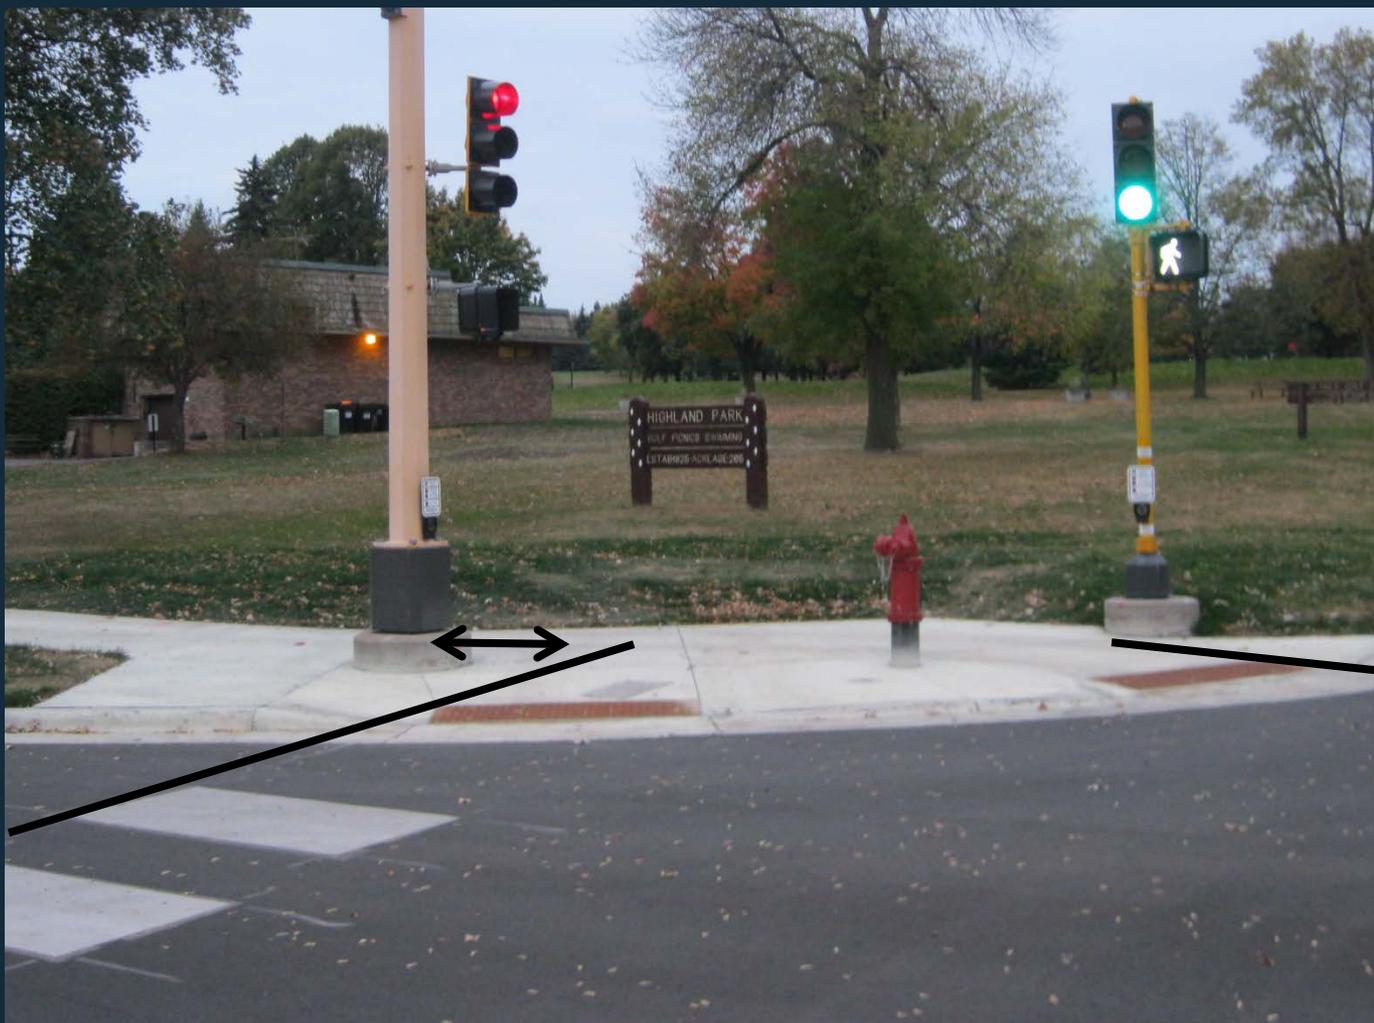
3) Distance from crosswalk edge to push button face: _____

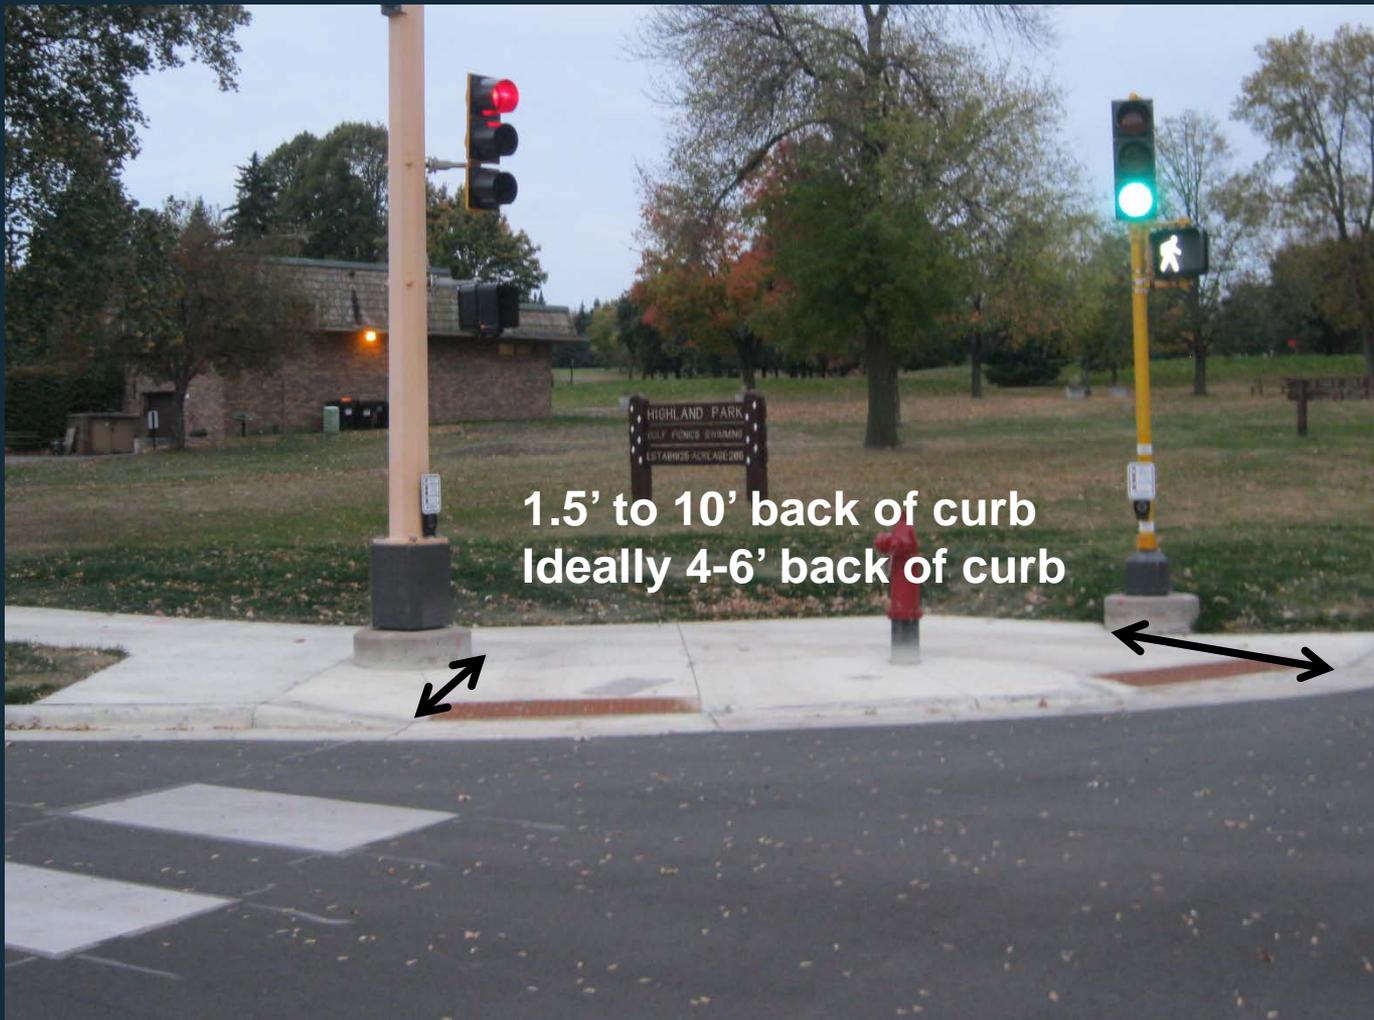
4) Distance from the push buttons to the back of curb: _____

1.5' to 10' back of curb
Ideally 4-6' back of curb

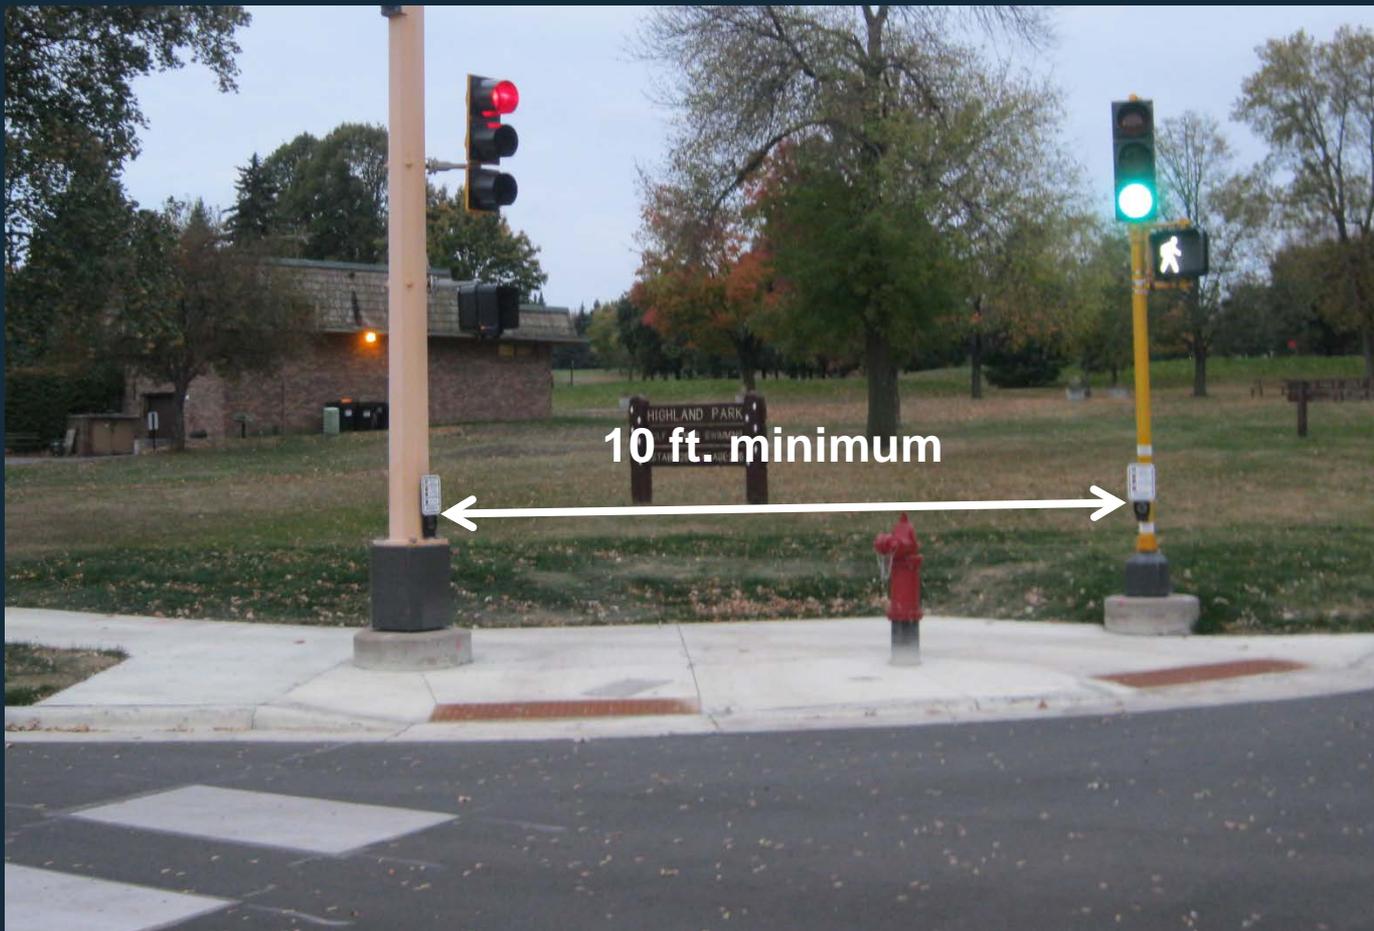
5) Distance between the push buttons: _____

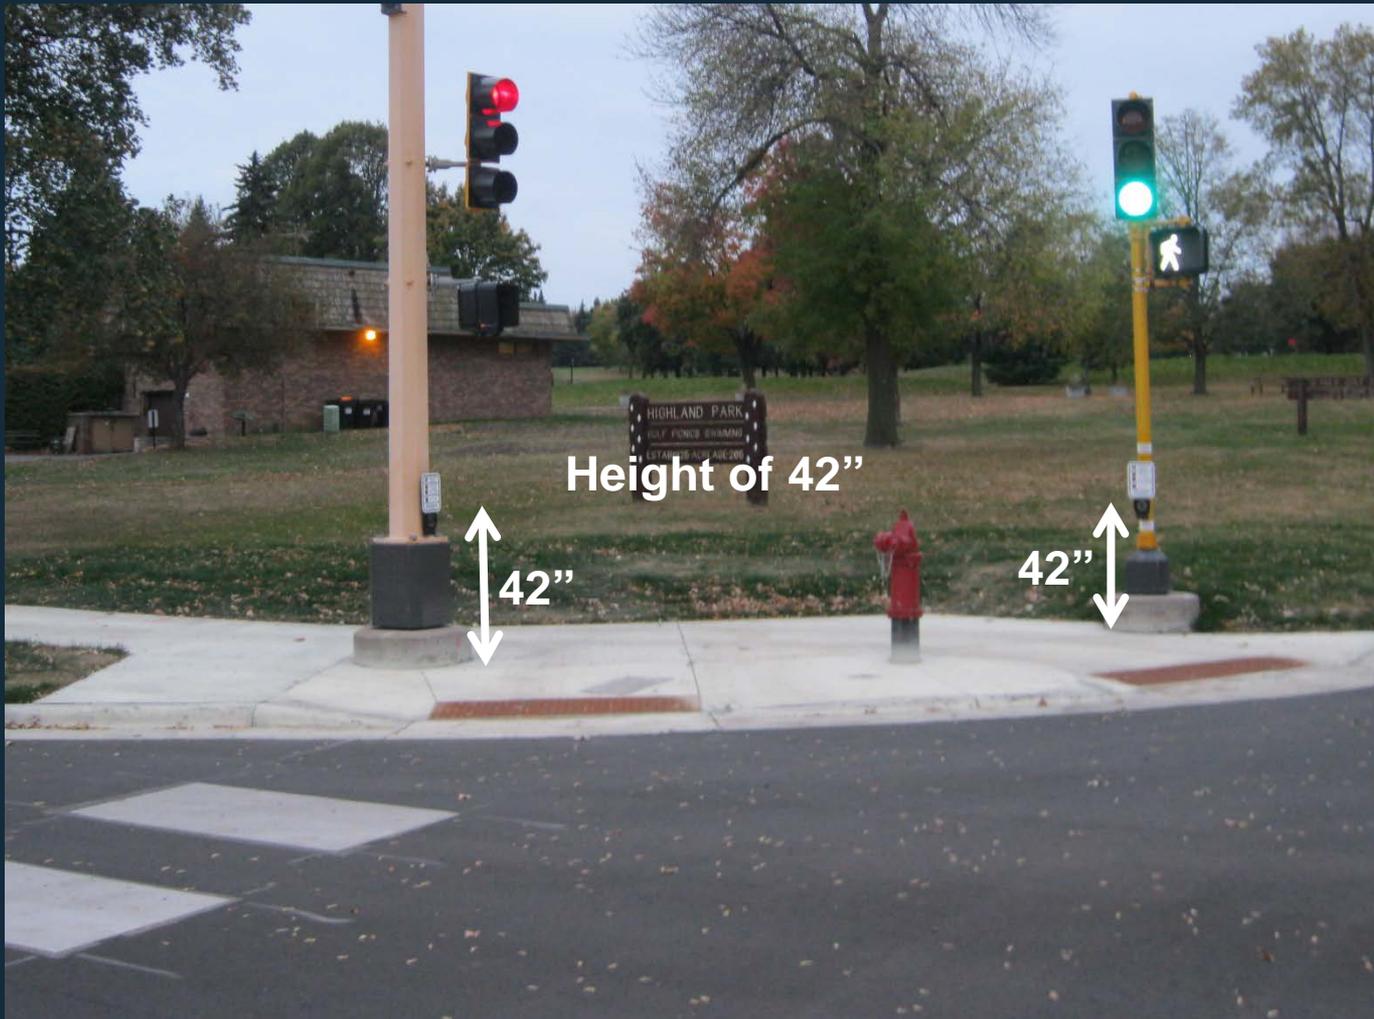
6) Push button height: _____

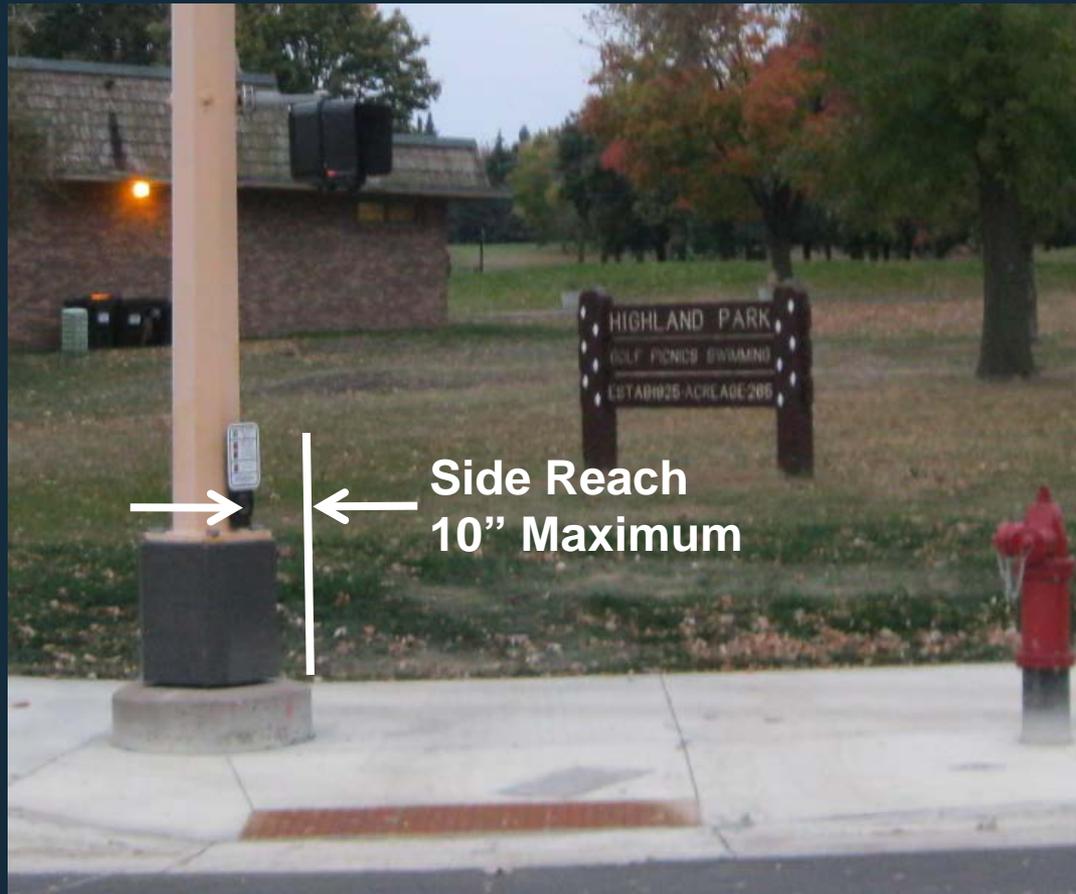
7) The push button needs an unobstructed side reach of 10" maximum.
