Pavement Condition Report

Wheaton Municipal Airport (ETH)

December 2017

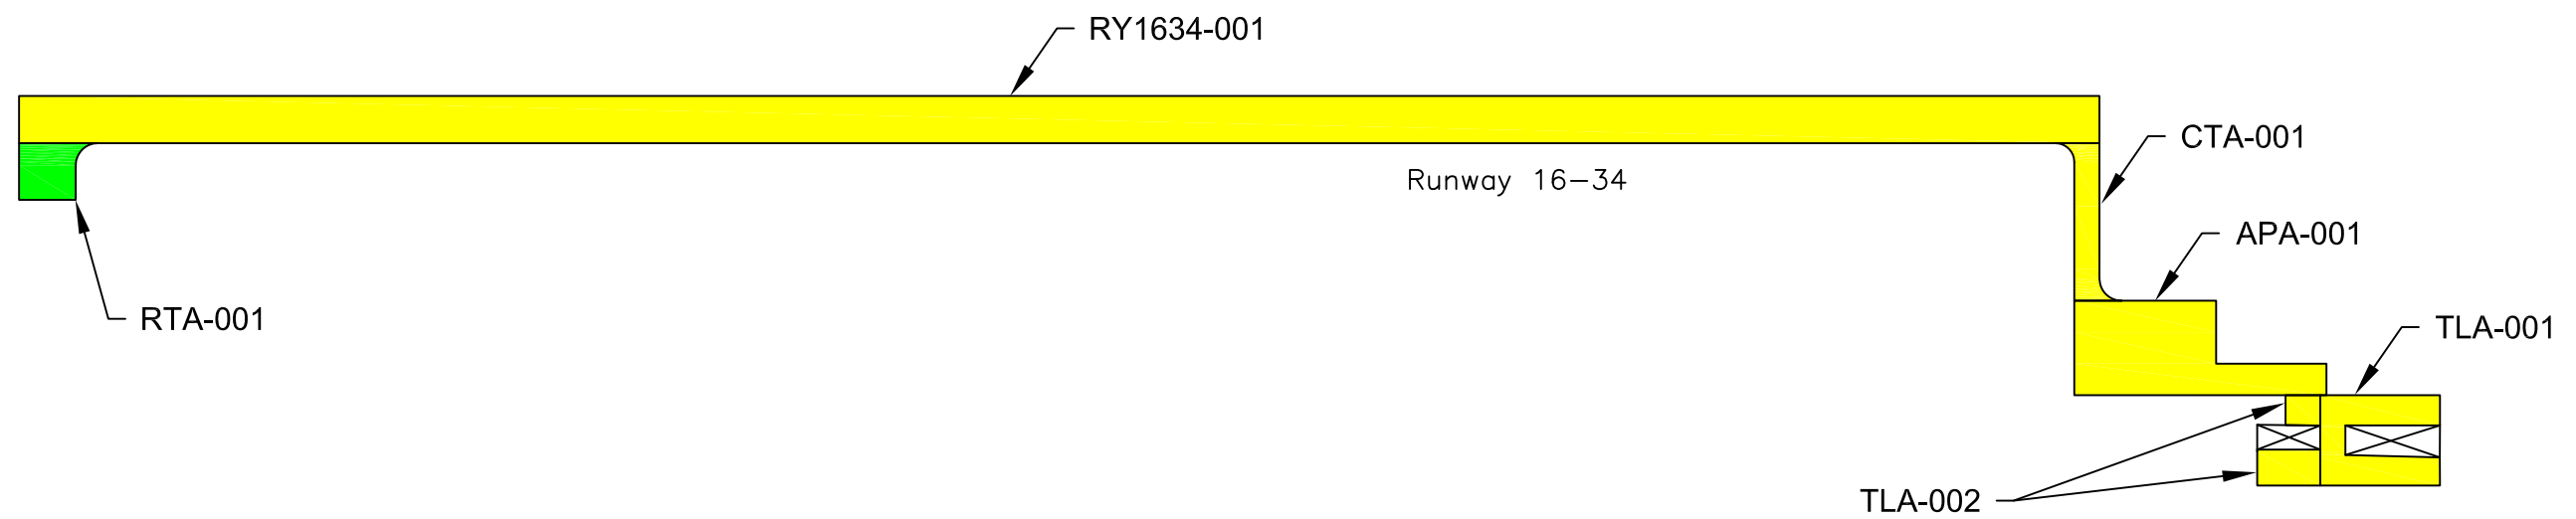
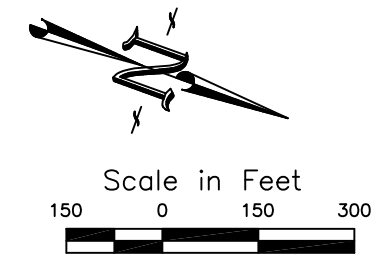
Figure 4. 2017 Pavement Condition Index Rating at Wheaton Municipal Airport (ETH).

The results of the 2017 PCI inspection are presented in figure 4. The overall area-weighted, inspected PCI for ETH is 64. When summarizing PCI values, an area-weighted calculation is used instead of a straight mathematical average because the area-weighted calculations eliminate the skewing of the PCI due to the disparity of the section sizes.
