Pavement Condition Report

Duluth International Airport (DLH)

December 2018

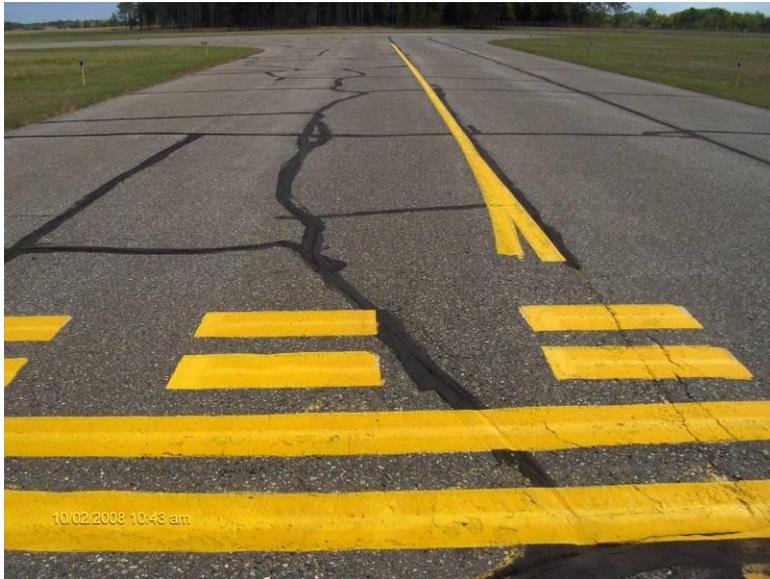
Example of Longitudinal and Transverse Cracking (L&T cracking)

Longitudinal and transverse cracks are caused by pavement aging, by construction, and by subsurface movement. Aging occurs as pavement loses some of its components to the atmosphere and becomes more brittle. Consistent application of pavement sealcoats can help to prevent the occurrence of age related cracks. Cracks will also develop along poorly constructed paving lane joints. Ensuring that joints are made when both sides are still hot, and near the same temperature, is one of the best ways to mitigate this potential problem. Seasonal movement caused by changes in moisture content or temperature differences can also cause pavement cracks. Asphalt pavement placed over a PCC pavement or cement stabilized base course may evidence reflective cracking from the underlying material. Longitudinal and transverse cracks are not caused by wheel loads, although traffic may worsen their condition.

Low severity longitudinal and transverse cracks are less than $\frac{1}{4}$ inch wide, or if sealed with suitable filler material in satisfactory condition can be any width, less than 3 inches, if they are not spalled. Maintenance usually is not indicated for low-severity cracking. Moderately spalled cracks and cracks wider than $\frac{1}{4}$ inch which are not satisfactorily sealed are at medium severity. Medium-severity cracks should be sealed with a high-quality crack filling material. Severely spalled cracks and cracks wider than 3 inches are at high severity. High-severity L&T cracks normally require patching.

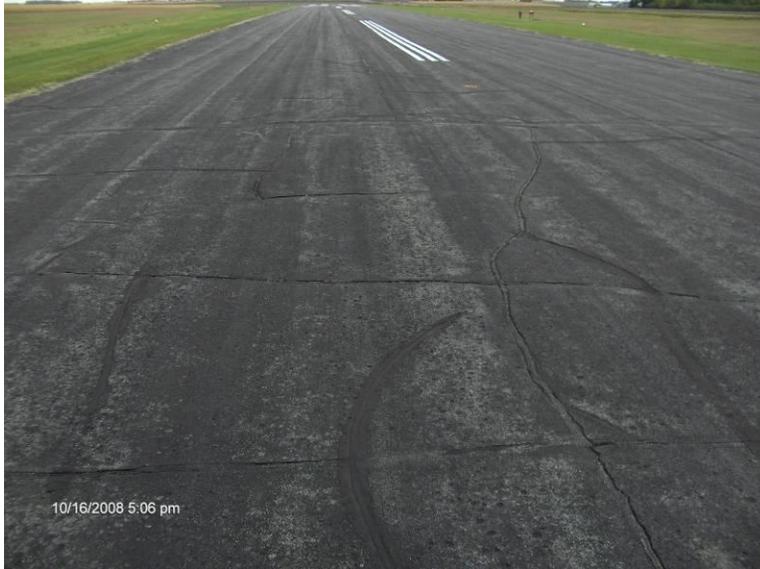
Example of Block Cracking

Block cracking is longitudinal and transverse cracking that has established a pattern of blocks ranging in size from 1ft x 1ft to 10ft x 10ft. This distress typically happens in older asphalt pavements and is an indication that the bituminous binder has lost most of its flexibility. The severity determination is basically determined by the crack width criteria defined for longitudinal and transverse cracking. Crack sealing typically is used to repair block cracking; however, the amount of required sealant can be extensive due to the high density of cracks.

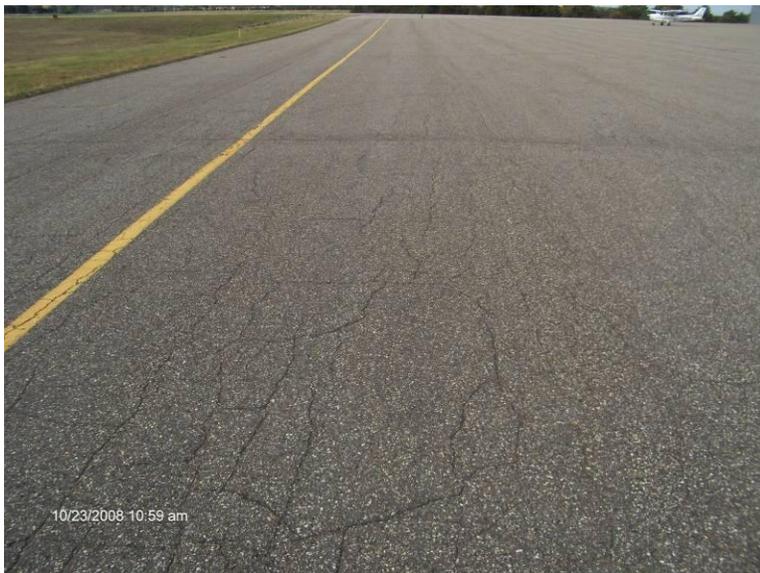
Example of Alligator Cracking

Alligator (or fatigue) cracks are a series of interconnected load-related cracks caused by fatigue of the asphalt surface. Alligator cracking is a significant structural distress and develops only in places subject to traffic loads. These cracks typically initiate at the bottom of the asphalt layer (where tensile strains

are highest) and propagate upward - so once a fatigue crack is visible, significant damage has already occurred.

At low severity, alligator cracks are evidenced by a series of parallel hairline cracks (usually in a wheel path). Further traffic and deterioration leads to the interconnection of these cracks. Medium severity alligator cracking is a well-defined pattern of interconnected cracks, some spalling may be present. High severity alligator cracks have lost aggregate interlock between adjacent pieces, the cracks may be severely spalled with FOD potential, and most likely the pieces will move freely under traffic. Alligator cracking is a structural failure and cannot be repaired with sealant, the proper repair is full-depth patching.

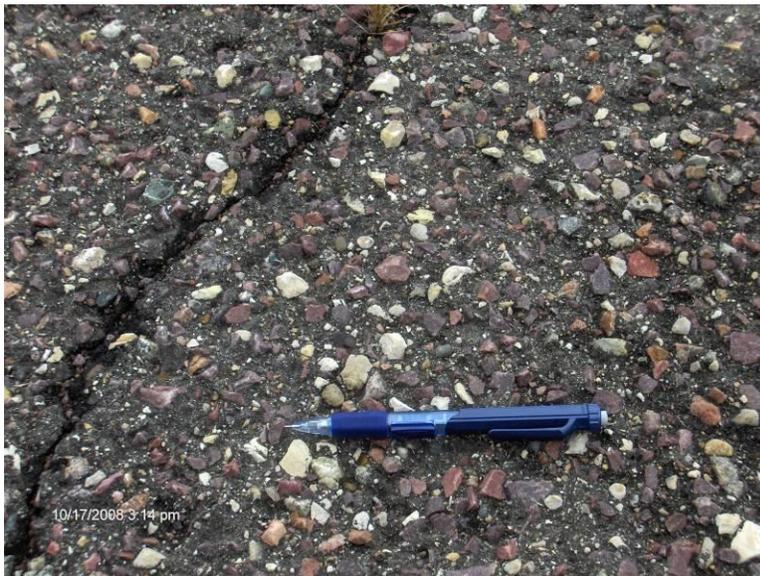
Example of Raveling/Weathering

Raveling and weathering are the wearing away of the pavement surface. Raveling is the condition where the mid- to large size aggregates are becoming dislodged; weathering is when the fine aggregate wears away exposing the edges of the larger aggregate. These distresses are usually evident over large areas and may occur together (pictured above) or separately. Raveling and weathering may indicate that the asphalt binder has hardened significantly.

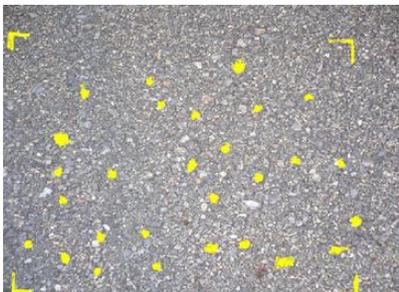
Raveling – At low severity, the number of missing coarse aggregates (> 3/8 inch) is between 5-20 missing/yd², medium severity (pictured below where the missing coarse aggregates have been dotted with yellow paint) is 21-40 missing/yd², and high severity is > 40 missing/yd².

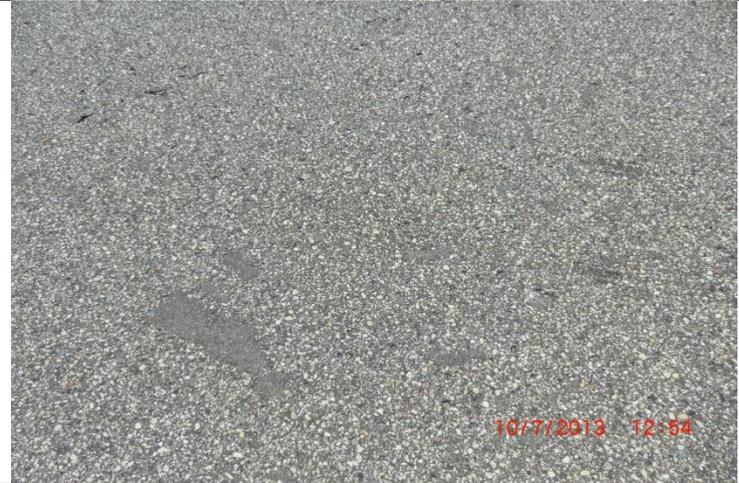
Low severity

Weathering – At low severity, the coarse aggregate is slightly exposed due to the wearing away of the fine aggregate. At medium severity, the coarse aggregate is exposed up to ¼ the width of the longest side. At high severity, the coarse is exposed greater than ¼ the width of the longest side.

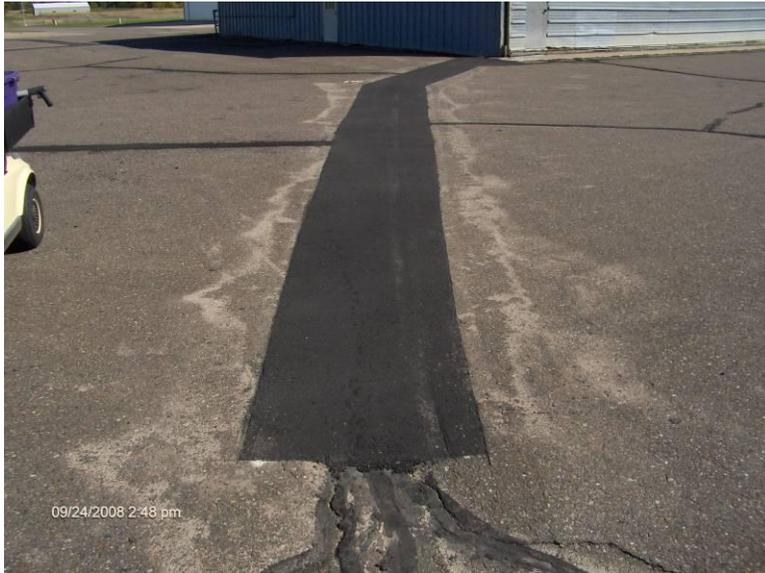
Example of Patching

Patched areas are defined when a portion of the original pavement is replaced with a material intended as a semi-permanent repair. A patch is documented as a defect because it is considered a break in the integrity of the pavement structure. Patches are constructed for a variety of reasons including utility repairs, correcting grade issues, and addressing a defect in the original pavement. The severity level of patches is determined by the amount of distress (i.e. cracking, depression, weathering/raveling, etc.) occurring within the limits of the patched area.

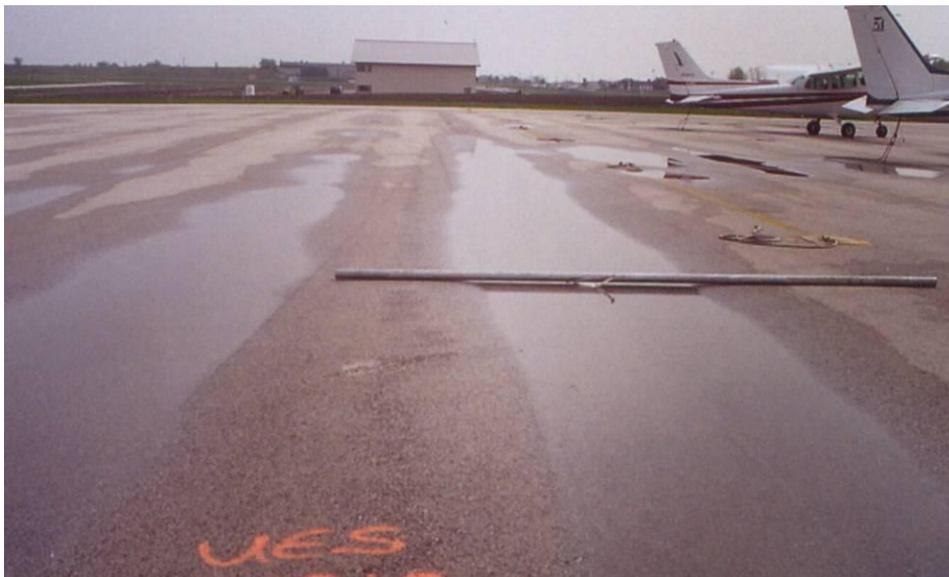
Example of Rutting

Ruts are localized, load related, areas of pavement having elevations lower than the surrounding sections. Rutting is due to base and subgrade consolidation, caused by excessive wheel loads or poor compaction. Ruts indicate structural failure, and can cause hydroplaning. At low severity, ruts have an

average depth of ¼ to ½ inches. At medium severity, ruts have an average depth of ½ to 1 inch. High severity, ruts have an average depth greater than 1 inch. Full-depth patching is the appropriate repair for ruts.

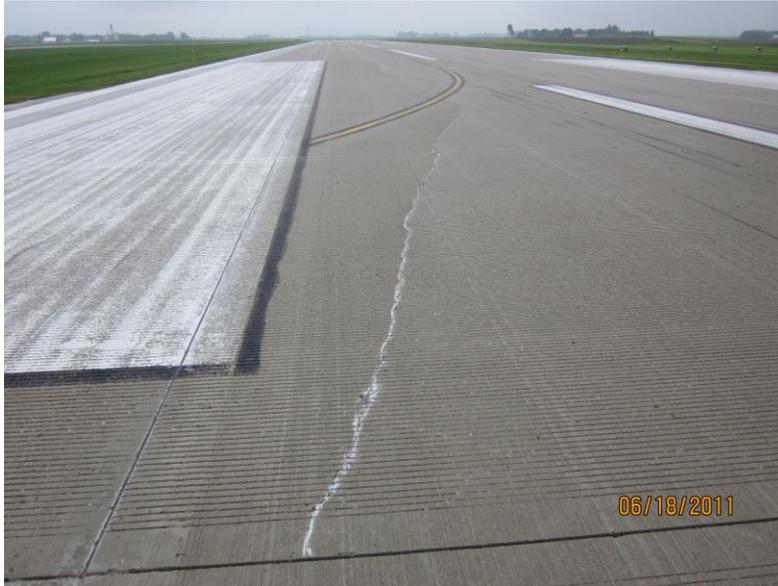
Example of Longitudinal, Transverse, and Diagonal Cracking

LTD cracking is most often a result of externally applied loads and/or constrained temperature deformations. External loads cause LTD cracking through flexure. Temperature changes on restrained slabs will result in stresses due to friction or curling. When any of these stresses exceed the strength of the slab, cracking will occur. LTD cracking is recorded at low, medium, or high severity, depending on the width of crack opening and degree of deterioration. At low severity, the crack is less than 1/8th inch wide with little spalling and no corrective action is indicated. At medium severity, LTD cracks can be up to 1 inch wide with moderate spalling, and should be repaired and sealed using procedures similar to joint sealing. At high severity, cracks exceed 1 inch in width and may be severely spalled. High-severity LTD cracking is evidence of serious load failure of the slab, and correction may require patching or slab replacement. If the distress occurs in several adjacent slabs at medium or high severity, major rehabilitation of that pavement area is indicated.

When a slab is divided by LTD cracks into four or more pieces, the slab is said to be "divided" or "shattered." Shattered slab is a separate distress category and is indicative of significant structural failure as the slab loses its ability to distribute loads to subgrade and further slab deterioration can be expected. Shattered slabs are rated in three severities, with slab replacement recommended for medium and high severities.

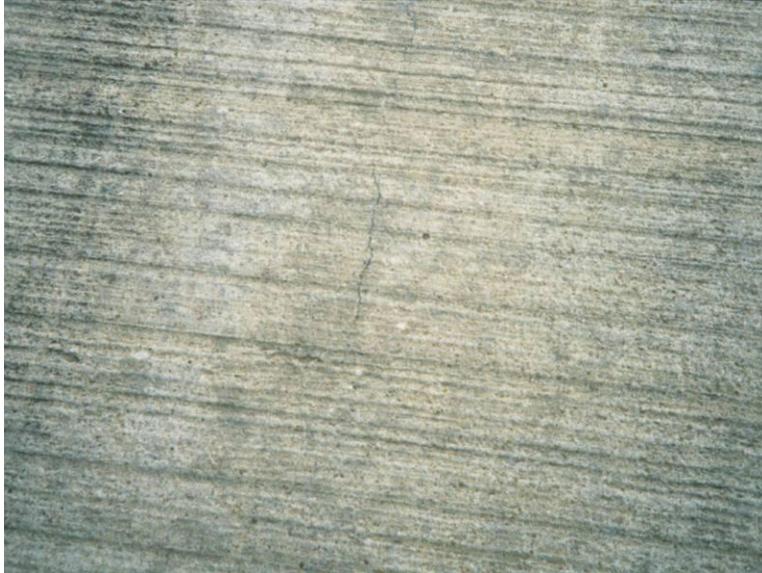
Example of Shrinkage Cracking

Shrinkage cracks are small, nonworking (no spalling along edge) cracks that are visible at the surface but do not penetrate through the full depth of concrete. Shrinkage cracks most commonly occur shortly after construction due to concrete shrinkage during the curing process. Shrinkage cracks are usually so small that they are not visible until staining or material loss at crack edges begins to take place. Shrinkage cracks do not represent a structural weakness, and no corrective action is prescribed.

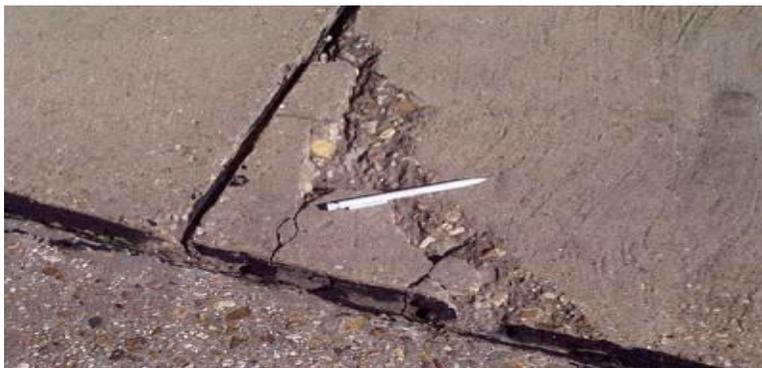
Example of Joint and Corner Spalling

Spalls at slab joints and corners are caused by excessive internal stress in the pavement. Spalls occur when these stresses exceed the shear strength of the concrete. Spalling usually results from thermal expansion during warm or hot weather. As slabs expand, they push against one another at joints. If the joints are filled with incompressibles, such as sand, or if adjacent slabs offset slightly, stresses can become severe, causing spalls. Spalling can be reduced significantly by conscientious maintenance of joint sealant.

Spall repair requires patching. The extent and severity of spalling on a pavement surface suggests appropriate action. For example, at low severity, spalled concrete remains securely in place in the slab. A low-severity spall should be monitored closely for further deterioration and should be patched when

spalled particles become loose in place, or at the next scheduled patching activity in the section. Medium- and high-severity spalls should be repaired immediately to prevent the incidence of FOD. If the pavement can be restored to serviceable condition, spalls should be carefully patched for long-term service. If the pavement is beyond repair, temporary patching should be considered to control FOD.

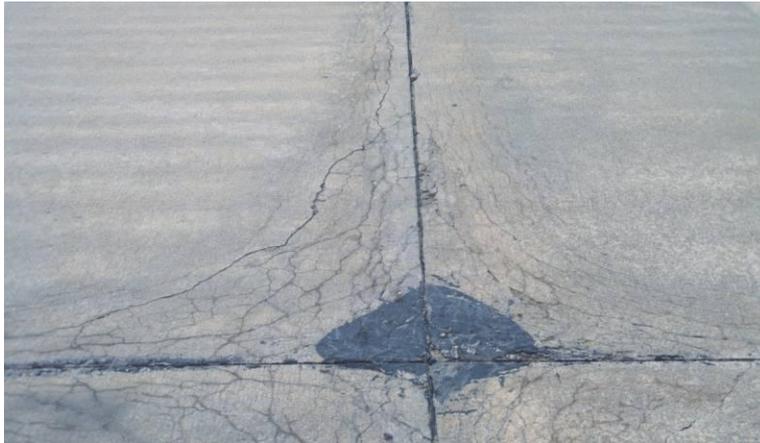
Example of Durability Cracking

Durability cracking (D-cracking) is caused by environmental factors, the most common of which is freezing/thawing. It usually appears as a pattern of hairline cracks running parallel to a joint or crack, or in a corner, where water tends to collect. This type of cracking eventually leads to disintegration of the pavement, creating FOD potential. At low severity, D-cracking is evident, but no disintegration has occurred. As the distress advances to medium severity, the distress pattern is evident over a significant area of the slab, and some disintegration and FOD potential exists. High severity durability cracking is evidenced by extensive cracking with loose and missing pieces and significant FOD potential.

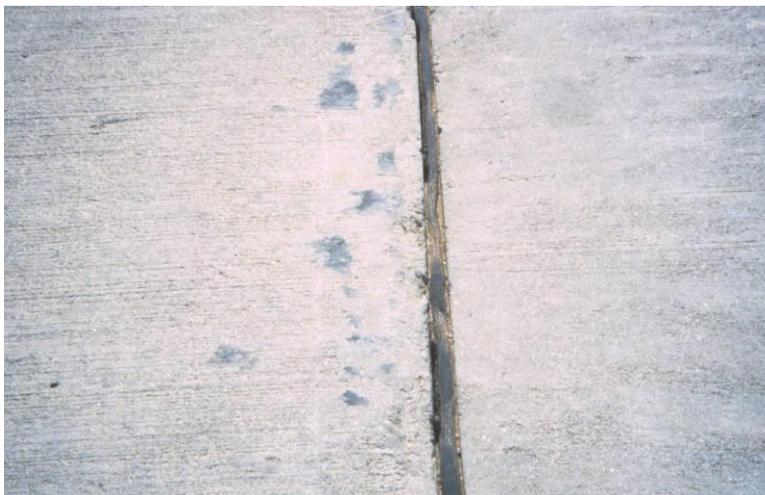
Example of Joint Seal Damage

Joint seal damage is recorded at three severities: low, medium, and high. When joint sealant is in perfect condition (no damage), it is not a distress. At low severity, at least 10 percent of the sealant is debonded but still in contact with the joint edges (i.e., joint sealant is in serviceable condition but should

be monitored for evidence of more serious failure). Medium-severity joint seal damage is recorded when at least 10 percent of the sealant has visible gaps smaller than 1/8th inch and is an indicator that replacement should be programmed as soon as is practicable. In the meantime, aggressive inspection and sustaining maintenance is recommended to minimize subsurface damage from moisture penetration. At high severity, visible gaps exceed 1/8th inch and the amount and degree of joint seal damage is such that repair is no longer feasible. The only appropriate corrective action is sealant replacement.

On serviceable pavement, deteriorated joint sealant should be repaired or replaced to preserve pavement and subgrade integrity and prolong service life. The issue is not so clear-cut with unserviceable pavement. Pavement that can be restored to serviceable condition by maintenance activities such as patching and joint seal repair, or by slab replacement, should be so maintained as long as the process is cost-effective. However, when age and condition preclude economical return to serviceable condition by such means, joint seal repair would no longer be cost-effective and should be suspended except for an interim maintenance program to control FOD potential.

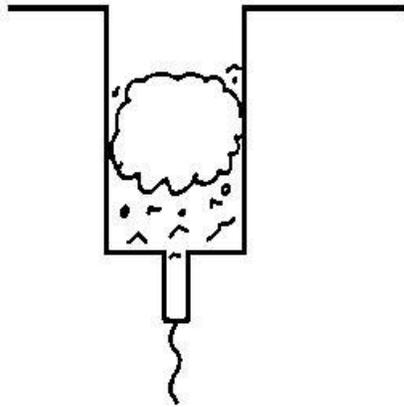
Typical joint with deficient sealant and a collection of debris & incompressibles.
