# Pavement Condition Report

## St Cloud Regional Airport (STC)

**December 2018**

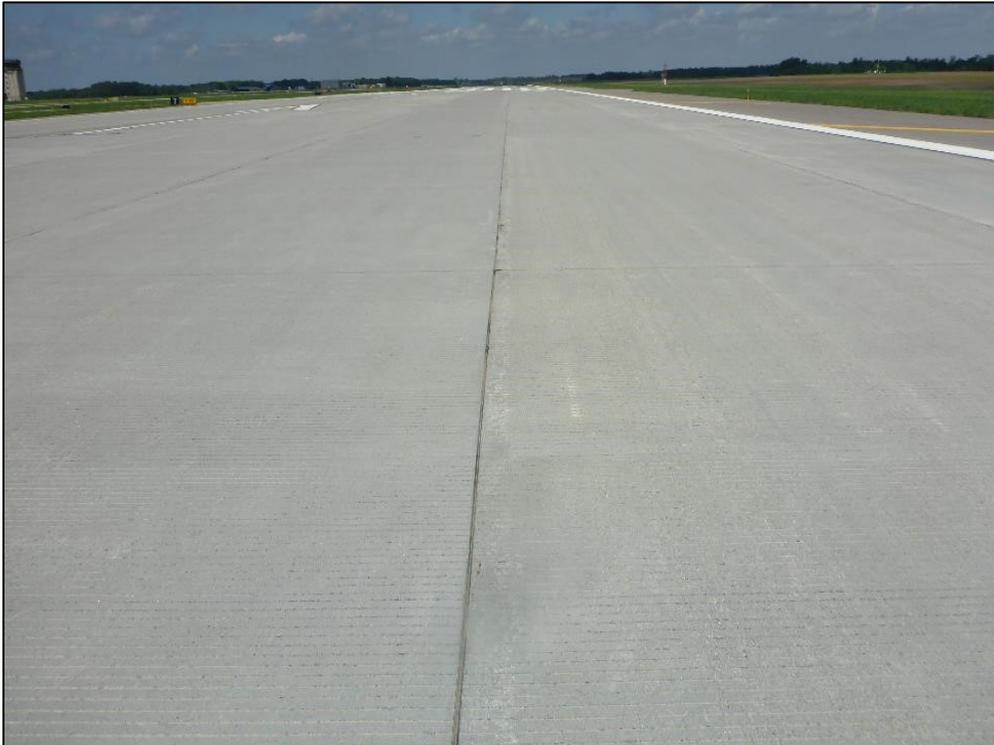
STC RY1331 003 (PCI = 94)

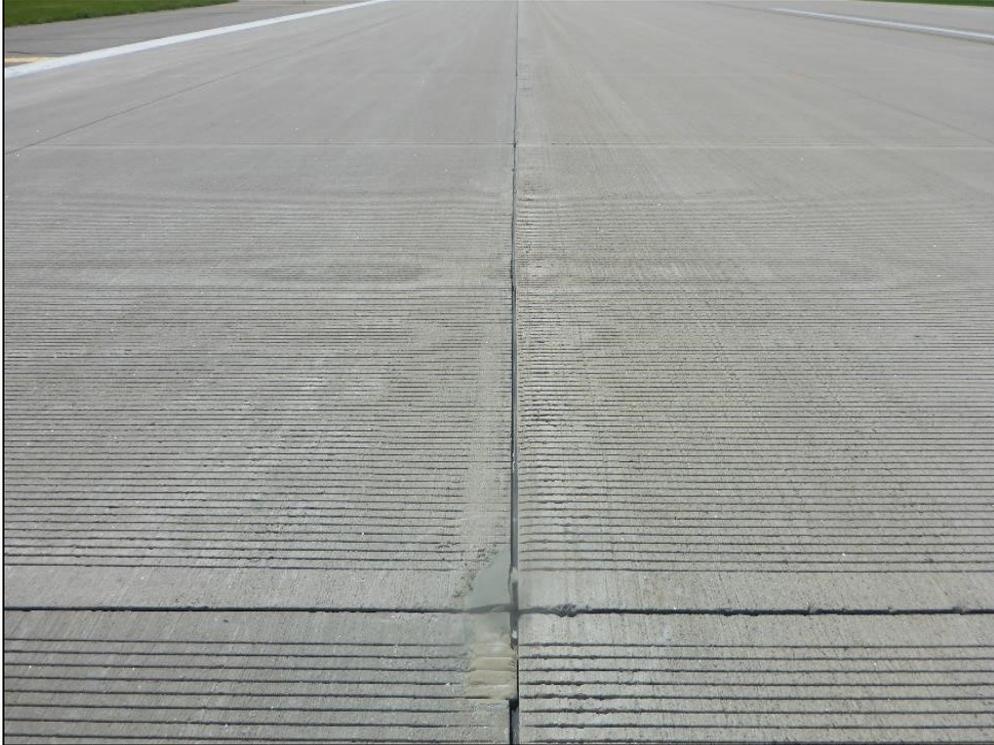
STC RY1331 003 (PCI = 94)

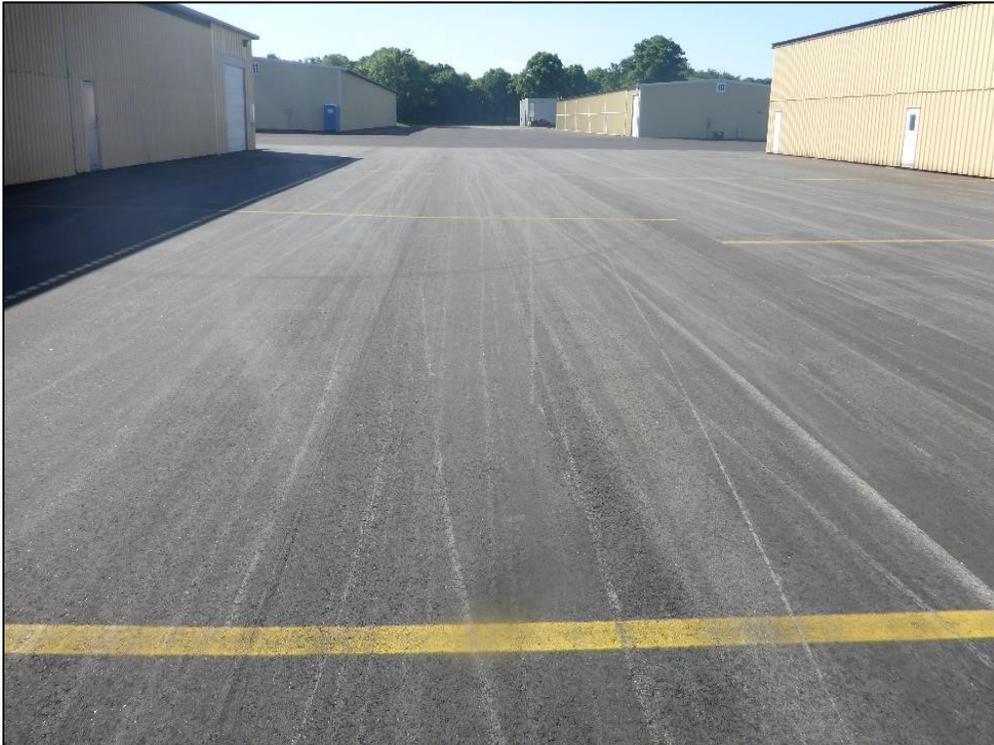
STC TLA 001 (PCI = 100)
